SIB 66 02 21

RECALL 21V-096: REARVIEW CAMERA

2021-02-22

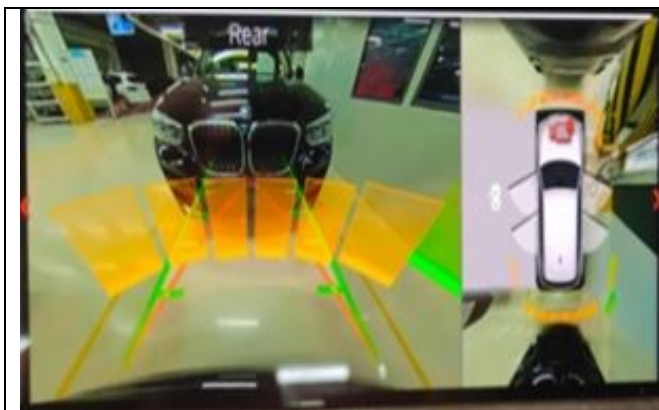
Picture 1.

The images are displayed in the **correct image position** on the CID for vehicles equipped with option code 6U3.

1. Visually check and compare the camera image in the display to pictures 1 and 2 above in the situation.
2. If the camera image displayed in the CID match picture 1, then no further repairs are required.
3. If the camera image displayed in the CID match picture 2, then complete the steps listed below.

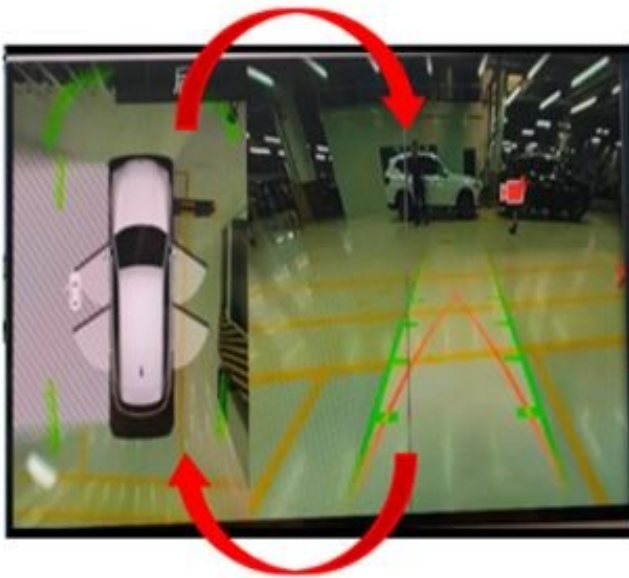
Picture 2.

Shows a possible failure in vehicles equipped with option 6U3.

The top view and rearview images are **incorrectly displayed** in the wrong position (swapped) on the CID.

Note: The camera icon is in the correct location, however it seems out of place due to wrong image location.

Software coding error in the ICAM control unit with Integration Level-

Encode the ICAM using ISTA 4.27.1x or higher (released December 2020).

4. Connect the vehicle to ISTA 4.27.1x or higher.
5. Start a new programming session, go to Advanced Tab.
6. Select **all** control units for encoding.
7. Calculate and accept measures plan.
8. Once the encoding/programming is completed, follow the rework list.
9. Depending on the rework list, if necessary, perform vehicle test and delete the error memory (faults).
10. Allow the vehicle to sleep for 5 minutes.
11. Reassess the vehicle.
Note: Camera image in the CID must match the picture 1 seen in the situation above.
12. If the image does not match picture 1, then recode the ICAM by repeating steps 5 – 9 above.

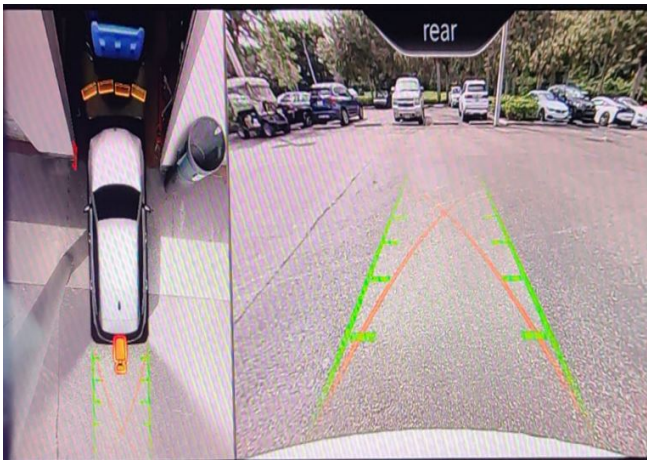
Picture 3.

Shows the **correct image position** for vehicles without option code 6U3.

1. Visually check and compare the camera image in the display to picture 3 above in the situation.
2. If the camera image is displayed in the CID match picture 3, then no further repairs are required.

3. If the CID is blank or black and the camera image is not displayed, only then should the steps listed below be completed.
4. Connect the vehicle to ISTA 4.27.1x or higher and start a new programming session.
