**Subject: BMW Recall 21V-xxx: Outer Headrest Second Row - Update**

SIB 52 04 21

## RECALL 21V-XXX : OUTER HEADREST SECOND ROW

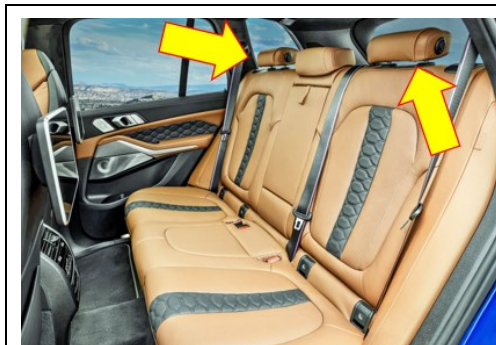
Left and right outer headrests may have been installed which do not have a positive stop movement limiter at their highest position. During a frontal impact, unsecured items (e.g., luggage) in the rear could move forward and contact the rear seat, which could cause the headrest to detach from the seat.

Check each headrest for the presence of the positive stop. If missing, replace the headrest.

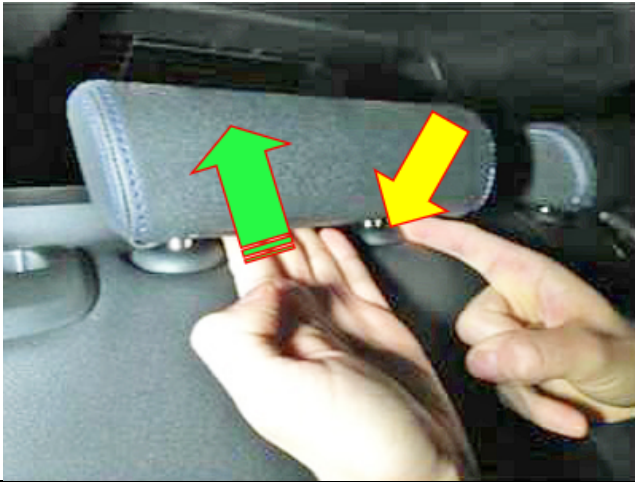
1. On either outer headrest, squeeze the headrest height release button (yellow arrow) at the seatback top retaining collar.

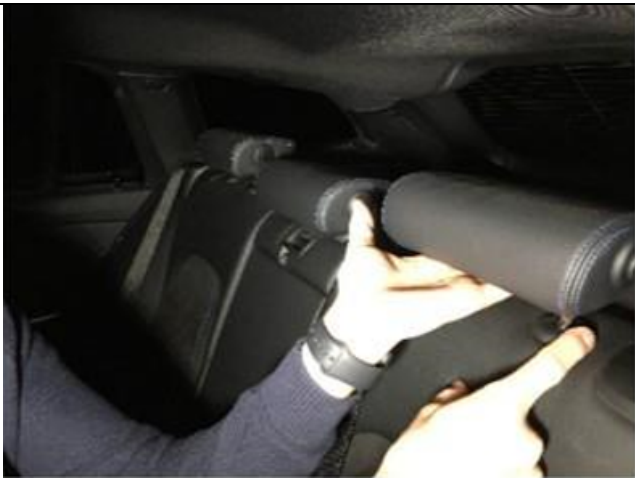
With your other hand, raise the headrest as far as possible with a light effort. Do not use excessive force to attempt raising the headrest.

a. If the headrest cannot be lifted out of the seat, the positive stop is present.

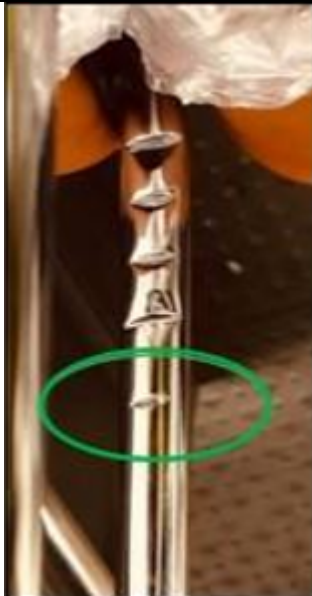
b. Carefully check if the headrest post has 5 notches (circled).

- If 5 notches are present AND the headrest cannot be lifted out of the backrest, the headrest is OK and does not need to be replaced.
- If there are only 4 notches, OR the headrest CAN be lifted out of the backrest, the headrest is NOT OK and needs to be replaced.

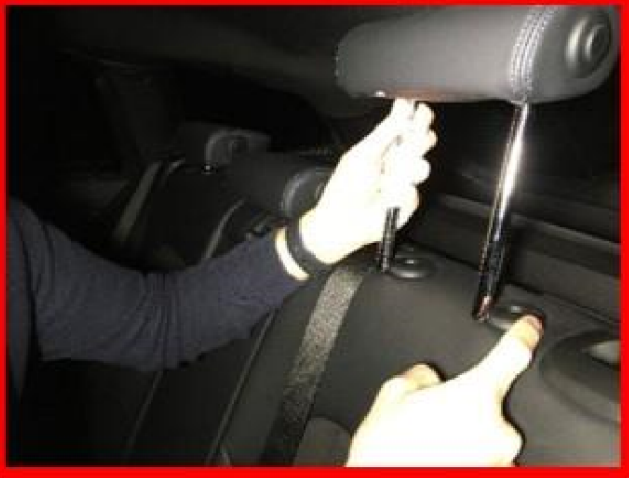
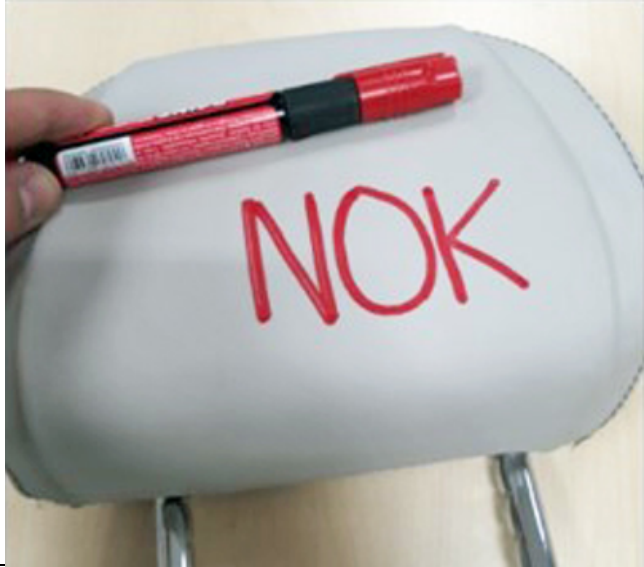
2. On headrests-

- Which can be easily pulled completely out of the backrest
- Have 4 notches in the posts

Mark the headrest "NOK" (not OK) with a permanent marker or paint pen so that it cannot be confused for a good headrest.

3. Replace the headrest with a new unit.
