RE: **Recall Campaign Launch Notification Update**
Sliding Roof Bonding - Amendment June 2021
MY06-07 203, 209, 211, 219 (C-Class, CLK-Class, CLS-Class, E-Class)

Campaign No. :	NHTSA ID	Campaign Desc. :	Sliding Roof Bonding - Amendment June 2021
2021040012	21V196	21P7891004

Campaign No. 2021040012, July 2021

SUBJECT: **Models C-Class, CLK-Class, E-Class, and CLS-Class (203, 209, 211, and 219 platform)**
Model Years 2001-2011
Sliding Roof Bonding

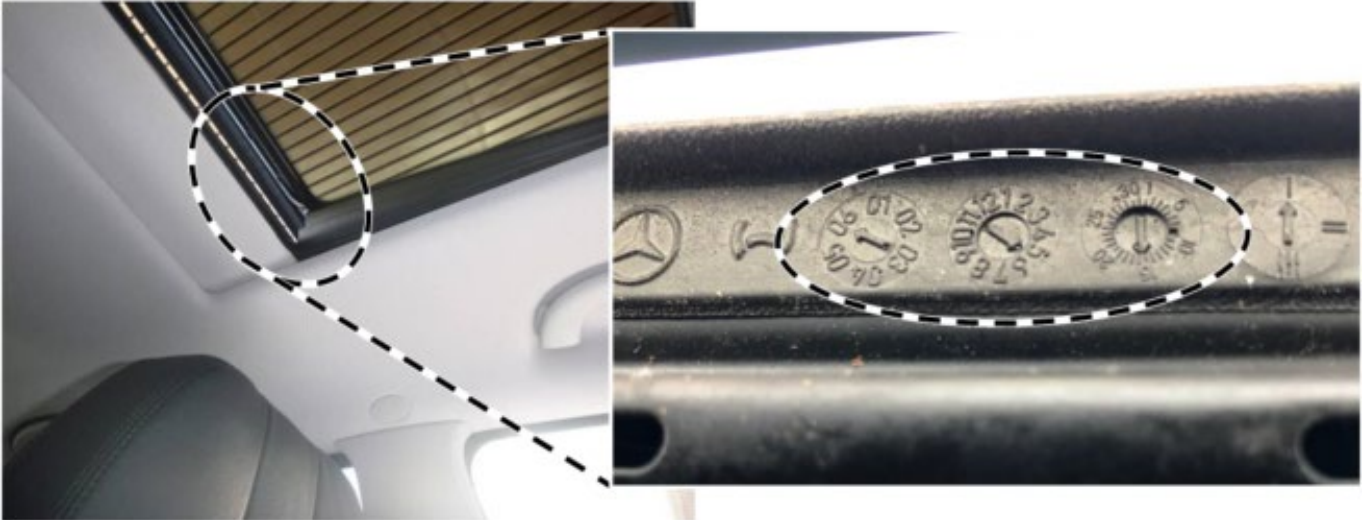
1. Move sliding sunroof to tilt position and check production date (**figure 1**).

i The production date **must** be on or **after 12-12-2005** or on or **before 07-15-2006**.

i If the production date is **not** at the shown location (**figure 1**), this vehicle is **not** affected.

Figure 1 (The production date in the sample picture is **06 year / 5 month / 15 day**)(5-15-2006)

A. Production date between 12-12-2005 and 07-15-2006: Carry out **check/test procedure B**.

B. Production date **not** between 12-12-2005 and 07-15-2006: **End measure**.

C. **No** production date present at shown location (figure 1): **End measure**.

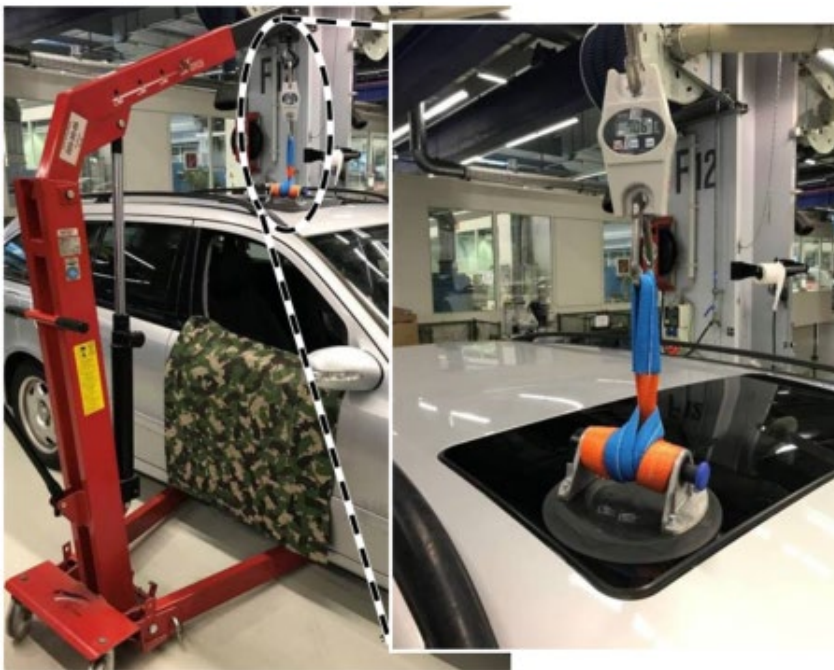
Figure 2

3. Position cup suction tool (**figure 2**) and pull as **vertically** as possible (tolerance of ± 10 degrees) using lifting tool (hoist/crane).

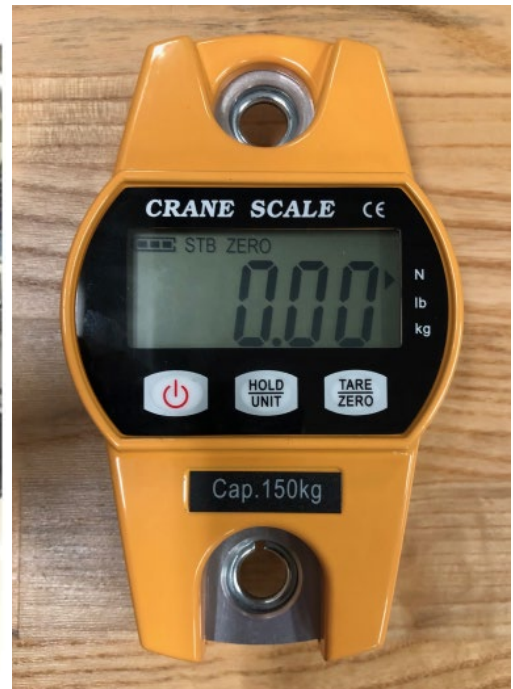
i Before the start of the measurement, the "(auto) hold function" of the hanging scale **must** be deactivated and the measurement scale is set to N (see operator's manual). (**See figure 3**) for correct scale display.

Figure 3 (Correct scale display)

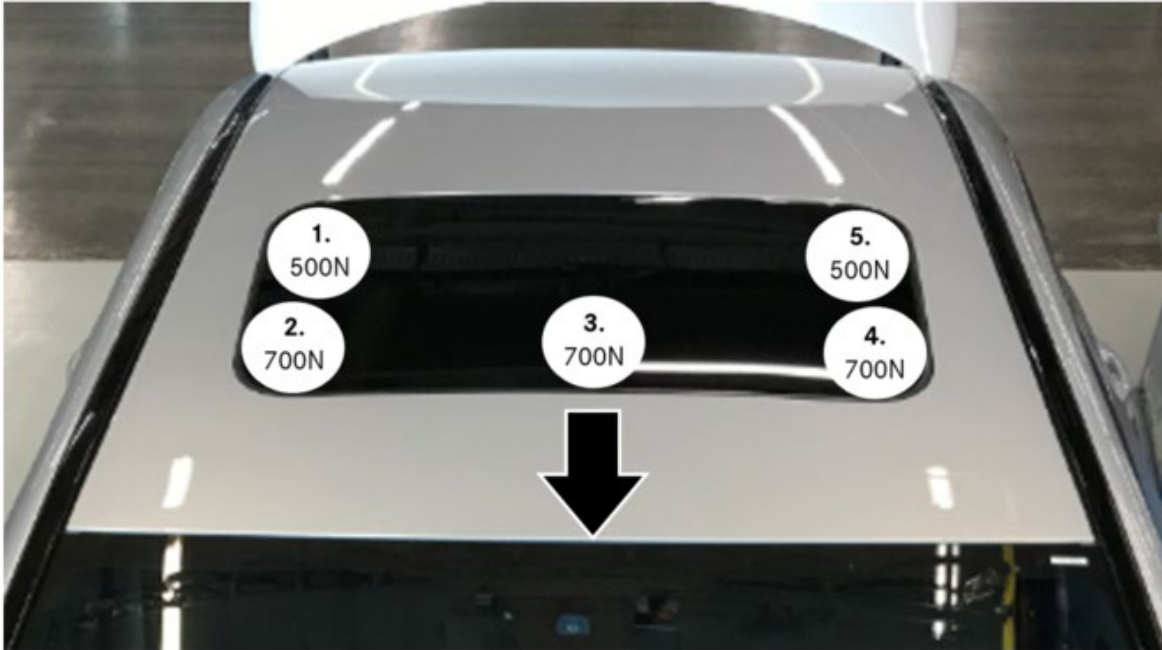
i Specified force **500 N/700N** (**figure 4**). **Please note that the scale is in N (newton) and should be measured in N. DO NOT attempt to convert to any other measurement. An incorrect conversion could result in an inaccurate test result and/or damage to the testing equipment and/or the vehicle. Any costs associated with an improper repair will be the responsibility of the repairing dealer.**

i Position cup suction tool at 5 positions in the sequence **1, 2, 3, 4, 5: (Figure 4)**.

Figure 4 (test sequence 1, 2, 3, 4, 5 – arrow specifies front of vehicle)

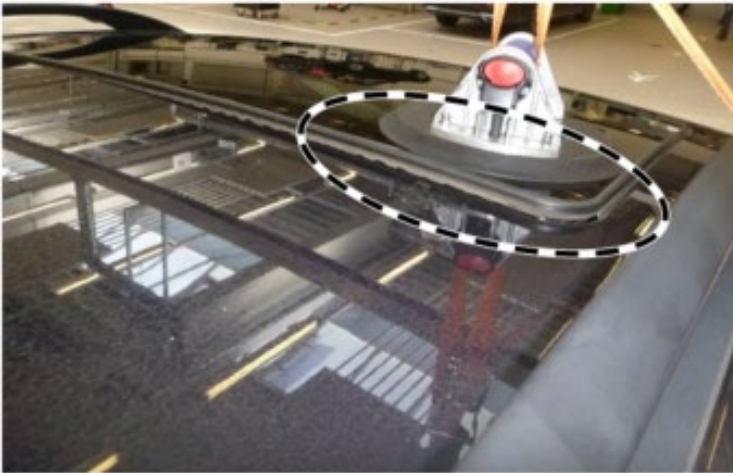
Figure5

- i** The sliding roof panel is lifted out of the roof frame noticeably at the rear test positions 1 and 5 (**figure5**).
- i** If the sliding roof panel detaches from the padding of the tilting/sliding roof frame at one of the test positions (**see figure 6**), the sliding roof panel must be replaced.

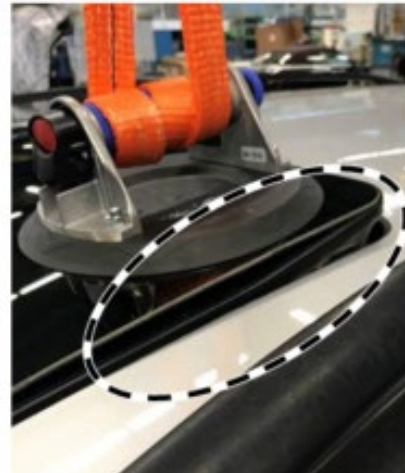
Figure 6 (NOT OK)

- D. If the sliding roof panel detaches from the padding: Carry out **work procedure**.
- E. If the sliding roof panel does **not** detach from the padding: **End measure**.
