RE: **Recall Campaign Launch Notification**
Sliding Roof Bonding - Amendment March 2021
MY06-07 203, 209, 211, 219 (C-Class, CLK-Class, CLS-Class, E-Class)

Campaign No. 2021040012, April 2021

SUBJECT: **Models C-Class, CLK-Class, E-Class, and CLS-Class (203, 209, 211, and 219 platform)**
Model Years 2001-2011
Sliding Roof Bonding

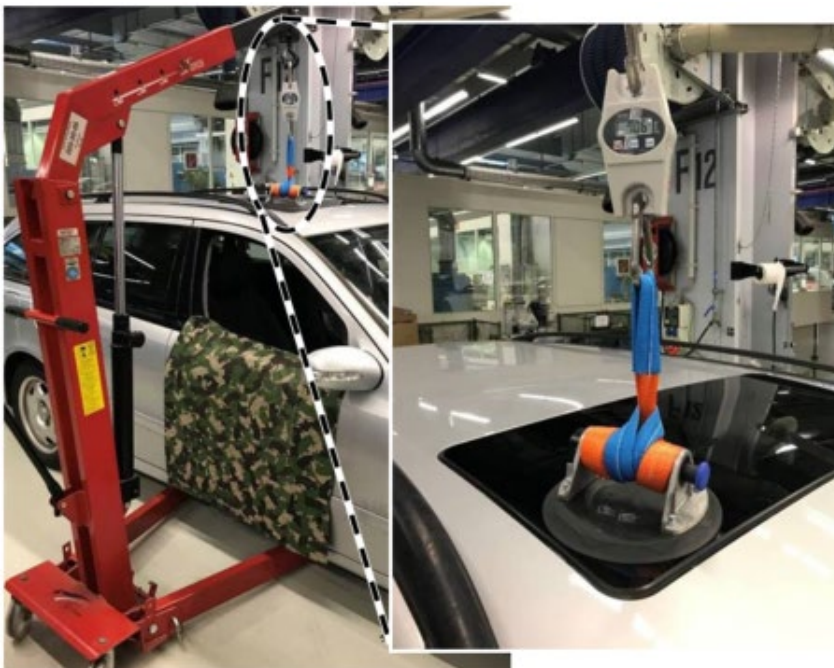
Figure 2

3. Position cup suction tool (**figure 2**) and pull as **vertically** as possible (tolerance of ± 10 degrees) using lifting tool (hoist/crane).

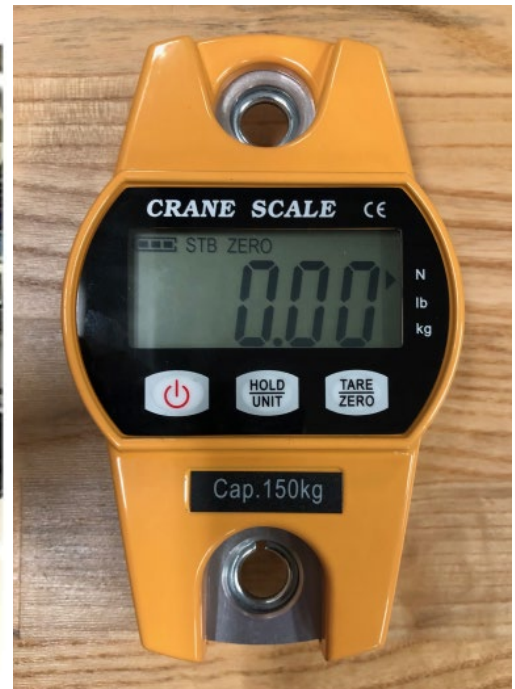
i Before the start of the measurement, the "(auto) hold function" of the hanging scale **must** be deactivated and the measurement scale is set to N (see operator's manual). **(See figure 3) for correct scale display.**

Figure 3 (Correct scale display)

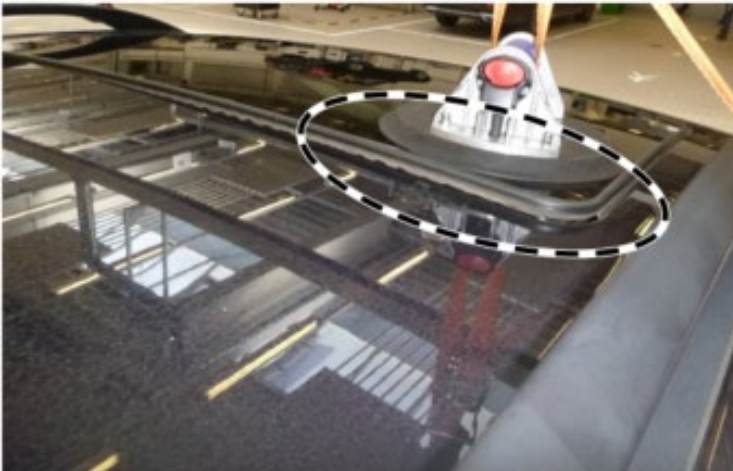
Figure5

- i** The sliding roof panel is lifted out of the roof frame noticeably at the rear test positions 1 and 5 (**figure5**).
- i** If the sliding roof panel detaches from the padding of the tilting/sliding roof frame at one of the test positions (**see figure 6**), the sliding roof panel must be replaced.

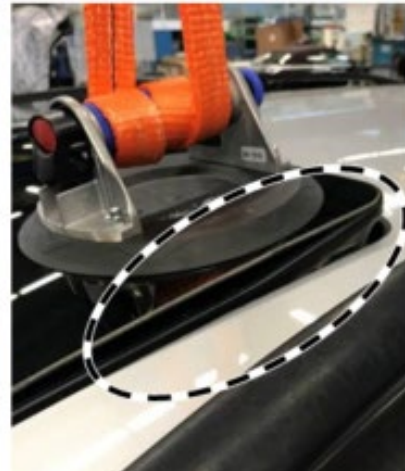
Figure 6 (NOT OK)

- D. If the sliding roof panel detaches from the padding: Carry out **work procedure**.
- E. If the sliding roof panel does **not** detach from the padding: **End measure**.
