FL884 (D21R6) **REV1**

NHSTA #21V-256 (Non-School Bus)

**Subject: DETROIT™ Tie Rod & Steer Arm Bolt Replacement**

**Models Affected: DETROIT™ Model 2 and Model 3 Steer Axles**

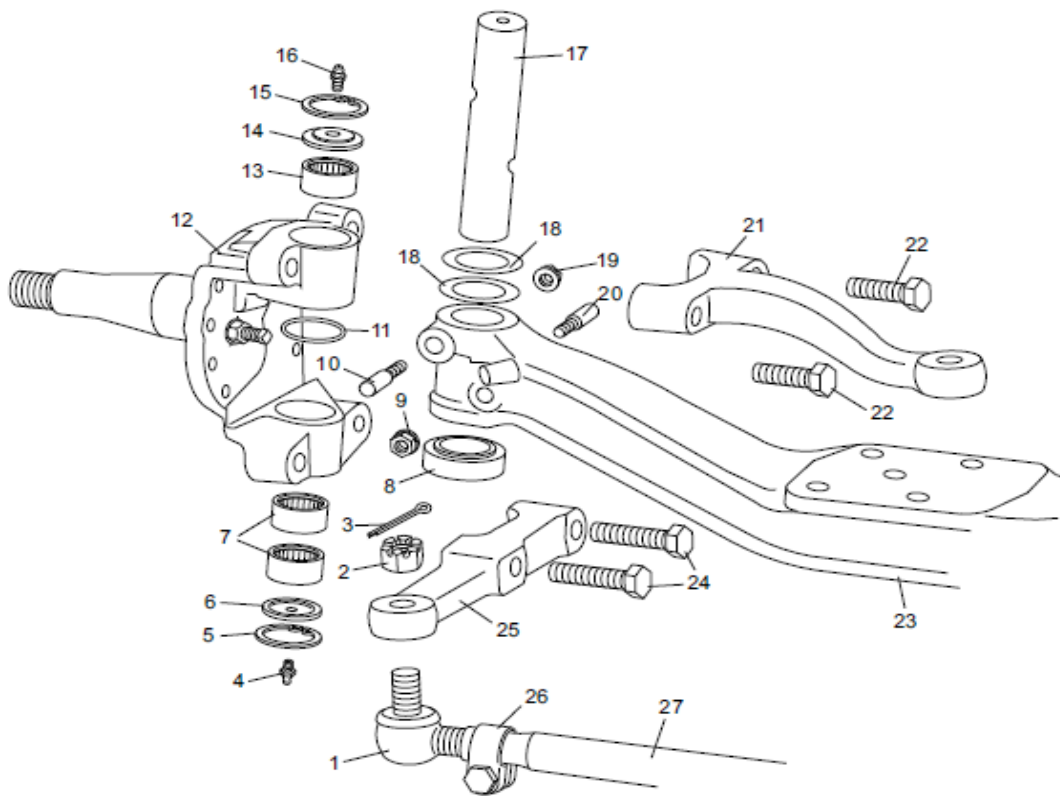
**Fig. 1, Front Axle Components, Integral Steering Gear (driver side shown)**

On certain Detroit Model 2 and 3 steer axles, the tie rod arm and steering arm bolts used to assemble front axle assemblies have a lengthwise "seam" defect which increases stress concentration, potentially leading to bolt failure or loss of pre-load.

**Only one bolt must be replaced at a time. If both tie-rod arm bolts, or both steering arm bolts are removed at the same time, a full truck alignment is required to be performed, which is not covered in this recall.**

8. At the passenger side, replace one tie-rod arm bolt as follows.
  - 8.1. Remove and discard the bolt.
  - 8.2. Clean the threaded hole from which the bolt was removed, and remove all oil and debris.

- 8.3. Clean a new bolt, remove any oil, and dry it completely.
  - 8.4. Apply Loctite® 277 to the bolt threads.
  - 8.5. Install the bolt on the steering knuckle. Tighten bolt to 425 lbf.ft (575 N.m).

9. Replace the other passenger side tie-rod arm bolt. Refer to substeps in step 8.
10. Turn the steering wheel to the left full-lock position.
11. At the driver's side, replace one tie-rod arm bolt. Refer to substeps in step 8.

12. Replace the other driver's side tie-rod arm bolt. Refer to substeps in step 8.
13. Replace one steering arm bolt. Refer to substeps in step 8.
14. Replace the other steering arm bolt. Refer to substeps in step 8.
