TO: Mercedes-Benz Dealer Principals, General Managers, Sales Managers, Service Managers, Parts Managers	FROM: Gregory Gunther, Department Manager, Vehicle Compliance and Analysis, Engineering Services
RE: Recall Campaign Launch Notification - Update Vehicle Body Sealing – water intrusion - Supplemental MY20 247 (GLB-Class)	Date: July 9, 2021

Campaign No. 2020070009, July 2021

SUBJECT: **Model GLB-Class vehicles (247 platform)**
Model Year 2020

Vehicle Body Sealing- water intrusion

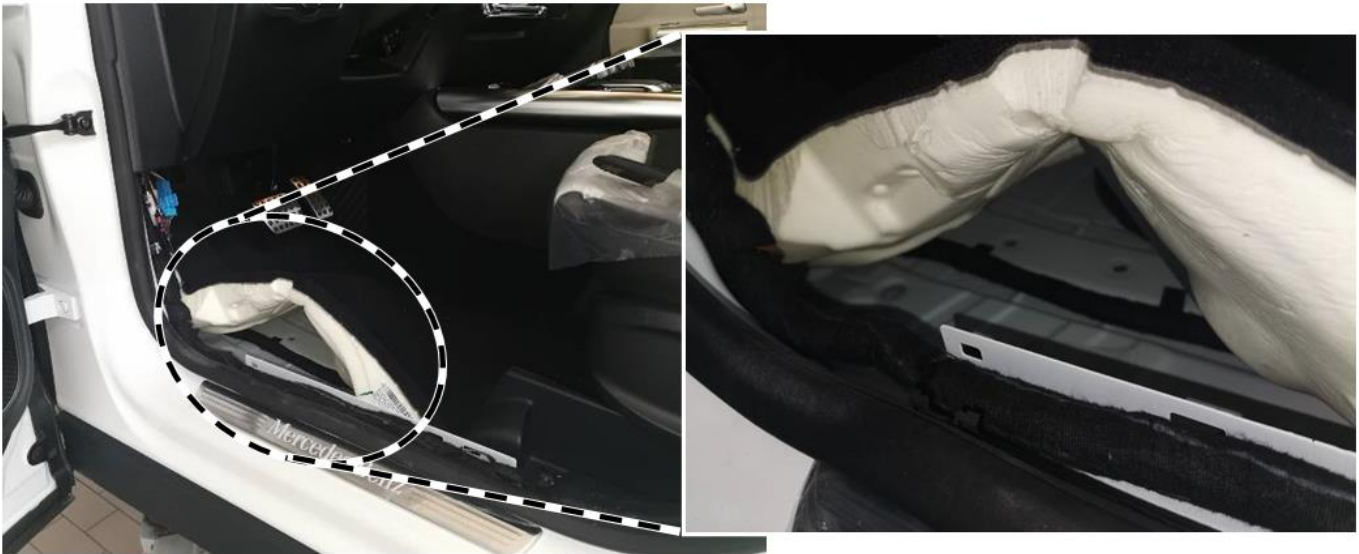
Figure 1

1. Remove right and left front door sills (**AR68.30-P-4101MFA**).
2. Lift floor covering in footwell on front driver's side and front passenger side and check for moisture (**Figure 1**).
i There may be no ingress of water under the floor covering in the footwell on the front driver's side and/or front passenger side.

- a. **No** ingress of water in footwell on front driver's side and/or front passenger side: **End measure.**
- b. Ingress of water in footwell on front driver's side and/or front passenger side:
Carry out **work procedure.**

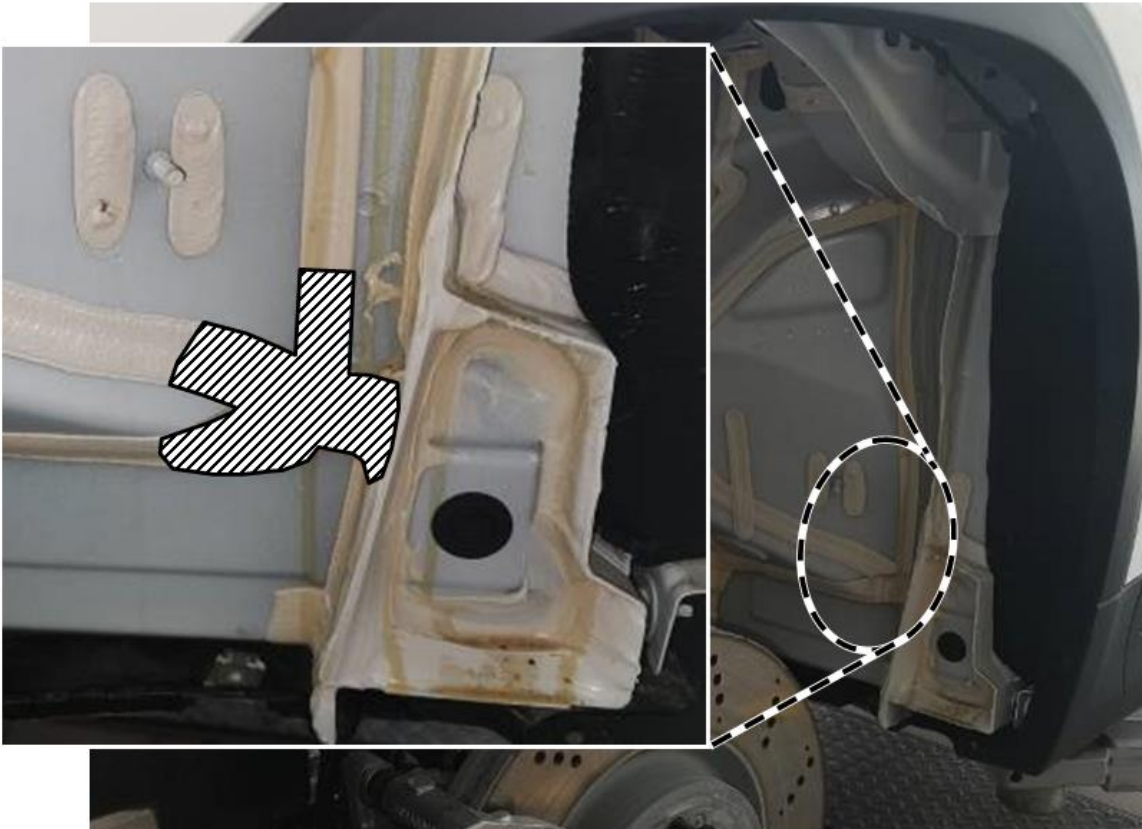
**Figure 2**

Mercedes-Benz AG ("MBAG"), the manufacturer of Mercedes-Benz vehicles, has determined that on certain Model Year ("MY") 2020 GLB-Class vehicles (247 platform), the vehicle body might not be sealed in the area of the front wheel wells according to current production specifications. Under certain conditions, it is possible for water to enter from the wheel wells into the front occupant foot wells. This might impair the functionality of control units and other electric components installed in these areas. For example, the instrument cluster might malfunction and not display any information. Furthermore, the engine might stall during driving or might not start, which could increase the risk of injury or a crash. The occupants might observe wet carpets in the front foot wells and fogged windows. In the event that water intrusion is confirmed, the necessary repairs will be performed.

1. Remove rear section of right and left front fender liners.
i For basic data, see (AR88.10-P-1301MFA).
2. Clean/prime seam seal on right and left of firewall (marked area) and rework with transparent seam seal (Figure 2).

3. Expose affected footwell, check component parts and wiring harnesses for water and signs of corrosion.
i After the inspection, repair or replace affected component parts.
