Campaign No. 2021090008, October 2022

SUBJECT: **Model AMG GT-Class vehicles (190 platform)**
Model Year 2016-2018
Check Carbon-Fiber Driveshaft Bonding

Order No. P-RC-2021090008

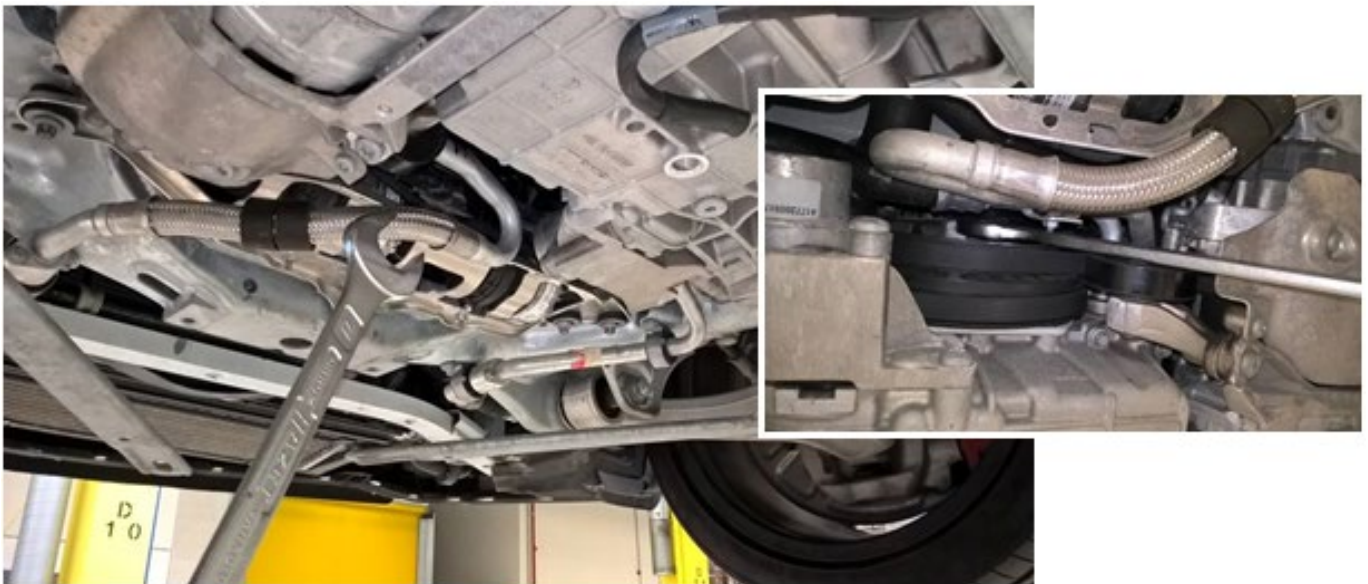
**Figure 2**

2. Open maintenance access on engine-side drive shaft housing.

Rotate engine at center bolt in direction of rotation until affixed label on drive shaft is visible.

- i** Rotate engine at center bolt in direction of rotation with a 27 mm open end wrench.

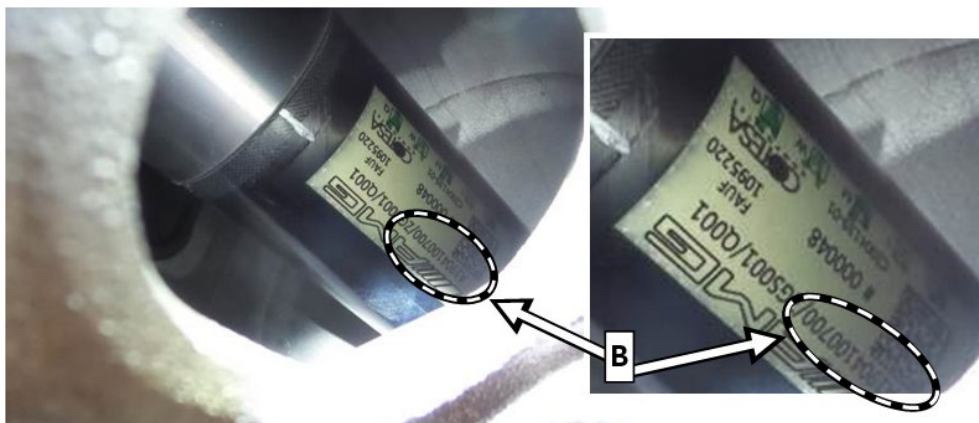
Figure 3

3. Check part item number (**B, figure 3**) of drive shaft.

- a. If part item number is **A 190 410 07 00**:
Carry out **work procedure**.
- b. If part item number is **A 190 410 06 00** or **A190 410 14 00** or **A 190 410 23 00**:
End measure.

1. Replace drive shaft.
i For basic data, see **AR41.10-P-0051MNB**.
