TO: Mercedes-Benz Dealer Principals, General Managers, Sales Managers, Service Managers, Parts Managers	FROM: Gregory Gunther, Department Manager, Vehicle Compliance and Analysis, Engineering Services
RE: <b>Recall Campaign Launch Notification</b> <b>Check Carbon-Fiber Driveshaft Bonding –Wave 2</b> <b>MY16-18 190 (AMG GT-Class)</b>	DATE: <b>June 3, 2022</b>

Campaign No. 2021090008, June 2022

SUBJECT: **Model AMG GT-Class vehicles (190 platform)**  
**Model Year 2016-2018**  
**Check Carbon-Fiber Driveshaft Bonding**

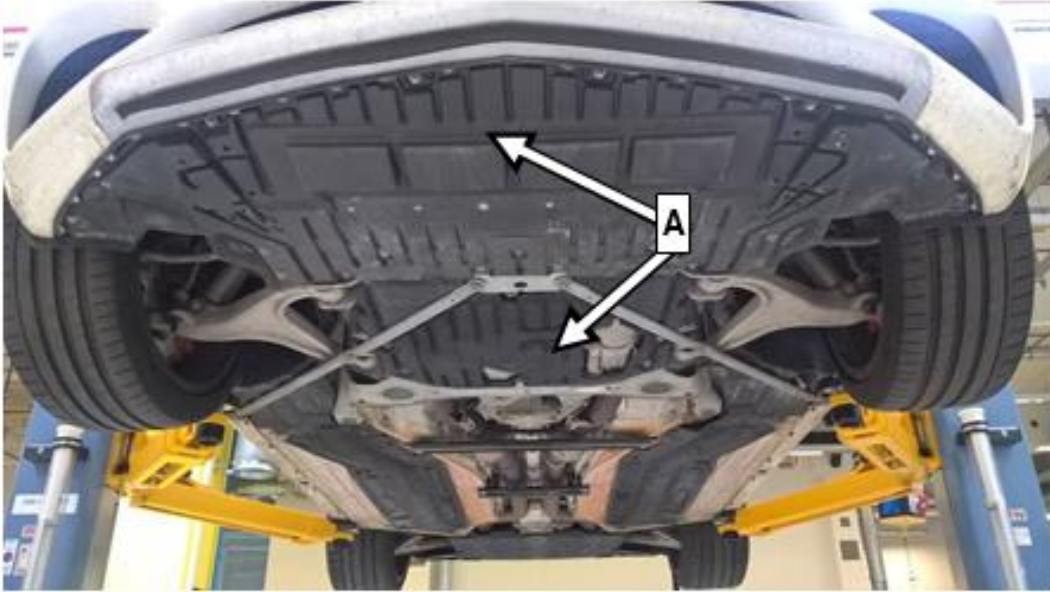
**Figure 1**

1. Remove lower engine compartment lining (A, figure 1).

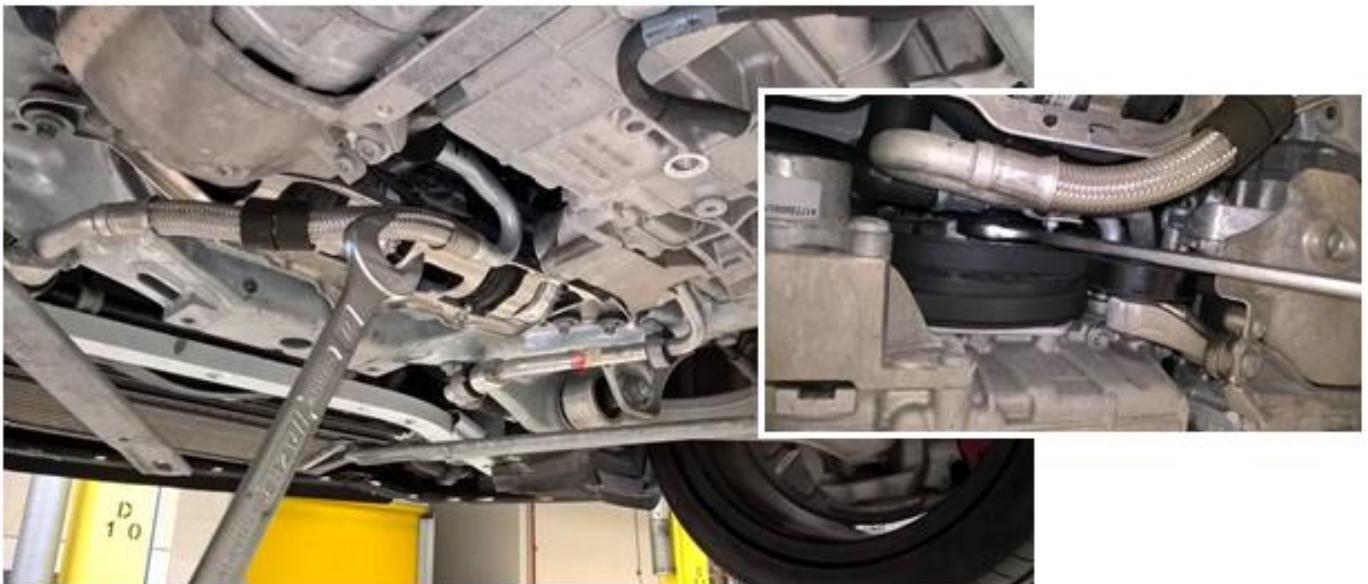
**Figure 2**

2. Open maintenance access on engine-side drive shaft housing.

Rotate engine at center bolt in direction of rotation until affixed label on drive shaft is visible.

- i** Rotate engine at center bolt in direction of rotation with a 27 mm open end wrench.

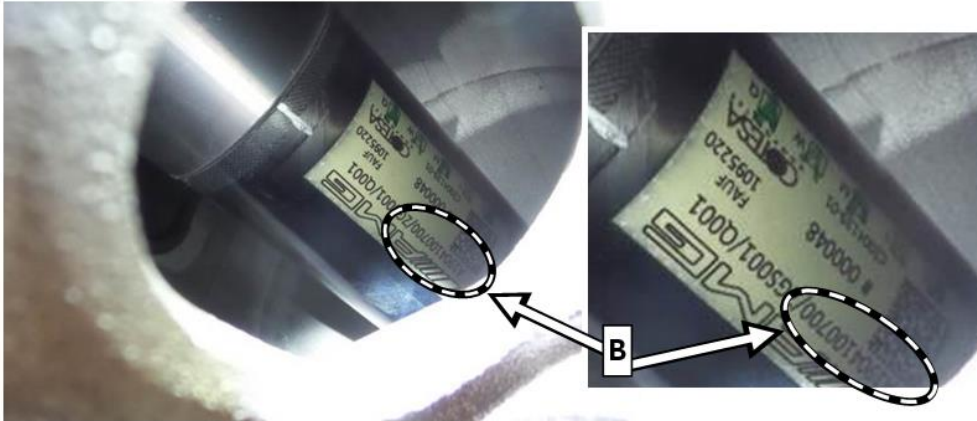
Figure 3

3. Check part item number (**B, figure 3**) of drive shaft.

- a. If part item number is **A 190 410 07 00**:  
Carry out **work procedure**.
- b. If part item number is **A 190 410 06 00** or **A190 410 14 00** or **A 190 410 23 00**:  
**End measure**.

1. Replace drive shaft.  
**i** For basic data, see **AR41.10-P-0051MNB**.
