TO: Mercedes-Benz Dealer Principals, General Managers, Sales Managers, Service Managers, Parts Managers	FROM: Gregory Gunther, Department Manager, Vehicle Compliance and Analysis, Engineering Services
RE: Recall Campaign Launch Notification Check the Rear Seat Row Seat Belts MY21-22 CLS-Class, G-Class, E-Class, AMG GT-Class (257, 213, 463, 290 platform)	DATE: September 10, 2021

Campaign No. :	NHTSA ID	Campaign Desc. :
2021080021	21V483	21P9290006

Check the Rear Seat Row Seat Belts

SUBJECT: **Model CLS-Class, G-Class, E-Class, AMG GT-Class vehicles
(257, 213, 463, 290 platform)
Model year 2021-2022**

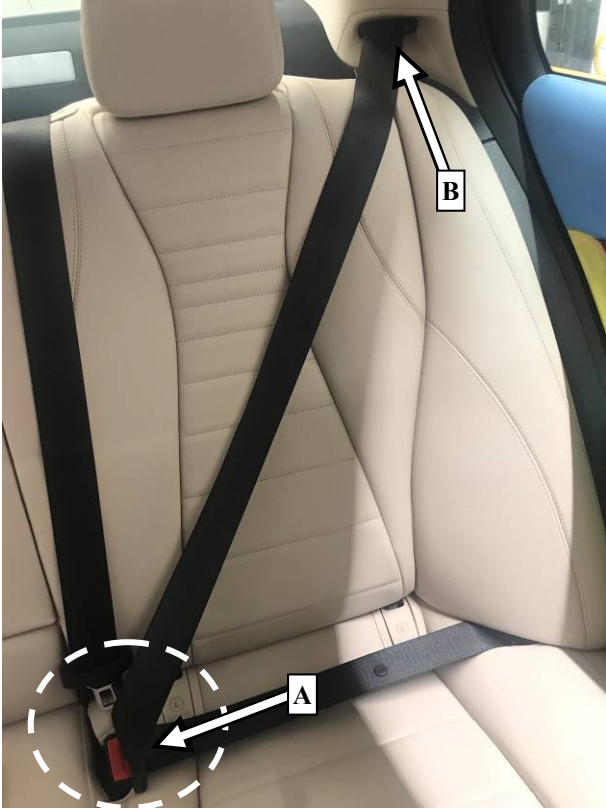
Figure 1

1. Insert seat belt latch (A, figure 1) into its respective seat belt buckle for the designated seating position.

2. Pull the seat belt webbing until **the entire length has been completely spooled out of the inertial reel, up to the end stop (B, figure 1)**.
3. Allow seat belt webbing to retract slowly until it is fully retracted and confirm:

- i** The seat belt latch remains engaged in the buckle.
 - i** A distinct ratcheting noise can be heard at the inertia reel as it is retracting.
 - i** The ratcheting noise indicates that the Automatic Locking Retractor (ALR) child seat safety feature has been activated.

4. Carefully try to pull the seat belt webbing out of the inertia reel.
 - i** Do not jerk the webbing while pulling.
 - i** **It must not be possible to pull out the seat belt webbing: It must remain engaged.**

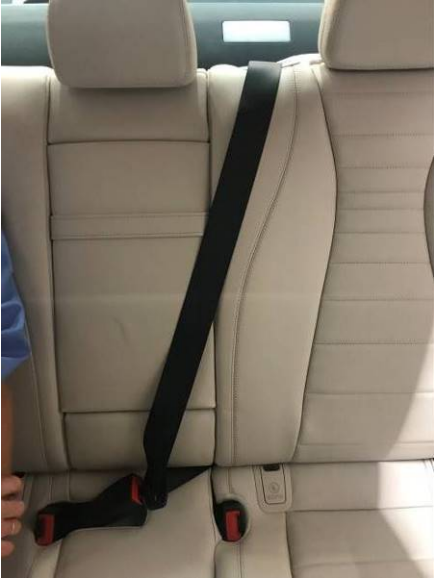
Figure 2

8. Insert center seat belt latch from the second row seat into its respective seat belt buckle.

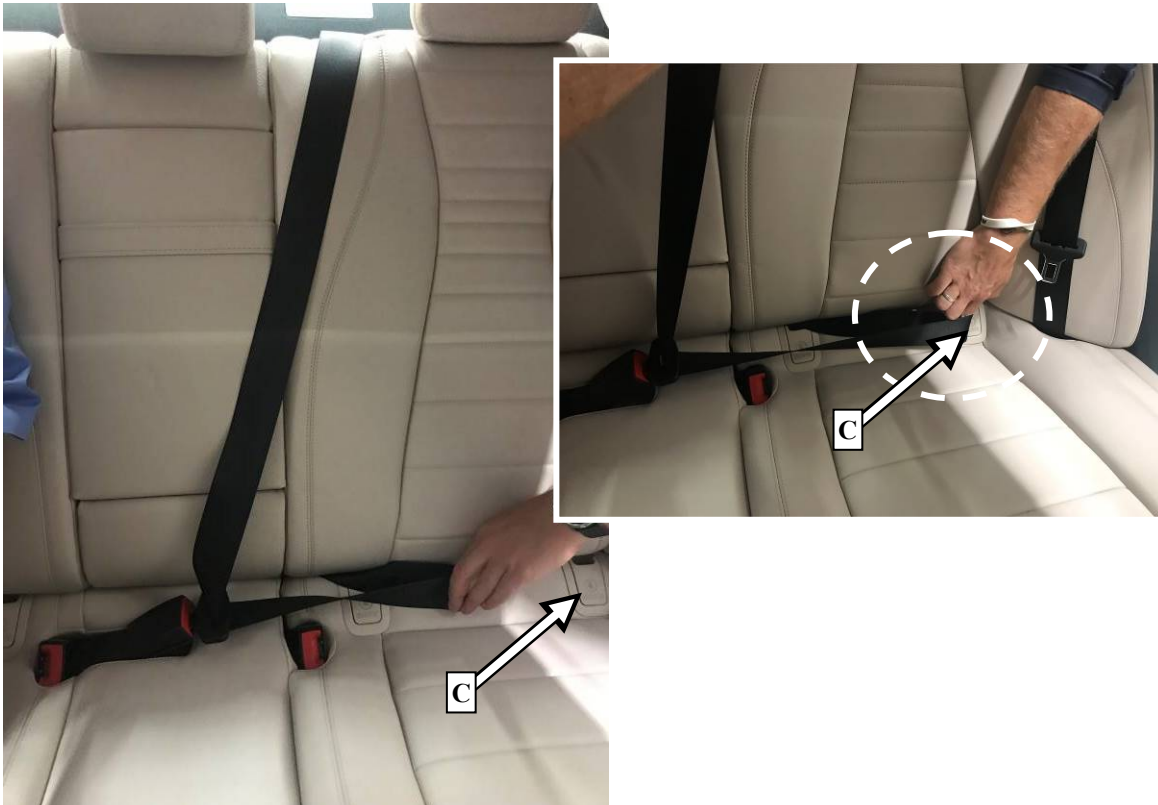
Figure 3, model 213

9. Pull on the seat belt webbing below the seat belt latch, and form a loop, extending to the outer-left ISOFIX mount (C, figures 3 and 4), and keep holding it in place for the next check.

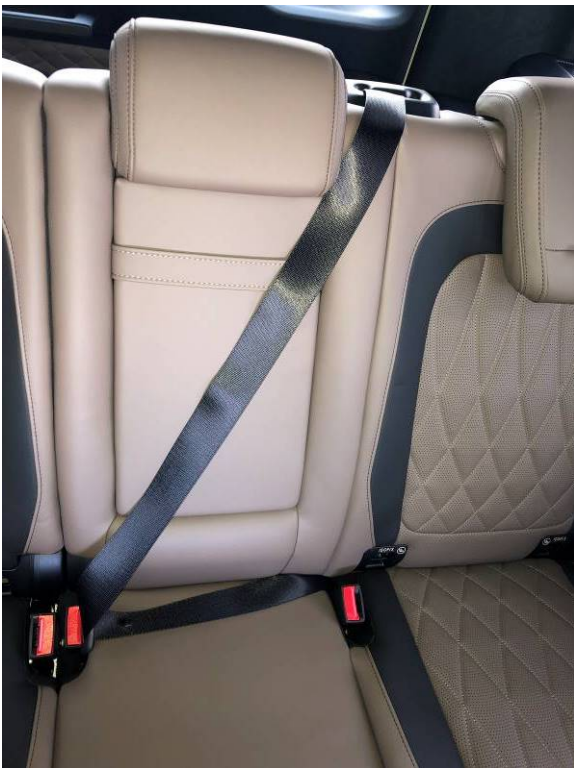
Figure 5, model 463

i Forming a loop is **not** required with model 463.
