TO: Mercedes-Benz Dealer Principals, General Managers, Sales Managers, Service Managers, Parts Managers	FROM: Gregory Gunther, Department Manager, Vehicle Compliance and Analysis, Engineering Services
RE: Recall Campaign Launch Notification Check the Side-impact Crash Sensor MY20-21 CLS-Class, E-Class, G-Class, AMG GT-Class, GLC-Class and S-Class (213, 222, 253, 257, 290 and 463 platform)	DATE: August 20, 2021

Campaign No. 2021070033, August 2021

SUBJECT: **Models various**
Model year 2020-2021**Check the Side Crash Sensor (Front doors only)**

Check airbag pressure sensors in front doors, replace if necessary

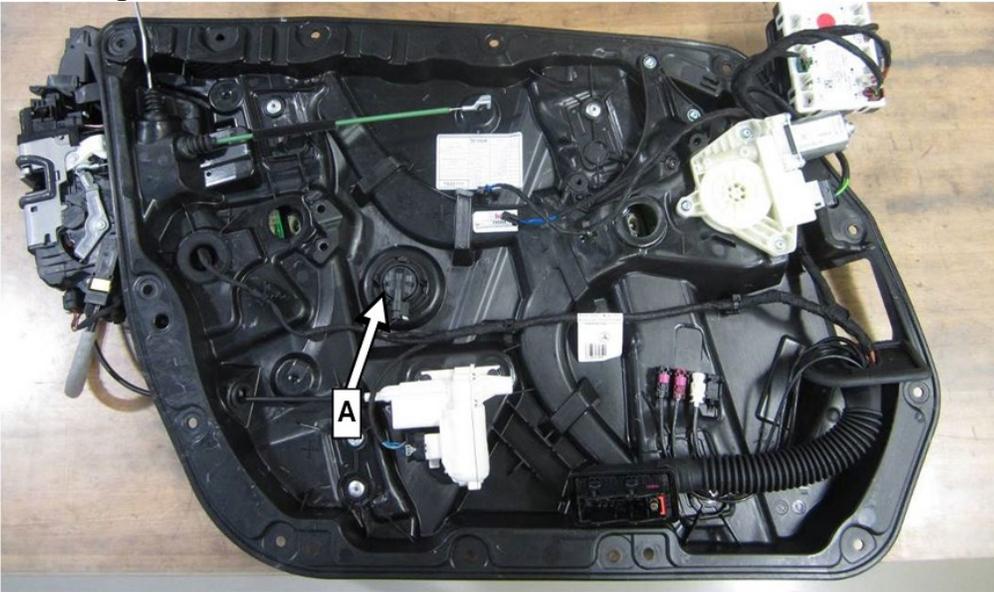
Figure 1, shown on model 213

1. Remove door lining on left and right front doors.
 - i** For basic data of models **213** and **253**, see **AR72.10-P-1000LW**.
 - i** For basic data of model **222**, see **AR72.10-P-1000LF**.
 - i** For basic data of models **257** and **290**, see **AR72.10-P-6575FR**.
2. Disconnect plug from airbag pressure sensors (**A, Figure 1**) of front doors and check whether two catch tabs (**B, Figure 2**) are present.
 - i** Door modules need **not** be removed.
 - i** There must be **two catch tabs**.
 - i** Figure 3 is **not OK**.

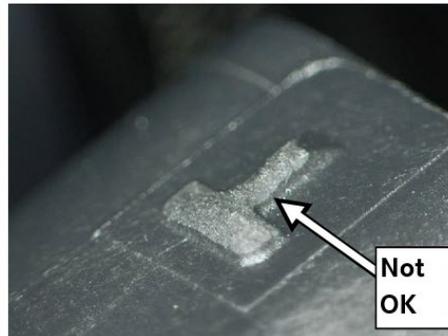
Figure 3, not OK

- a. Only **one catch tab** present: Carry out **work procedure**.
- b. **Two catch tabs** present: **End measure**.

1. Replace defective airbag pressure sensor.
 -
