SUBJECT: NEW VEHICLE DEMONSTRATION / DELIVERY HOLD Safety Recall 21S31

Certain 2020 - 2021 Model Year F-350 Pickup Trucks Equipped with 6.7L Diesel

Engine and Single Rear Wheel Axle – **Supplement #3**

Spring Seat Weld

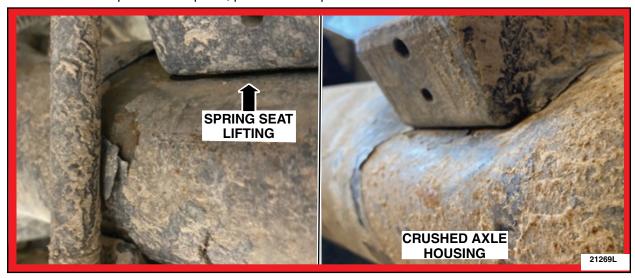
FIGURE 1

- 3. Visually inspect the front of the rear axle housing assembly below the leaf spring seat brackets for damage (dents, creases). See Figure 1.
- 4. Visually inspect the rear of the leaf seat spring bracket for damage (rips or breaks in the metal or welds) and to see if the leaf spring seat bracket is pulling away from the rear axle housing assembly.
 See Figure 1.
- 5. Inspection results. Is there damage present to either the LH or RH rear leaf spring seat brackets?
 - Yes Fails visual inspection, the rear axle housing will require replacement. Please follow the WSM procedures in Section 205-02A.
 - No Further inspection is required, proceed to Step 6.

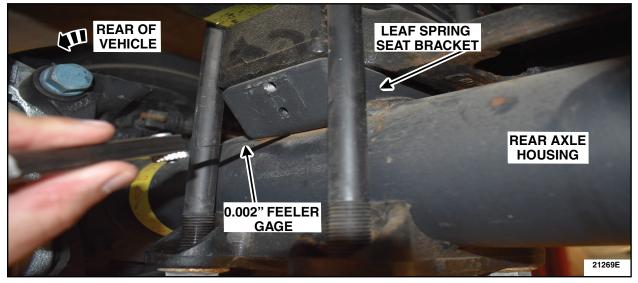
FIGURE 2

- 6. Using a 0.002" feeler gage measure the gap along the rear of the leaf spring seat bracket to the rear axle housing assembly. Is the gap greater than 0.002" on either the LH or RH side? See Figure 2.
 - YES The rear axle housing will require replacement. Please follow the WSM procedures in Section 205-02A.
 - NO Proceed to the Leaf Spring Seat Bracket Interface Weld Repair Procedure on Page 3.
