David J. Johnson
 Director
 Service Engineering Operations
 Ford Customer Service Division

SUBJECT: **NEW VEHICLE DEMONSTRATION / DELIVERY HOLD**
Safety Recall 21S31 - Supplement #1
 Certain 2020 - 2021 Model Year F-350 Pickup Trucks Equipped with 6.7L Diesel Engine and Single Rear Wheel Axle Spring Seat Weld

NEW VEHICLE DEMONSTRATION / DELIVERY HOLD Safety Recall 21S31 - Supplement #1

Certain 2020 - 2021 Model Year F-350 Pickup Trucks
Equipped with 6.7L Diesel Engine and Single Rear Wheel Axle
Spring Seat Weld

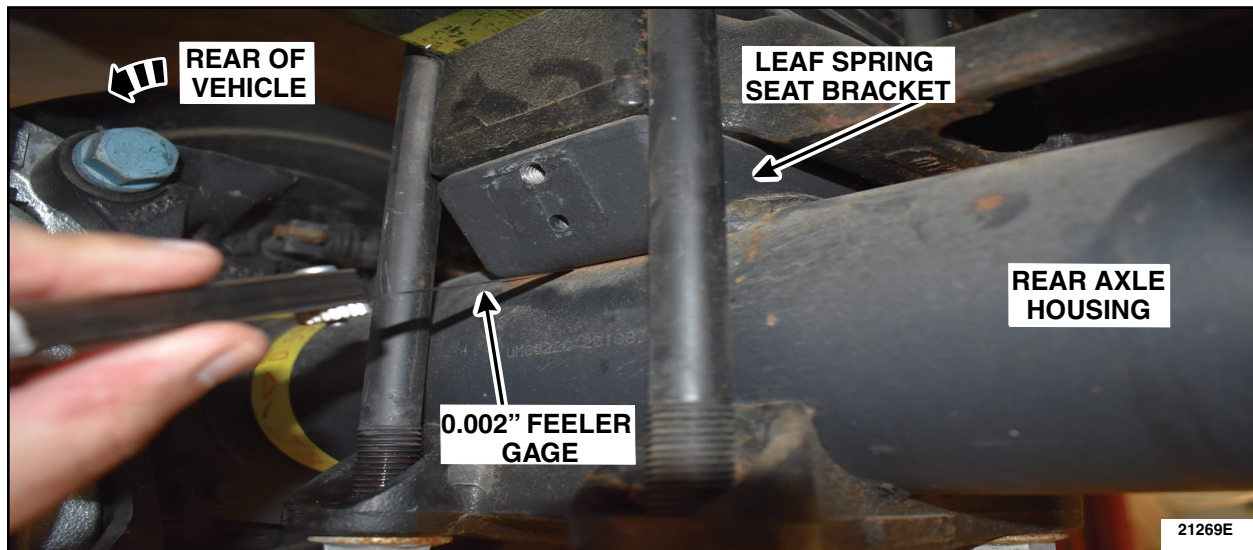
FIGURE 2

6. Using a 0.002" feeler gage measure the gap along the rear of the leaf spring seat bracket to the rear axle housing assembly. Is the gap greater than 0.002" on either the LH or RH side? See Figure 2.

YES - The rear axle housing will require replacement. Currently parts are not available for this repair. Vehicle cannot be safely driven. Contact SSSC.

NO - Proceed to the Leaf Spring Seat Bracket Interface Weld Repair Procedure on Page 3.
