# \* \* TECHNICAL INFORMATION NOTICE \* \*

RE: SEAT BELT AUTOMATIC LOCKING RETRACTOR (ALR) – SAFETY RECALL CAMPAIGN

TIN NO. TIN-21-SR-007C

# **AFFECTED VEHICLES: Certain 2022 Outlander vehicles**

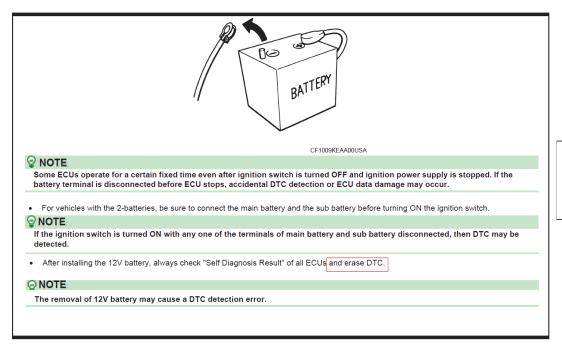
From Recall Bulletin: SR-21-007REV2 Page 6

MMNA would like to remind all dealers and technicians that <u>CHECKING AND CLEARING DTCs</u> are essential to the repair process when replacing seat belts for this recall. On CSI surveys, customers have indicated their vehicle was not *Fixed Right the First Time* due to the SRS light being illuminated after one of the seat belts were replaced. The most likely cause of this is the technician failed to insert and lock the connector in place and then turns the ignition on with the connector not fully attached. As referenced in Recall Bulletin SR-21-007REV2 and listed below, please be sure to <u>CHECK AND CLEAR ALL DTCs after seat belt replacement</u>. Many of these customers are new to the brand and having this recall completed is their first visit to your Service Department. It is imperative that we amplify our customer satisfaction efforts – including performing a thorough quality check – to retain these customers for their future service and sales needs.

After installing 12V battery, always check self-diagnosis results of all ECUs and erase DTC.
