# \* \* TECHNICAL INFORMATION NOTICE \* \*

anagers,
SAFETY RECALL CAMPAIGN

#### AFFECTED VEHICLES: Certain 2022 Outlander vehicles

#### PURPOSE

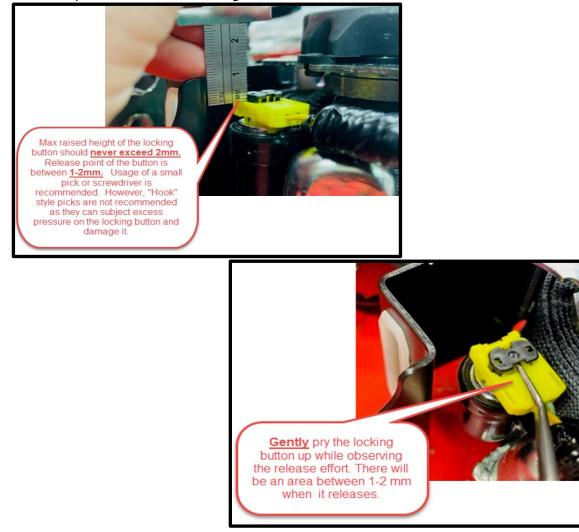
1. Removal process to avoid damage.

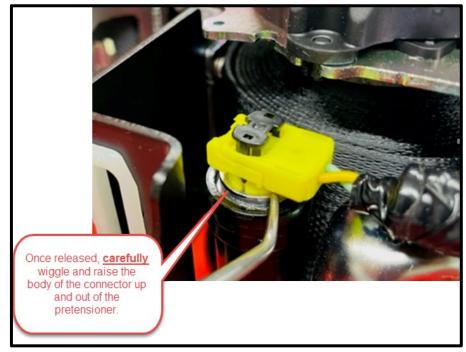
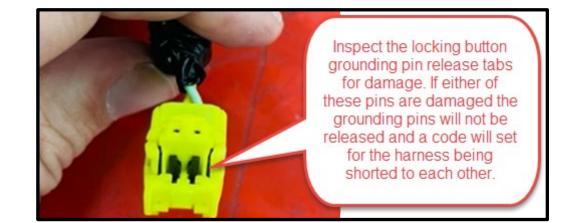
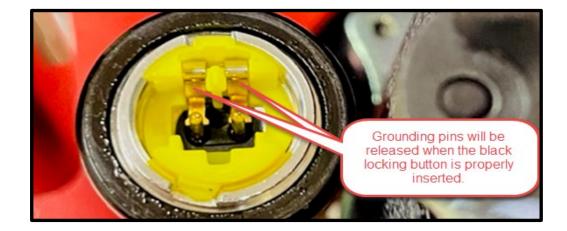
2. Removal and inspection of connector.

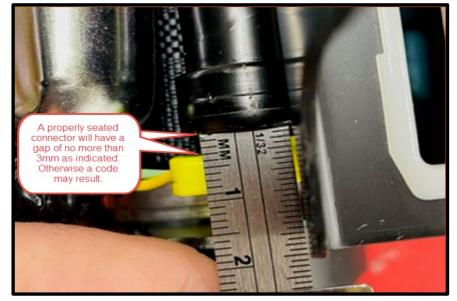
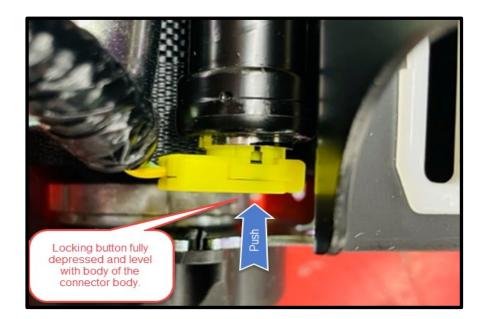
3. Proper installation and inspection.
