Bentley Bulletin

21-050

Subject: RECALL CAMPAIGN – Bentley Bentayga V8 Chassis Control Module update
(RE21/29)

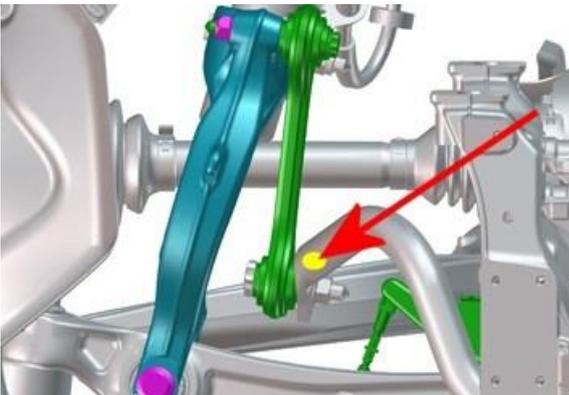
If the vehicle is not already listed as repaired in the "Repair history" (in Elsa Pro) refer to the Identification section and check for the yellow paint mark on the front anti roll bar (right hand side) as shown in the Identification section

- Confirm that the gear selection is now possible
6. Place a yellow paint mark on the front anti roll bar (right hand side) as shown in the Identification section
