IMPORTANT SAFETY RECALL

Re: Safety Recall - Smart-Steer 2.0 Self-Steer Axle

Recall 21E-019

Subject: SMART-STEER 2.0 Bolt-On Steer Arm Reinforcement Welds

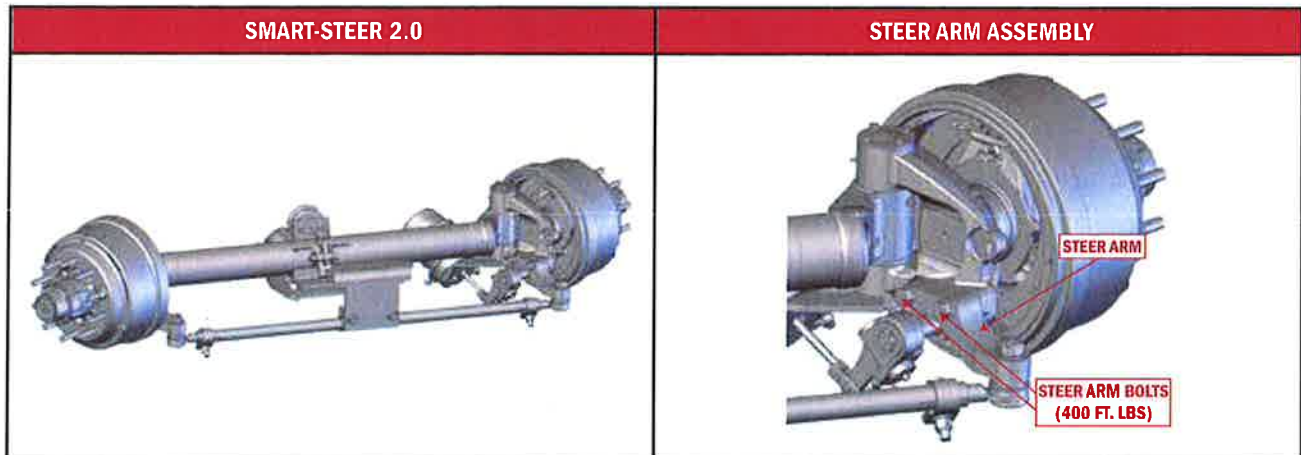
Based on feedback from our customers, Dexter Heavy Duty has become aware that under certain loading conditions, the 8-7/8" steer arm setup on the SMART-STEER 2.0 axle is prone to shearing the attaching steer arm bolts. This will lead to a failure in the steer arm assembly.

Dexter recommends that you perform a steer arm inspection of your axle(s) as soon as possible; but no later than four weeks after receiving this service bulletin. Please follow the steps listed below:

1. Visually inspect steer arm bolts and washers for mechanical tightness and replace if necessary.
2. Ensure the steer arm bolts are torqued to 400 Ft. Lbs.
3. Place welds as shown on page three of this bulletin. If you would like a copy of engineering drawing 750049, please contact one of the service technicians listed below.
