January 2022
FL903A
NHTSA #21V-741

Subject: TBB Minotour CNG Solenoid

Models Affected: Specific model years 2015-2018 Thomas Built Buses Minotour school buses built on a General Motors (GM) chassis and manufactured December 14, 2013, through June 29, 2017, and equipped with an IMPCO Automotive Compressed Natural Gas (CNG) conversion.

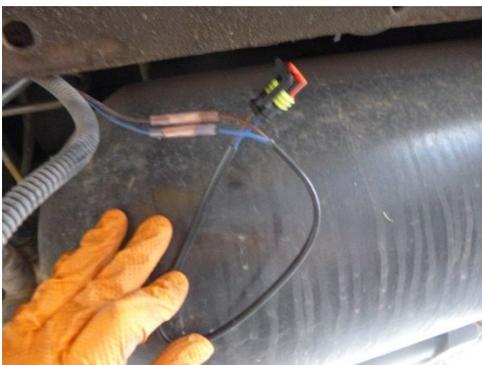
Fig. 5, New Connector Shown With Blue and Brown Wires

Due to HPL solenoid supply issues, some of these new parts have blue and brown wires, and others have red and black wires.

13. Cut the harness and replace the connector making sure to splice the matching wire colors (**blue-to-blue, and brown-to-brown**) shown in **Fig. 5**, or **red-to-blue, and black-to-brown** referenced in **Fig. 6**. To minimize water intrusion, use a moisture resistant type of splice that is equal to IP67 protection.
14. Put a mark on the valve to indicate the orientation of solenoid to ensure proper installation of the new solenoid.
