Ferrari North America, Inc.

U.S.A. RECALL CAMPAIGN NO. C24000078

Replacement of brake fluid reservoir cap and updating of Instrument Panel Node (NQS) software

SUBJECT: Recall Campaign No. C24000078

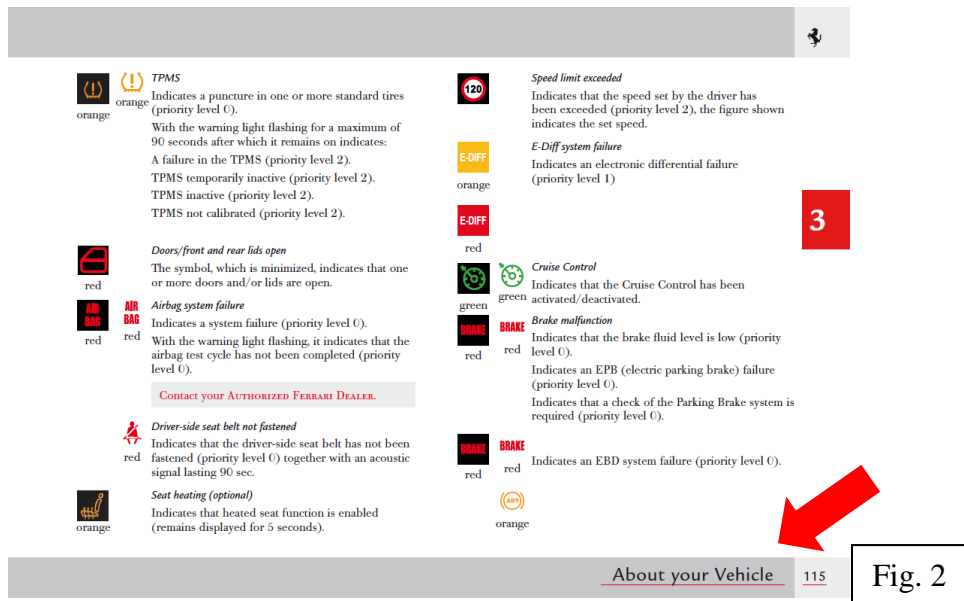
The sticker must be placed in the page shown above in the Owner's Manual. This page is located in the '*About your Vehicle*' section where the warning lights of the instrument panels are described. Please be sure to attach it to the page with the '*Brake Malfunction*' description as shown in Fig. 2

Once you locate the proper page, remove the adhesive protector off of the back of the sticker. Ensure there is no residue or other particles on the page that may inhibit the longevity of adhesion to the page. Place the sticker to allow the bottom of the sticker to lay directly above the gray margin at the bottom of the page that contains the text '*About your Vehicle*'. Once applied, apply pressure across the whole strip of 'glue' to confirm the sticker has been properly mated to the page.
