December 2021
FL905A
NHTSA #21V-864
Transport Canada #2021-681

Subject: Western Star 49X Steering Pinch Bolt

Models Affected: Specific model years 2021-2022 Western Star 49X model vehicles manufactured June 17, 2020, through October 19, 2021.

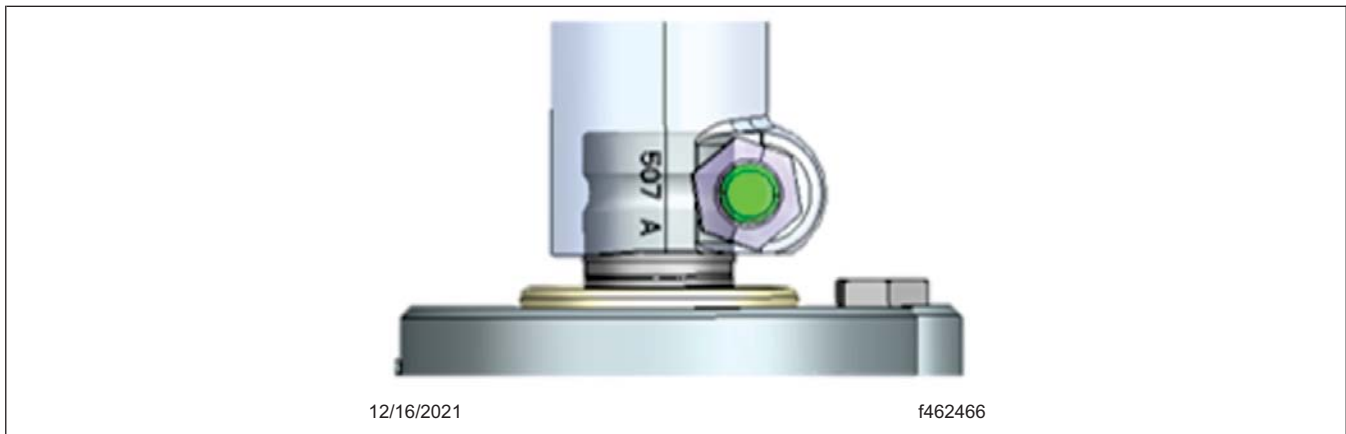
Fig. 1, I-shaft Installed Properly

If installed properly, no further action is required. Proceed to the step 5.

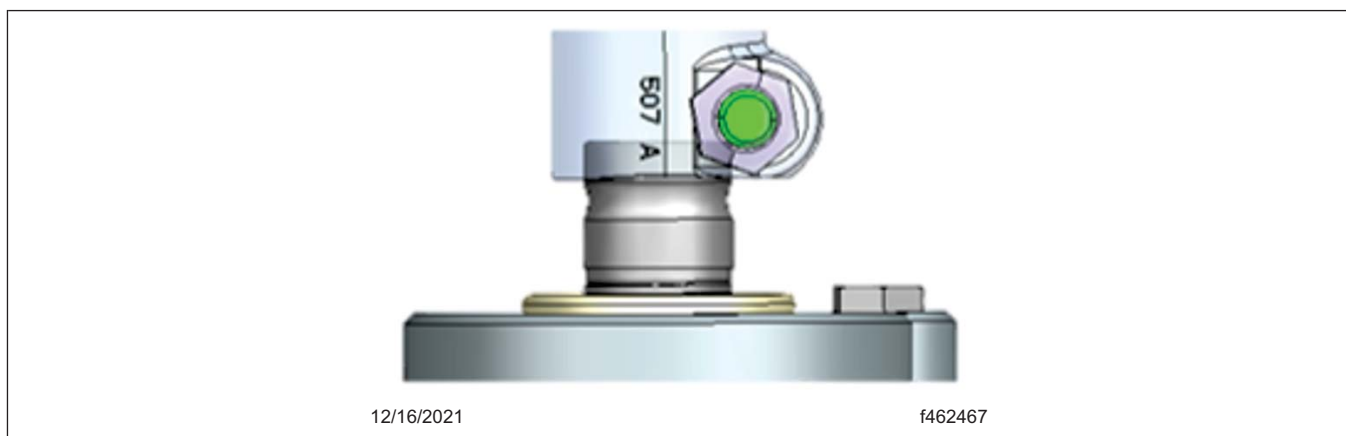
On certain vehicles, the steering shaft may not have been properly installed on the steering gear. If the steering shaft has not been properly installed, it may separate from the steering gear resulting in a loss of steering control which may lead to a vehicle crash.

Fig. 2, I-shaft is Lifted or Displaced

If lifted and not seated correctly, go to the Pinch Bolt Replacement procedure below.

1. Remove and discard the pinch bolt and nut on the gearside of the I-shaft.
2. Slide the steering shaft down so it is flush with the steering gear.
3. Install the new pinch bolt and nut.
4. Tighten the pinch bolt 30 to 35 lbf·ft (41 to 47 N·m).
5. Use blue torque seal after the required torque has been set.
6. Clean a spot on the base label (Form WAR259), write the recall number, FL905, on a blank red completion sticker (Form WAR260), and attach it to the base label, indicating this work has been completed.
