Recall Campaign Bulletin

Campaign No. 2021120004, December 2021

SUBJECT: **Model GLE-Class (167 platform)**
Model Year 2021
Electric Heater Ground Bolting

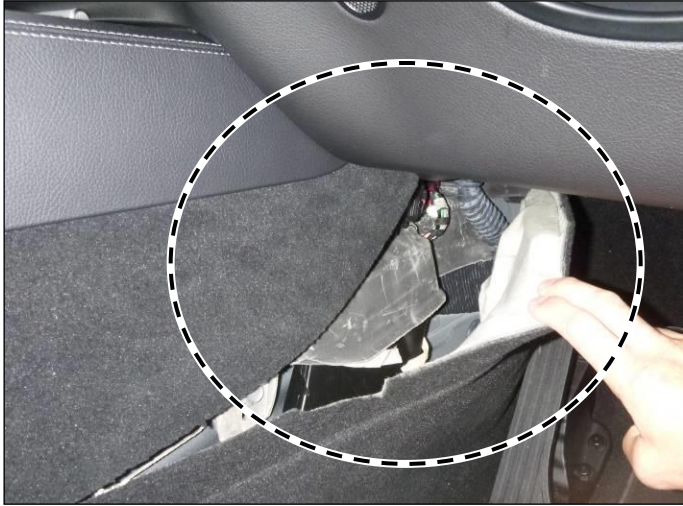
Figure 1

1. Slide front passenger seat backward to the end position.
2. Detach front right floor covering until area around ground connection of PTC booster heater is accessible (**Figure 1**).

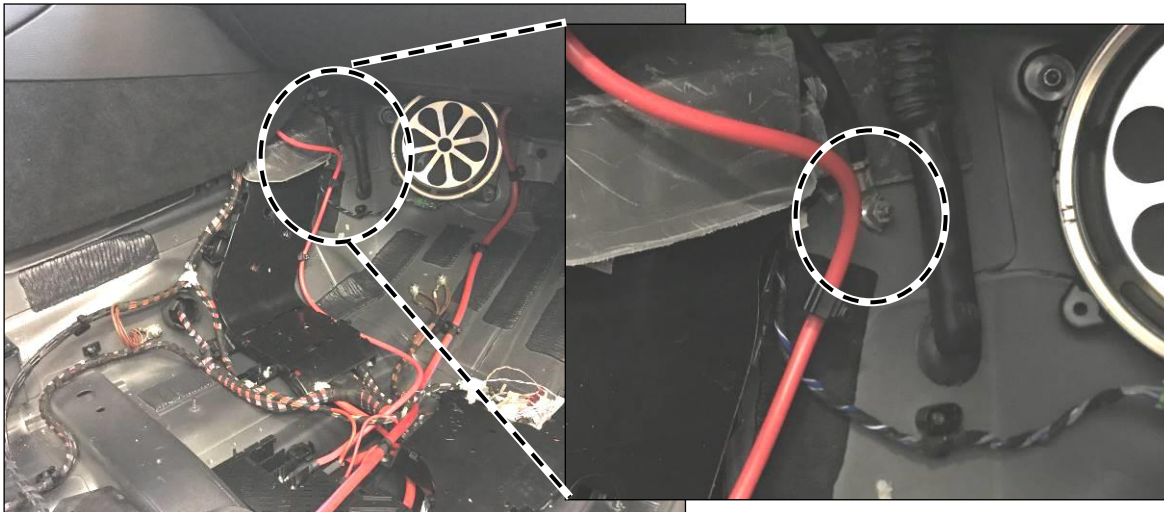
Figure 2

3. Check for scorch marks in area of ground connection of PTC booster heater (**Figure 2**).
4. Check ground connection of PTC booster heater as to whether loose or tightened with correct torque (**Figure 2**).

i The torque of the ground connection **must** be **Nm** 10!

- a. **Scorch marks present** in the area of the ground connection:
Carry out **work procedure**.
- b. **Scorch marks not present** in the area of the ground connection:
End measure.

1. Install new PTC booster heater.

i If further component parts in the area of the ground connection have been damaged, new component parts must also be installed!
