REF #: ICI22-011

SUBJECT: FL913 – Recall Parts Availability

February 2022
FL913AB
NHTSA #21V-945
Transport Canada #2021-738

Subject: FCCC Throttle Pedal

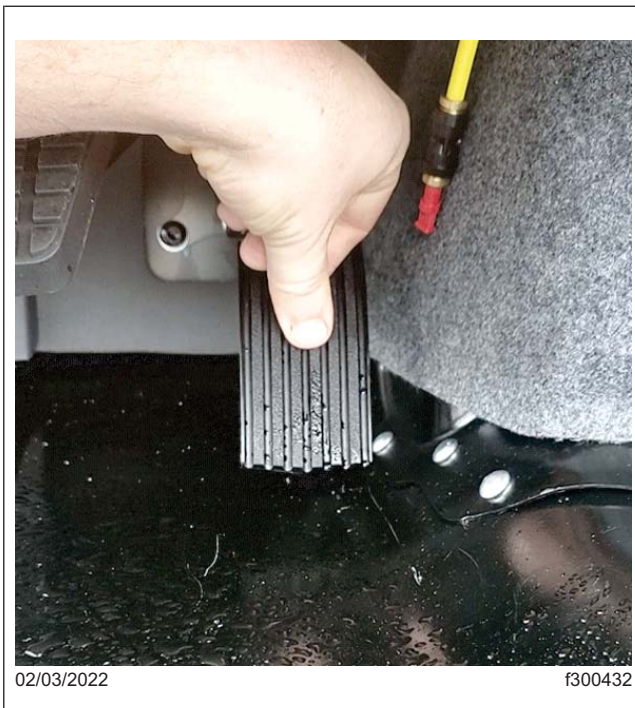
Fig. 1, Throttle Pedal with Sufficient Clearance

1. Inspect the base label (Form WAR259) for a campaign completion sticker for FL913 (Form WAR260). If a sticker is present for FL913, no work is needed. If there is no sticker, proceed with the steps below.
2. Park the vehicle on a level surface, shut down the engine, and apply the parking brakes. Chock the tires.
3. Inspect the throttle pedal for clearance between the floor and bottom of the pedal. See [Fig. 1](#) for a pedal having sufficient clearance and see [Fig. 2](#) for insufficient clearance between the throttle pedal and the floor.

YES → No further action is required. Go to the next step.

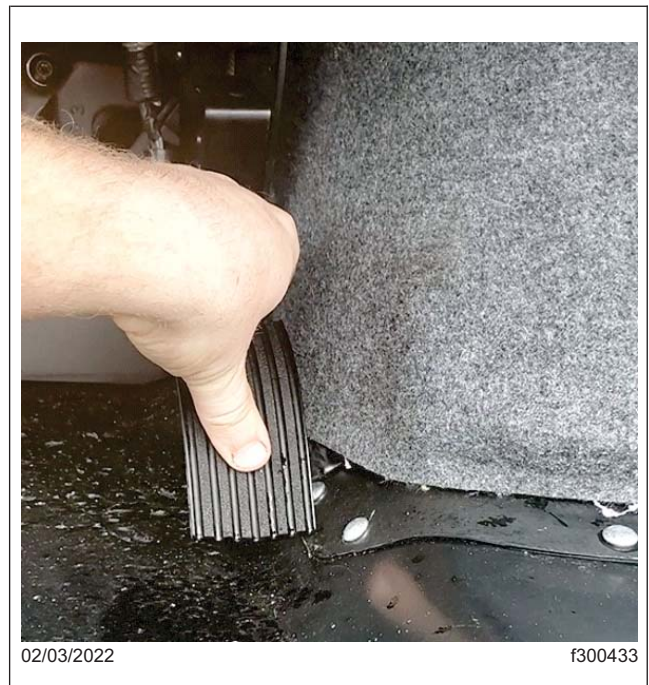
Fig. 2, Throttle Pedal with Insufficient Clearance

On certain school buses equipped with a specific accelerator pedal, the accelerator pedal could be misaligned, allowing it to rub against the floor and potentially stick in an off-idle position without the driver's knowledge. This could cause an unexpected loss of control of the vehicle speed, increasing the risk of a crash.

NO → Go to **Removal** below.

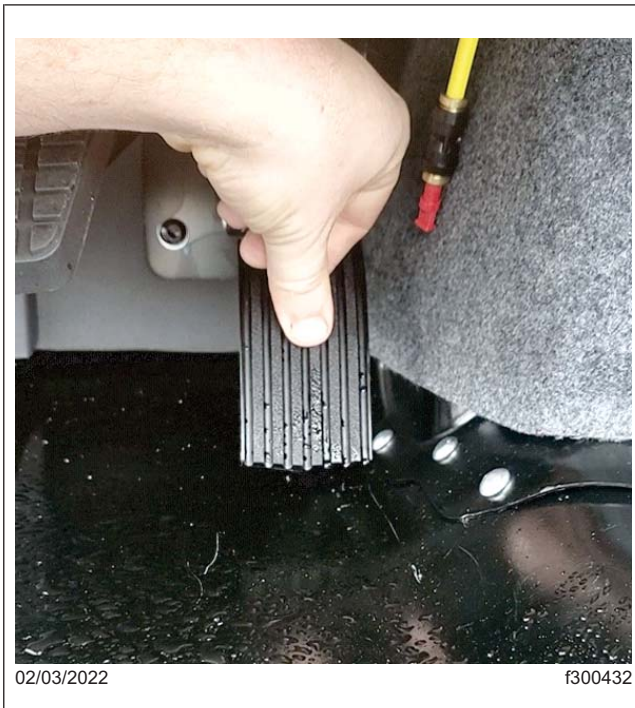
Fig. 7, Throttle Pedal with Sufficient Clearance

1. Inspect the base label (Form WAR259) for a campaign completion sticker for FL913 (Form WAR260). If a sticker is present for FL913, no work is needed. If there is no sticker, proceed with the steps below.
2. Park the vehicle on a level surface, shut down the engine, and apply the parking brakes. Chock the tires.
3. Inspect the throttle pedal for clearance between the floor and bottom of the pedal. See [Fig. 7](#) for a pedal having sufficient clearance and see [Fig. 8](#) for insufficient clearance between the throttle pedal and the floor.

YES → No further action is required. Go to the next step.
