## PRODUCT CAMPAIGN BULLETIN

**APPLICABILITY:** 2019-20MY Ascent  
 2020-21MY Legacy 2.4L (turbo models)  
 2020-21MY Outback 2.4L (turbo models)

**NUMBER:** WRK-21/22R  
**DATE:** 07/05/22  
**REVISED:** 12/29/22

**SUBJECT:** CVT Chain Guide Breakage

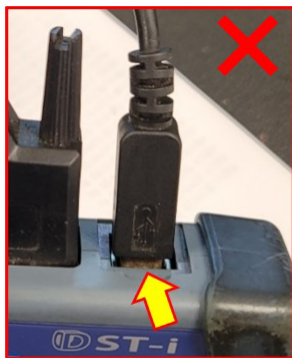
Corroded Connection

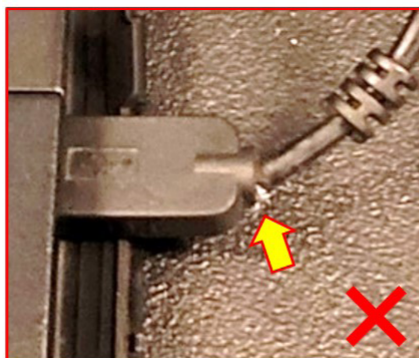
Exposed Wiring &  
Incorrect Cable
