August 10, 2022

**SUBJECT: NEW VEHICLE DEMONSTRATION / DELIVERY HOLD -**

**Safety Recall 21S56 – Supplement #7**

Certain 2021 - 2022 Model Year F-150 Vehicles Equipped with Crew Cab, 145" Wheelbase, 4x4, 302a & Above Option Package, and One-Piece Aluminum Driveshaft Loose/Sagging Underbody Insulators

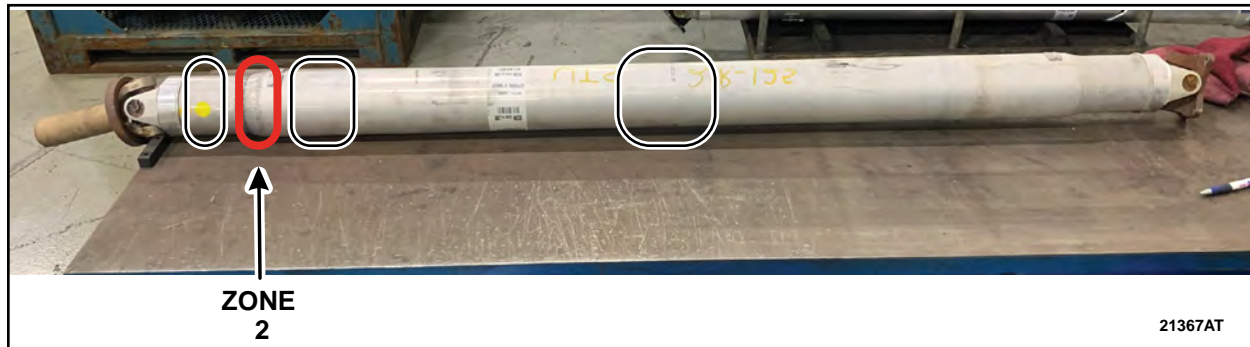
FIGURE 5

Yes – Does not pass inspection. Proceed to step 13.

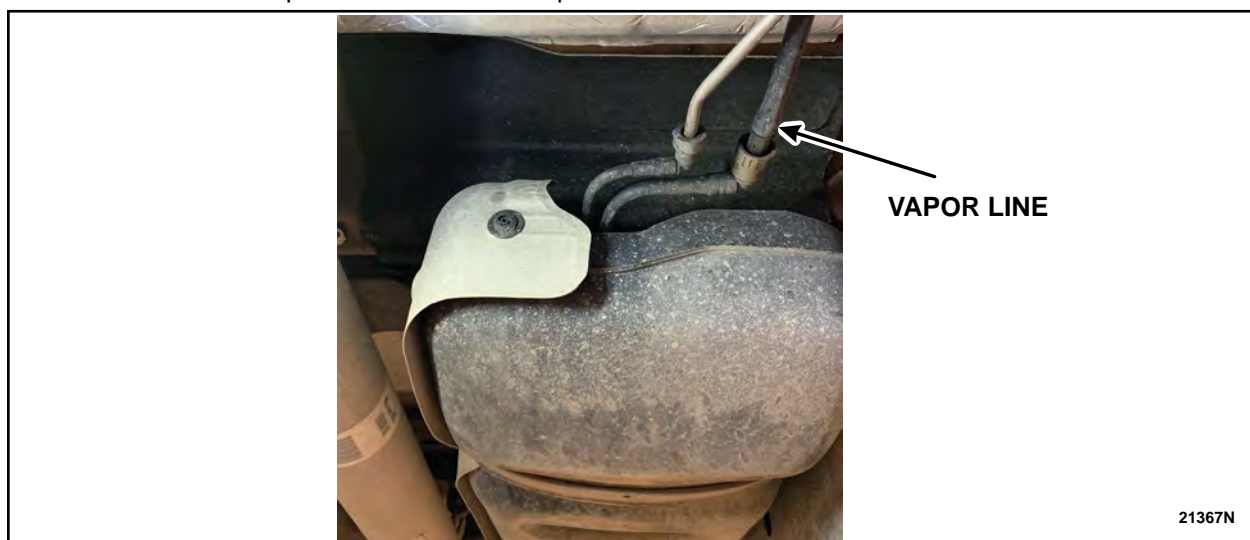
**FIGURE 11**

Yes – Does not pass inspection. Replace the damaged line. Please follow WSM procedures in Section 310-01, then proceed to step 17.
