**SUBJECT: NEW VEHICLE DEMONSTRATION / DELIVERY HOLD -**

**Safety Recall 21S56 – Supplement #6**

Certain 2021 - 2022 Model Year F-150 Vehicles Equipped with Crew Cab, 145" Wheelbase, 4x4, 302a & Above Option Package, and One-Piece Aluminum Driveshaft Loose/Sagging Underbody Insulators

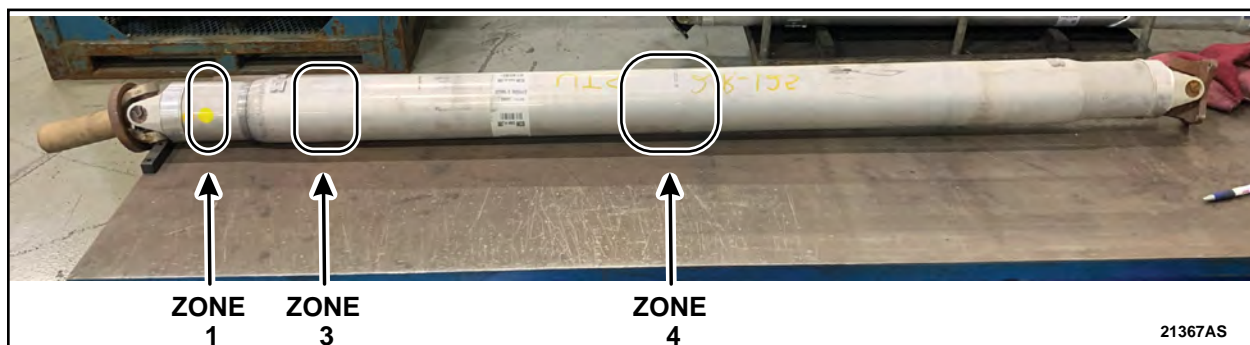
**FIGURE 2**

- Inspect Zones 1, 3 and 4 of the rear driveshaft for any marks caused by the front and/or rear edges of the passenger side insulator. Are there any marks present in Zones 1, 3 or 4?  
See Figure 2.

Yes – Proceed to step 10.  
No – Proceed to step 12.

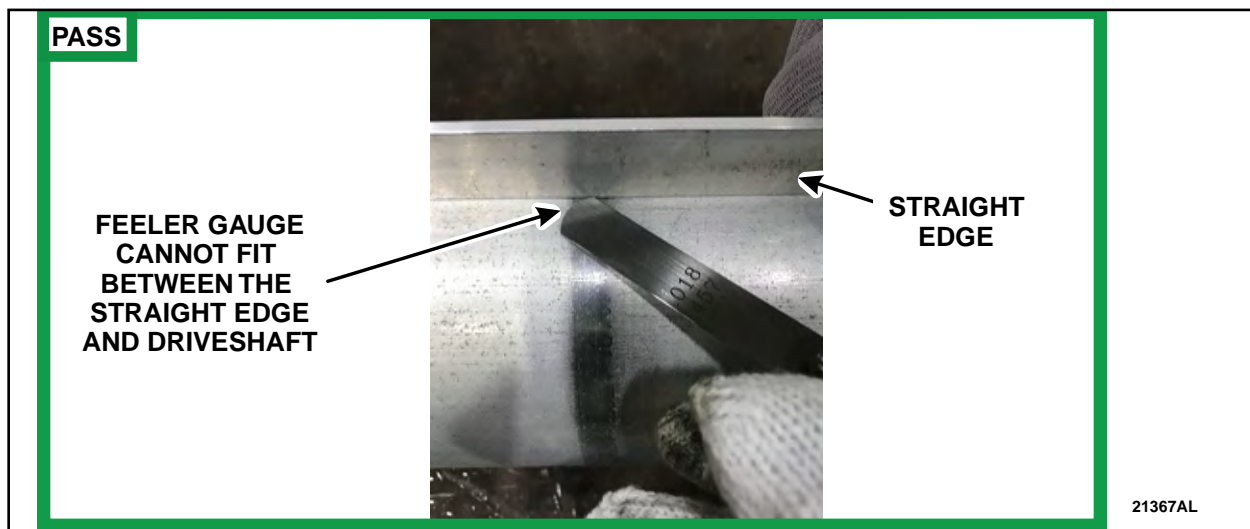
FIGURE 3

Yes – Does not pass inspection. Contact the SSSC and provide a picture of the driveshaft with the feeler gauge fitting between the straight edge and wear mark. Once approved, rear driveshaft replacement will be required, but do not install at this time. Proceed to step 14.

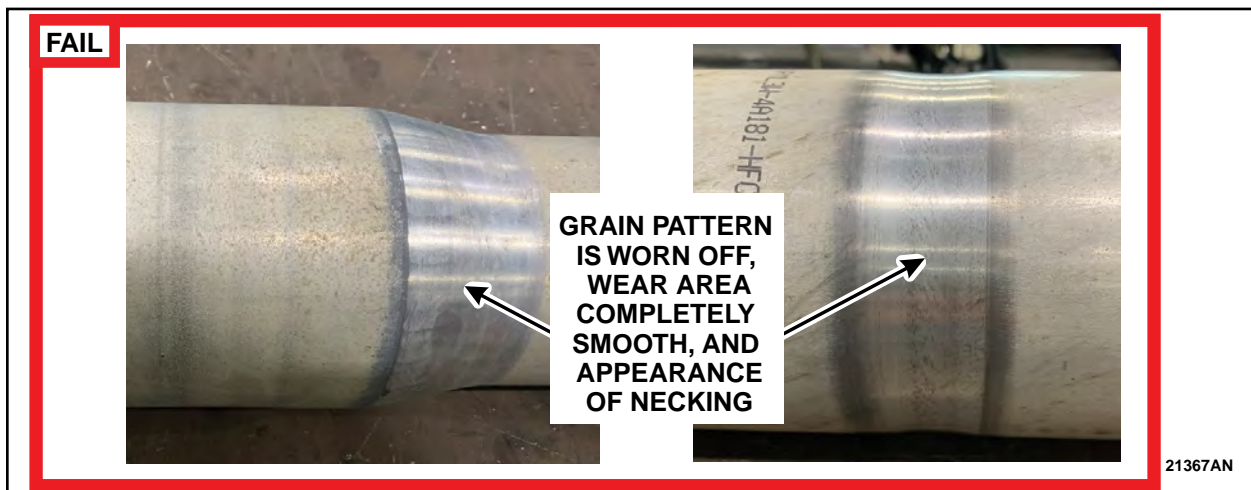
FIGURE 6

13. Inspect the marks found on Zone 2. Is the aluminum tube surface grain pattern worn off, completely smooth, or have an appearance of necking? See Figures 6 through 9.

Yes – Does not pass inspection. Contact the SSSC and provide a picture of the driveshaft with the grain pattern worn off. Be sure to show a clear image of the grain pattern missing. Once approved, rear driveshaft replacement will be required, but do not install at this time. Proceed to step 14.

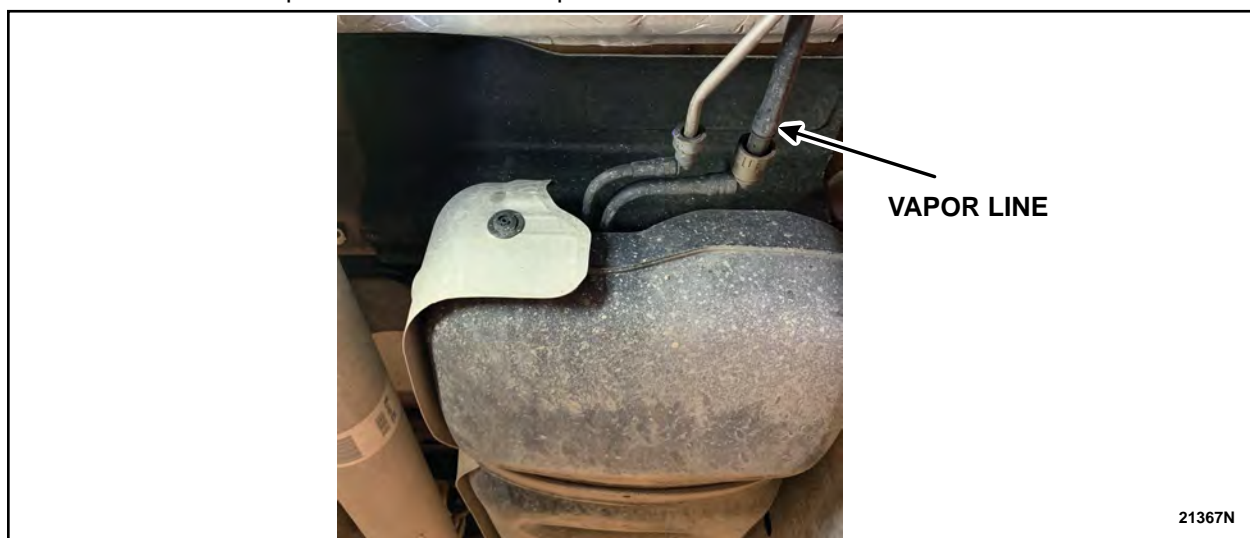
**FIGURE 11**

Yes – Does not pass inspection. Replace the damaged line. Please follow WSM procedures in Section 310-01, then proceed to step 17.

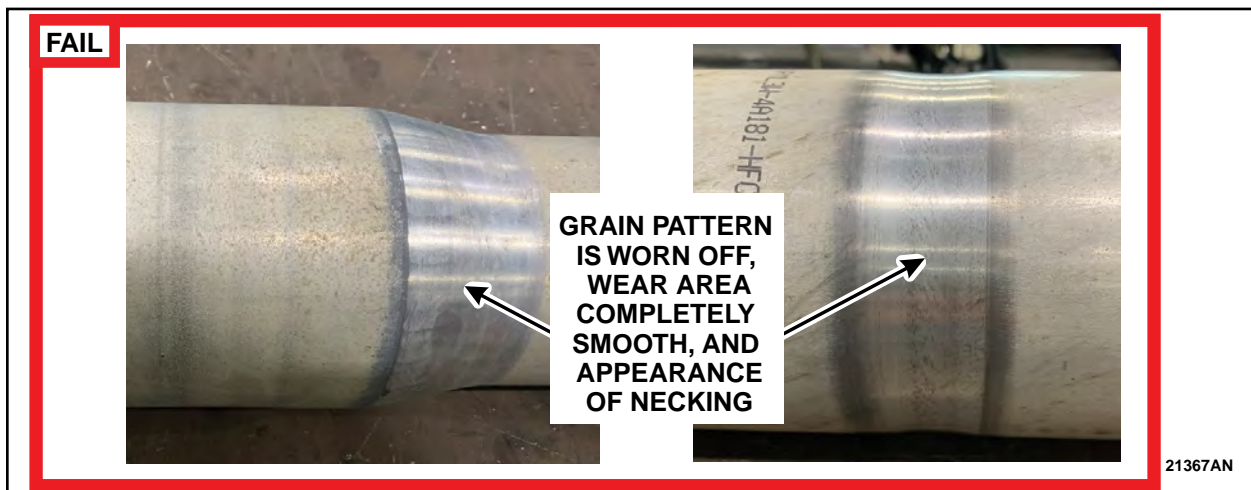
FIGURE 6

10. Inspect the marks found on Zone 2. Is the aluminum tube surface grain pattern worn off, completely smooth, or have an appearance of necking? See Figures 6 through 9.

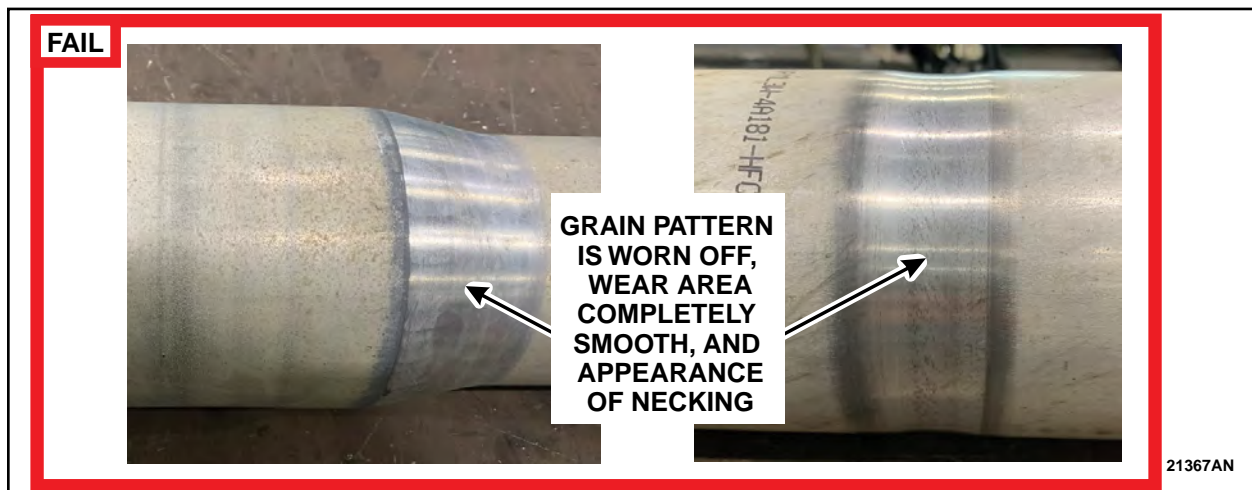
FIGURE 6

9. Inspect the marks found on Zone 2. Is the aluminum tube surface grain pattern worn off, completely smooth, or have an appearance of necking? See Figures 6 through 9.

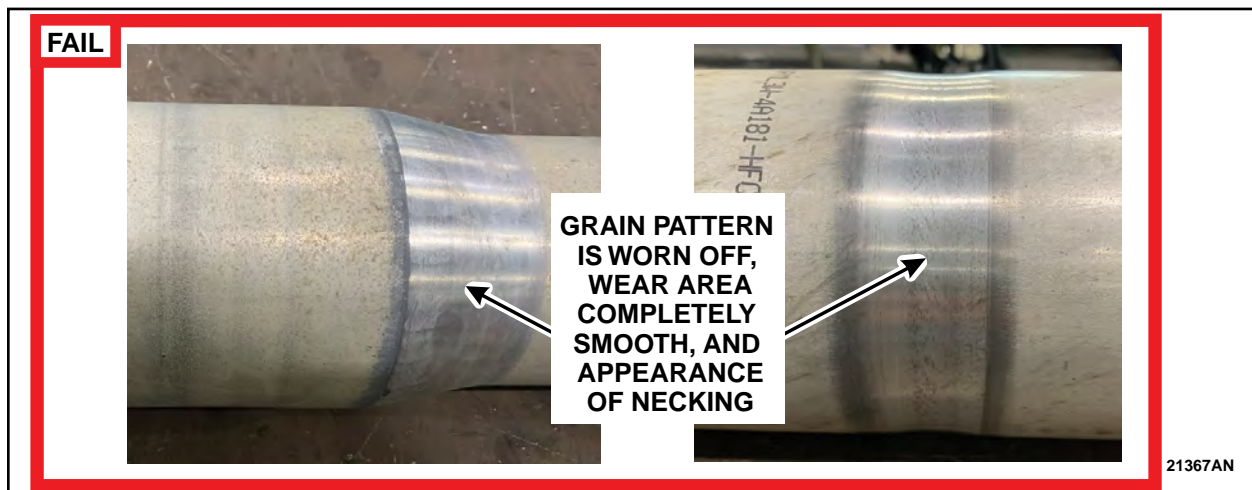
**FIGURE 6**

11. Inspect the marks found on Zone 2. Is the aluminum tube surface grain pattern worn off, completely smooth, or have an appearance of necking? See Figures 6 through 9.
