February 7, 2022

**SUBJECT: NEW VEHICLE DEMONSTRATION / DELIVERY HOLD -
 Safety Recall 21S56 – Supplement #2**

Certain 2021 - 2022 Model Year F-150 Vehicles Equipped with Crew Cab, 145”
 Wheelbase, 4x4, 302a & Above Option Package, and One-Piece Aluminum Driveshaft
 Loose/Sagging Underbody Insulators

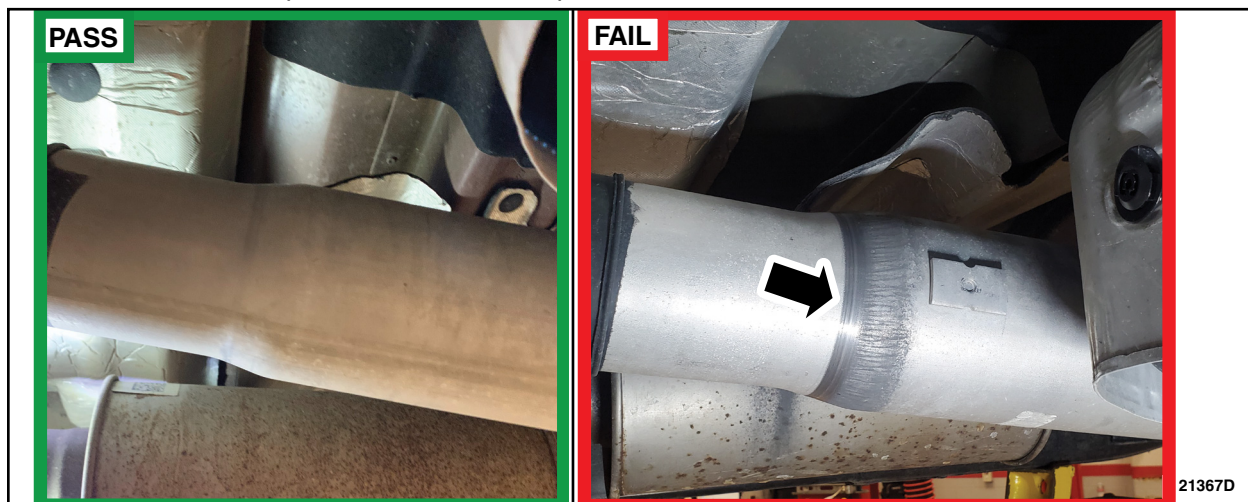
- Inspect the rear driveshaft for any marks caused by the passenger side insulator. Are there any marks present on the driveshaft due to contact from the insulator? See Figures 2 and 3.

Yes – Does not pass inspection. Contact the SSSC and provide a picture of the driveshaft with the marks. Once approved, rear driveshaft replacement will be required, but do not install at this time. Proceed to step 10.

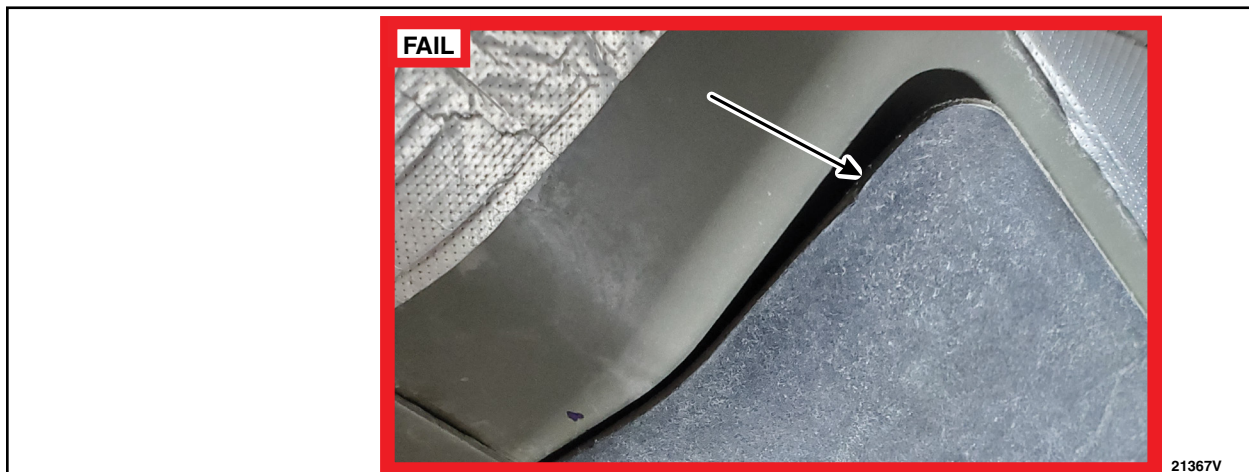
FIGURE 4

Yes – Does not pass inspection. Proceed to step 11.

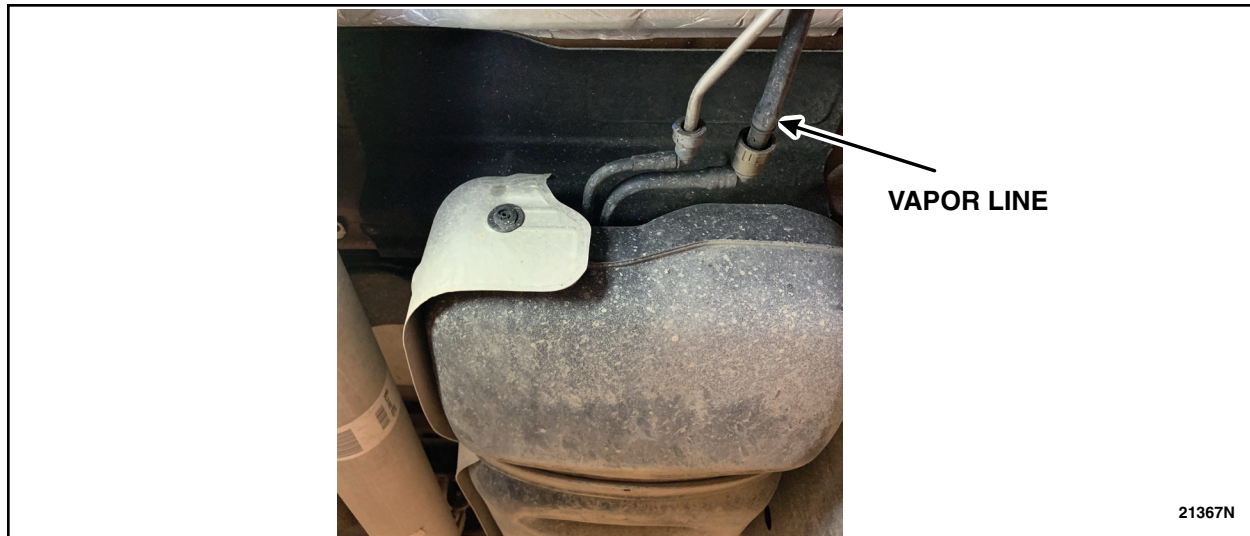
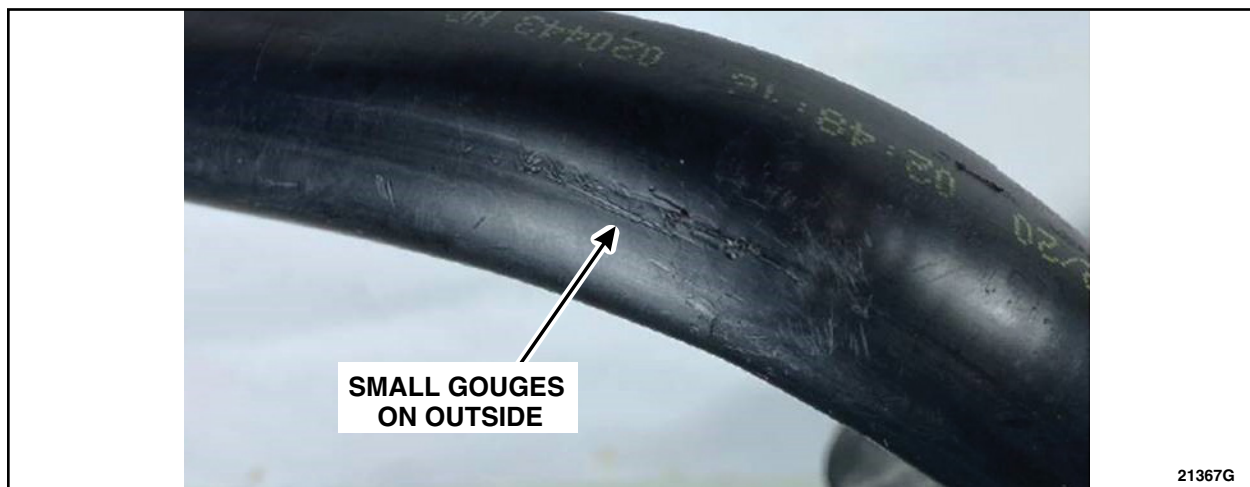
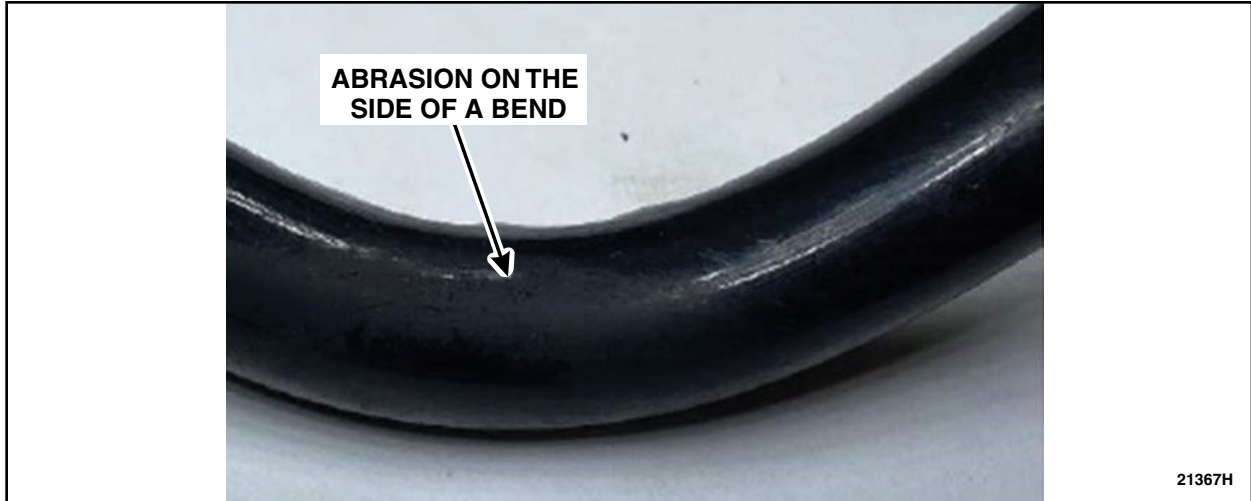
11. Remove the fuel tank to gain access to the vapor line. Please follow WSM procedures in Section 310-01.
12. Inspect the vapor line for any damage caused by the driver side insulator. Is there any damage to the line? See Figures 5 through 7.

Yes – Does not pass inspection. Replace the damaged line. Please follow WSM procedures in Section 310-01, then proceed to step 13.

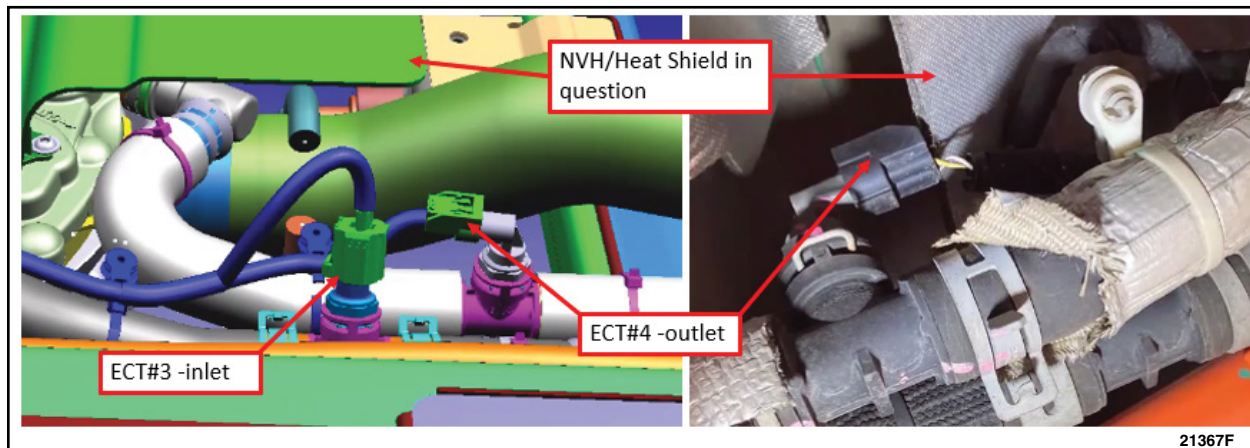
FIGURE 4

Yes – Does not pass inspection. Contact the SSSC and provide a picture of the damage for proper technical instructions and part numbers, then proceed to step 9.

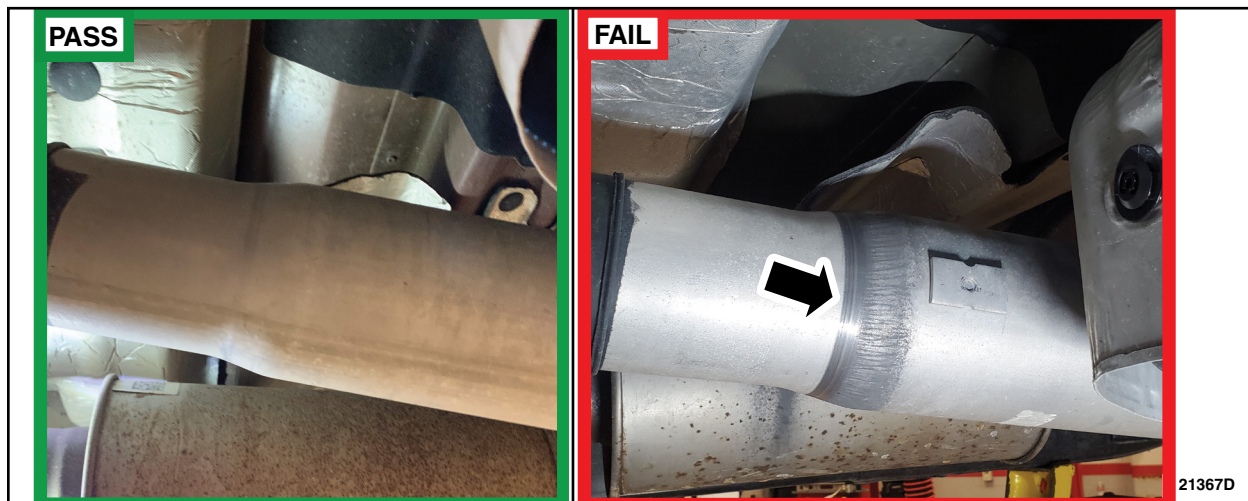
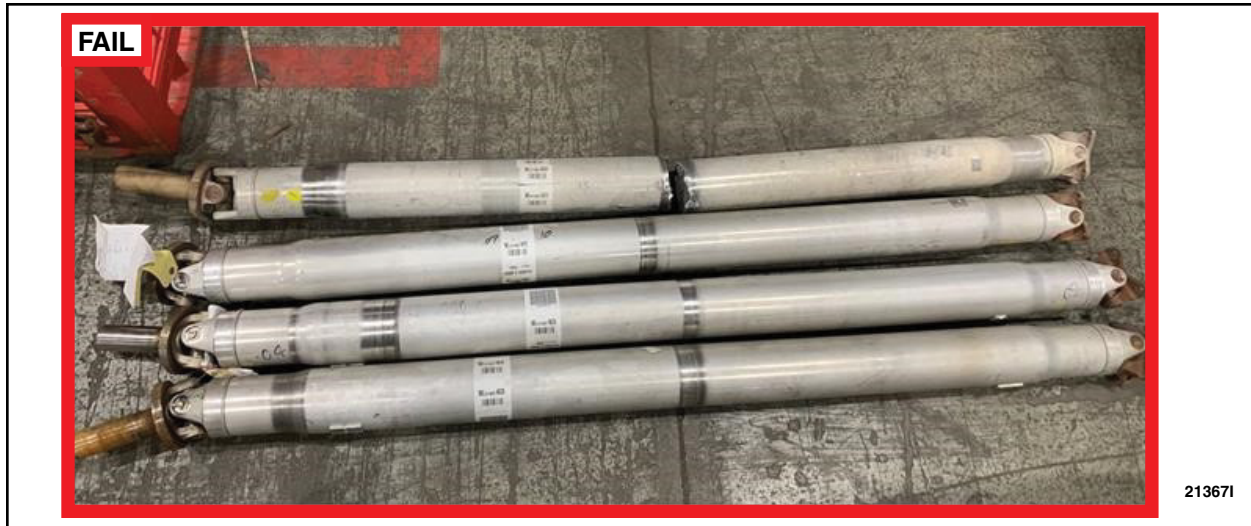
Yes – Does not pass inspection. Contact the SSSC and provide a picture of the driveshaft with the marks. Once approved, rear driveshaft replacement will be required, but do not install at this time. Proceed to step 8.
