**SUBJECT: NEW VEHICLE DEMONSTRATION / DELIVERY HOLD -  
 Safety Recall 21S56 – Supplement #5**

Certain 2021 - 2022 Model Year F-150 Vehicles Equipped with Crew Cab, 145" Wheelbase, 4x4, 302a & Above Option Package, and One-Piece Aluminum Driveshaft Loose/Sagging Underbody Insulators

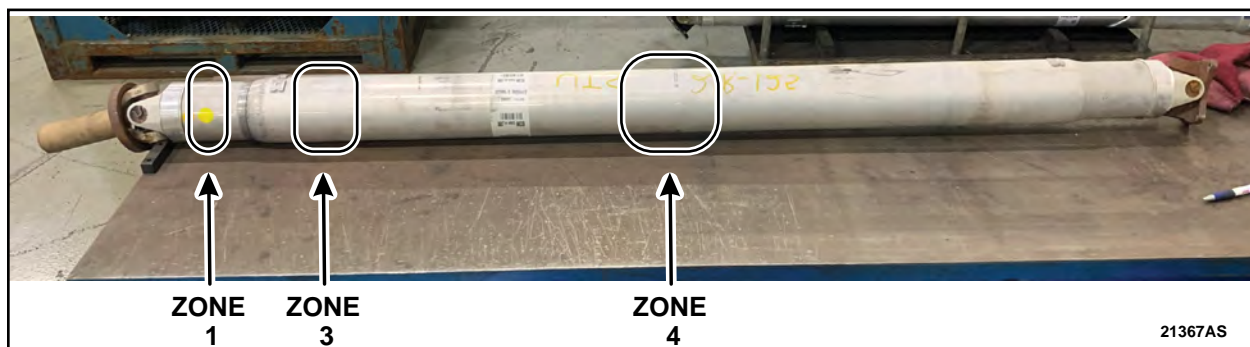
**FIGURE 2**

- Inspect Zones 1, 3 and 4 of the rear driveshaft for any marks caused by the front and/or rear edges of the passenger side insulator. Are there any marks present in Zones 1, 3 or 4?  
See Figure 2.

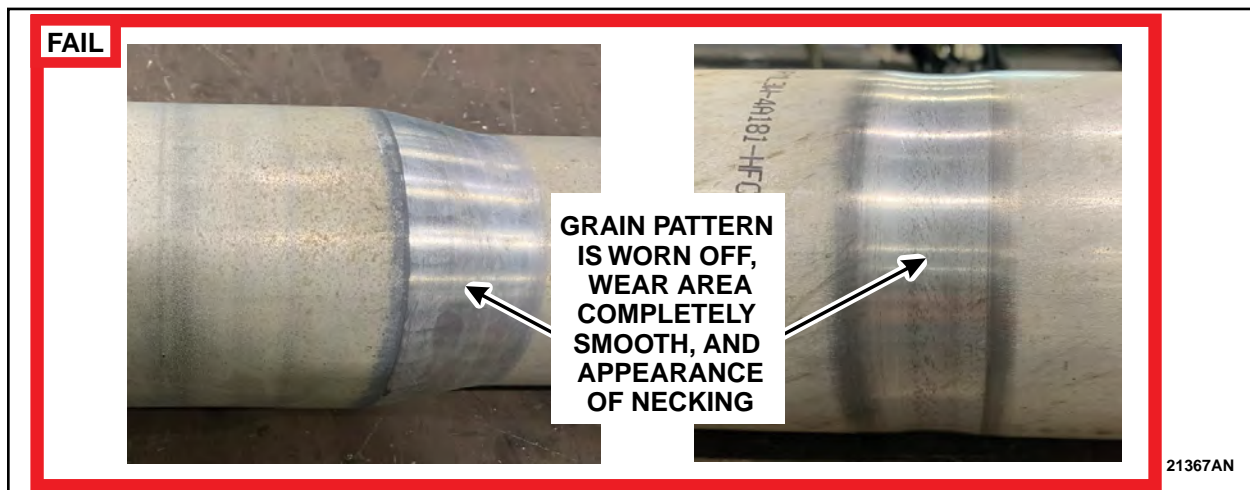
FIGURE 6

13. Inspect the marks found on Zone 2. Is the aluminum tube surface grain pattern worn off, completely smooth, or have an appearance of necking? See Figures 6 through 9.

Yes – Does not pass inspection. Contact the SSSC and provide a picture of the driveshaft with the grain pattern worn off. Be sure to show a clear image of the grain pattern missing. Once approved, rear driveshaft replacement will be required, but do not install at this time. Proceed to step 14.
