December 20, 2021

**SUBJECT: NEW VEHICLE DEMONSTRATION / DELIVERY HOLD -
 Safety Recall 21S56**

Certain 2021 - 2022 Model Year F-150 Vehicles Equipped with Crew Cab, 145”
 Wheelbase, 4x4, 302a & Above Option Package, and One-Piece Aluminum
 Driveshaft
 Loose/Sagging Underbody Insulators

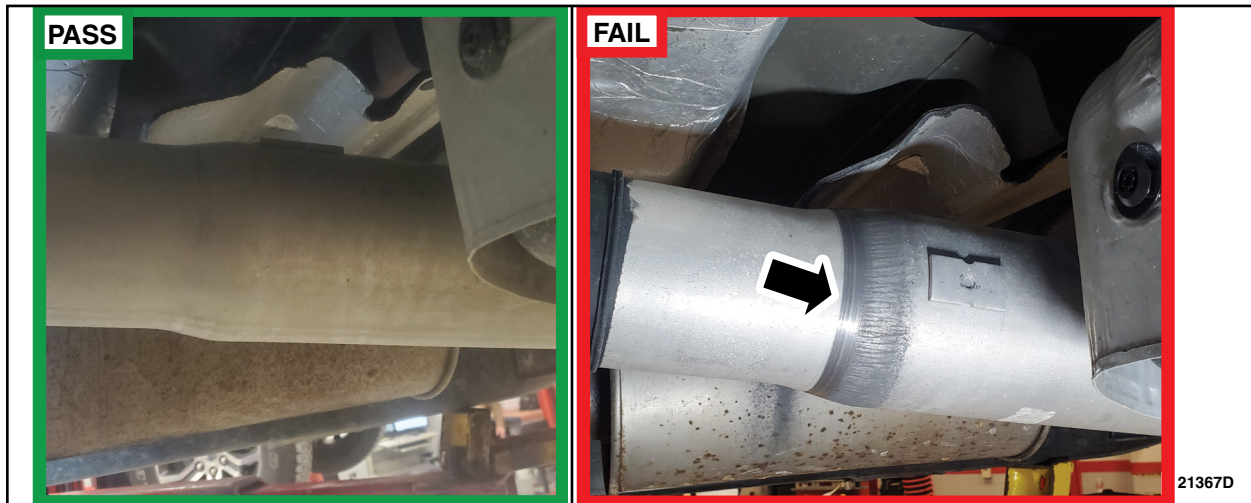
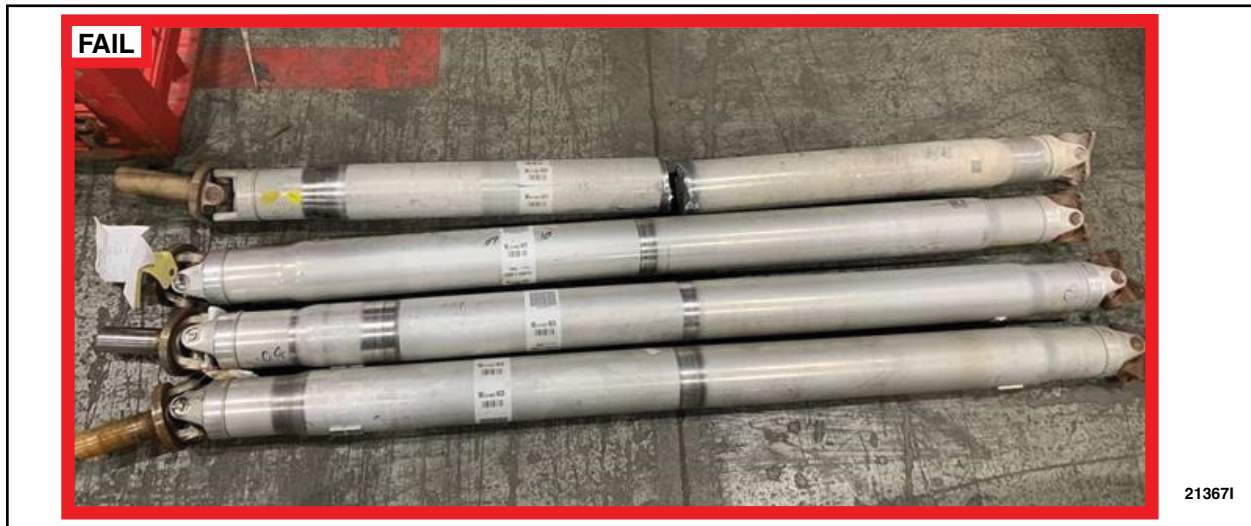
2. With the vehicle in NEUTRAL, position it on a hoist. Please follow Workshop Manual (WSM) procedures in Section 100-02.
3. Remove the driveshaft. Please follow WSM procedures in Section 205-01.
4. Inspect the rear driveshaft for any marks caused by the passenger side insulator. Are there any marks present on the driveshaft due to contact from the insulator? See Figures 2 and 3.

Yes – Does not pass inspection. Contact the SSSC and provide a picture of the driveshaft with the marks. Once approved, rear driveshaft replacement will be required, but do not install at this time. Proceed to step 5.

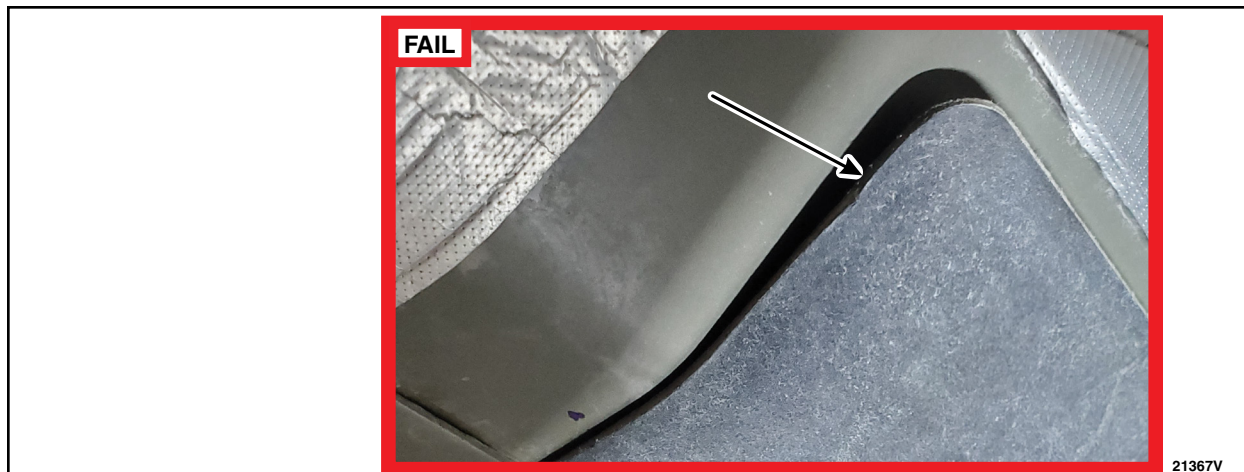
FIGURE 4

Yes – Does not pass inspection. Proceed to step 6.

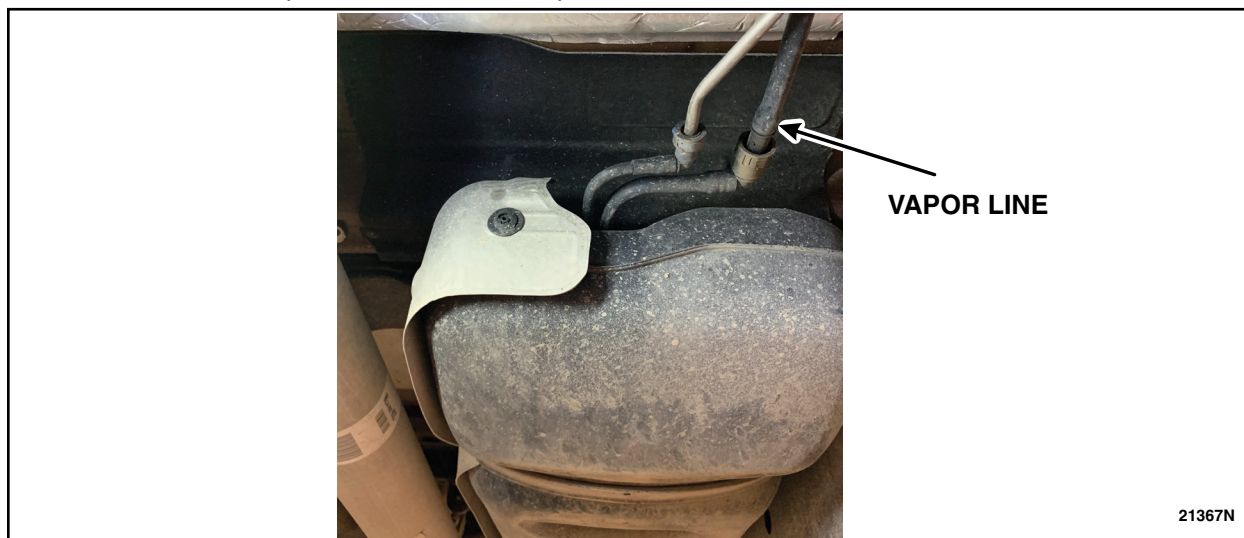
6. Remove the fuel tank to gain access to the vapor line. Please follow WSM procedures in Section 310-01.
7. Inspect the vapor line for any damage caused by the driver side insulator. Is there any damage to the line? See Figures 5 through 7.

Yes – Does not pass inspection. Replace the damaged line. Please follow WSM procedures in Section 310-01, then proceed to step 8.

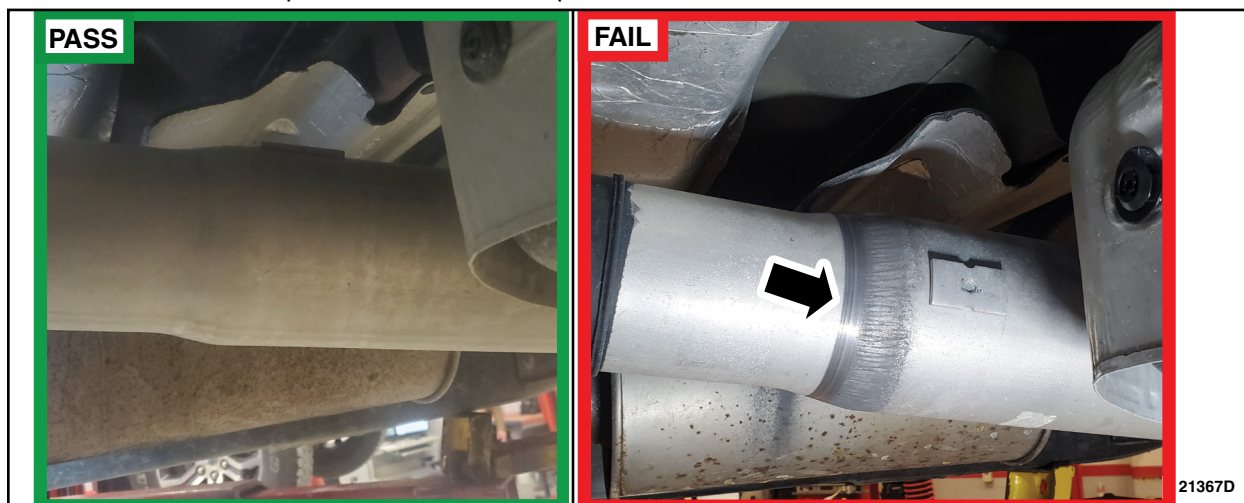
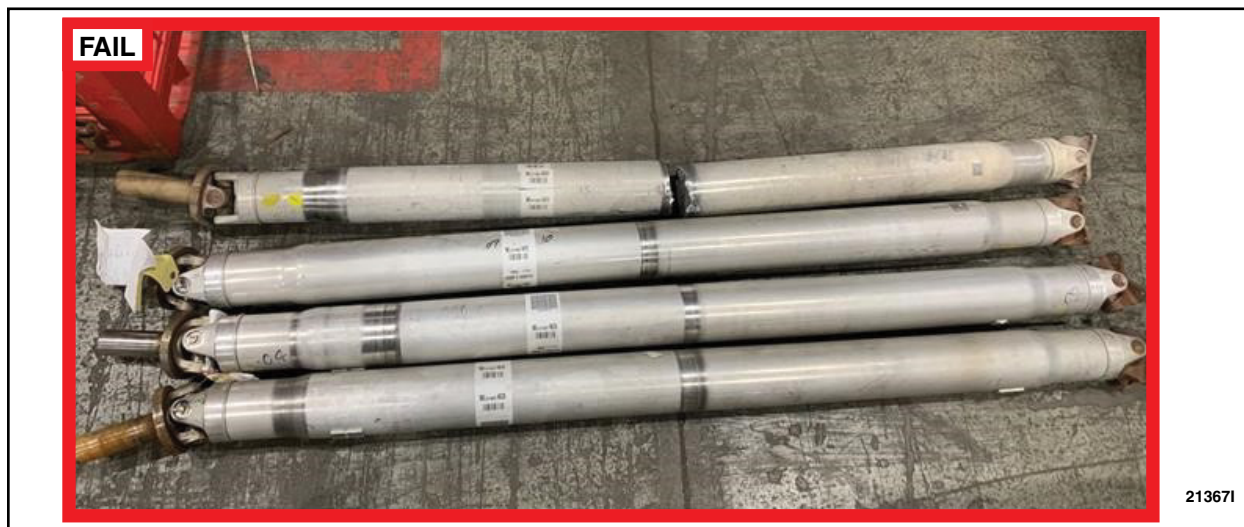
1. With the vehicle in NEUTRAL, position it on a hoist. Please follow Workshop Manual (WSM) procedures in Section 100-02.
2. Remove the driveshaft. Please follow WSM procedures in Section 205-01.
3. Inspect the rear driveshaft for any marks caused by the passenger side insulator. Are there any marks present on the driveshaft due to contact from the insulator? See Figures 2 and 3.

Yes – Does not pass inspection. Contact the SSSC and provide a picture of the driveshaft with the marks. Once approved, rear driveshaft replacement will be required, but do not install at this time. Proceed to step 4.

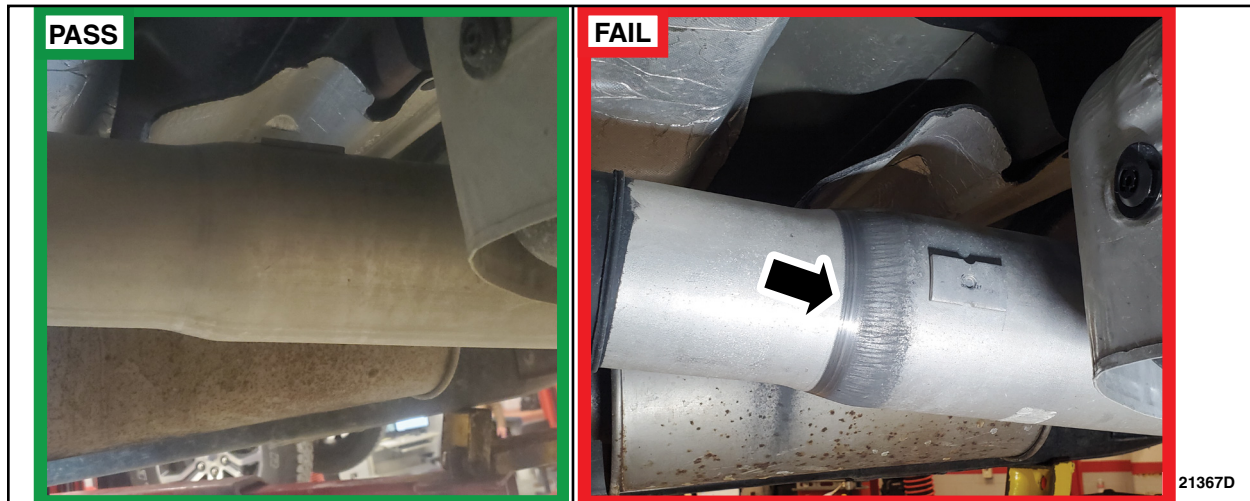
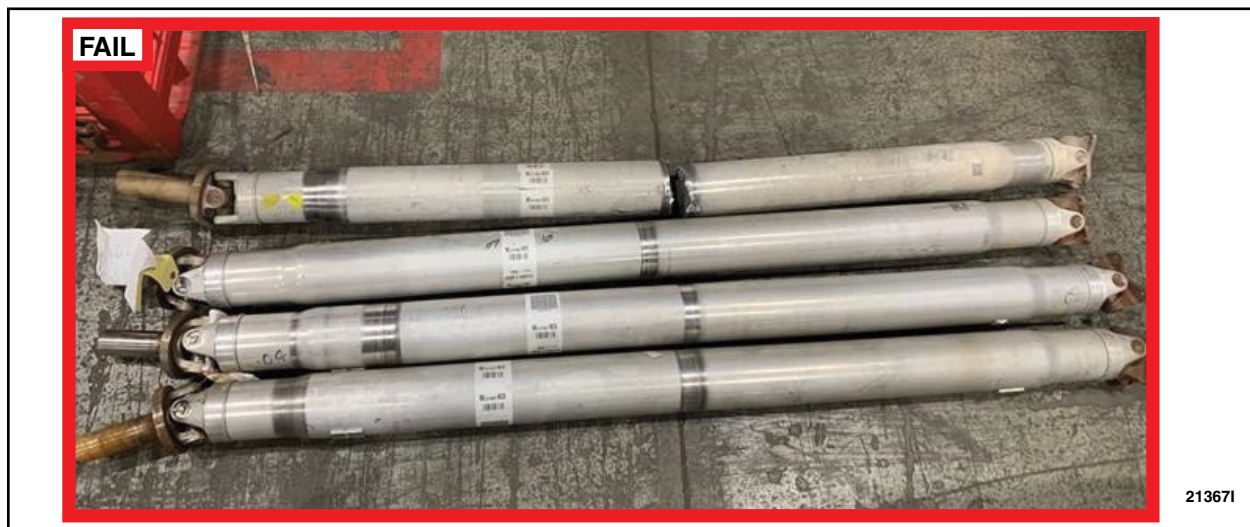
1. With the vehicle in NEUTRAL, position it on a hoist. Please follow Workshop Manual (WSM) procedures in Section 100-02.
2. Remove the driveshaft. Please follow WSM procedures in Section 205-01.
3. Inspect the rear driveshaft for any marks caused by the passenger side insulator. Are there any marks present on the driveshaft due to contact from the insulator? See Figures 2 and 3.

Yes – Does not pass inspection. Contact the SSSC and provide a picture of the driveshaft with the marks. Once approved, rear driveshaft replacement will be required, but do not install at this time. Proceed to step 4.

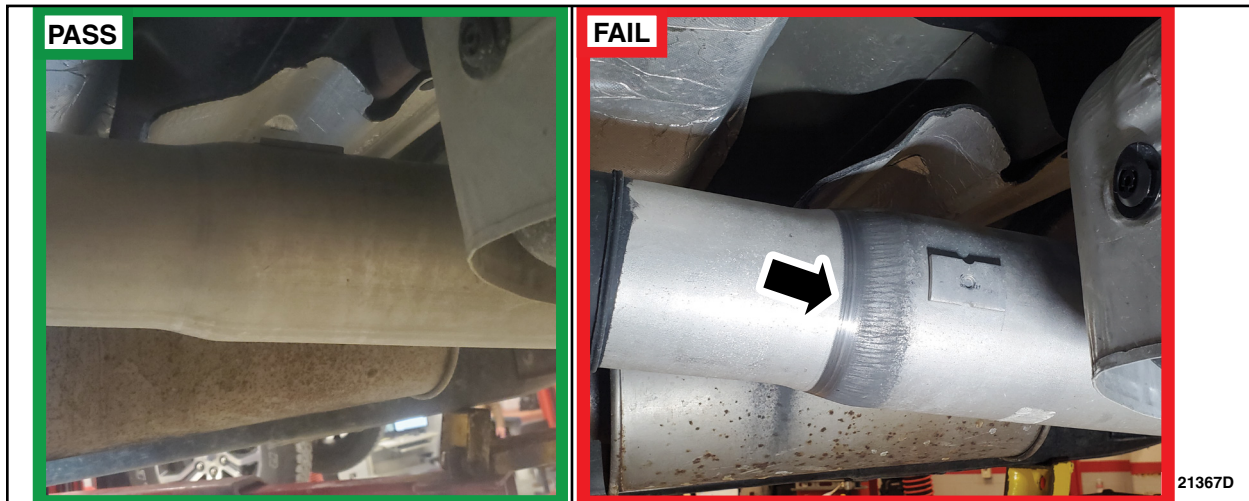
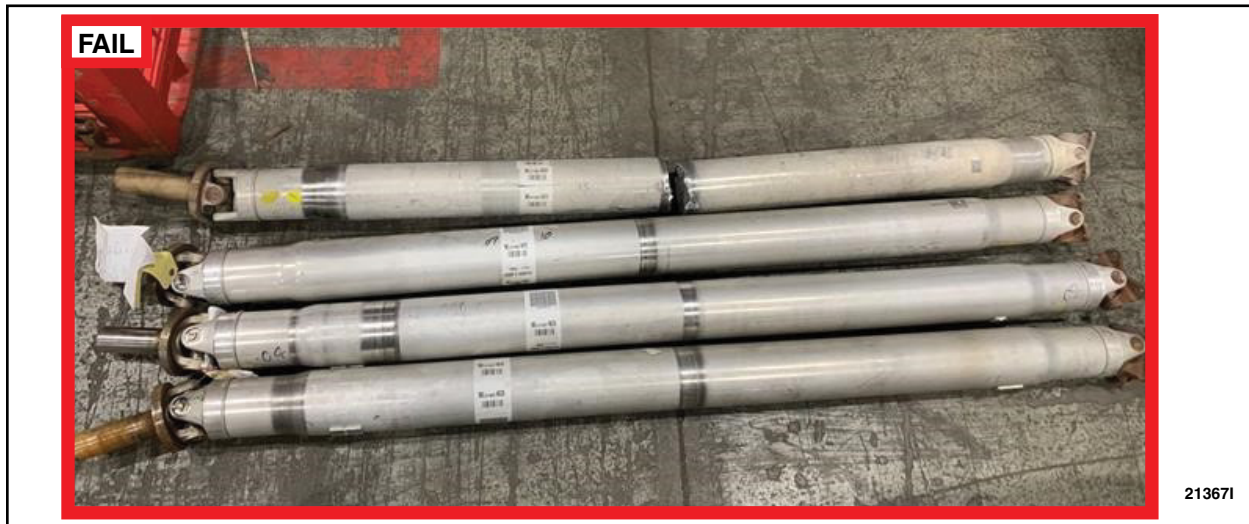
2. With the vehicle in NEUTRAL, position it on a hoist. Please follow Workshop Manual (WSM) procedures in Section 100-02.
3. Remove the driveshaft. Please follow WSM procedures in Section 205-01.
4. Inspect the rear driveshaft for any marks caused by the passenger side insulator. Are there any marks present on the driveshaft due to contact from the insulator? See Figures 2 and 3.

Yes – Does not pass inspection. Contact the SSSC and provide a picture of the driveshaft with the marks. Once approved, rear driveshaft replacement will be required, but do not install at this time. Proceed to step 5.
