IMPORTANT SAFETY RECALL - This notice applies to your **Vehicle(s)**

Safety Recall Notice 21V456

August 20, 2020

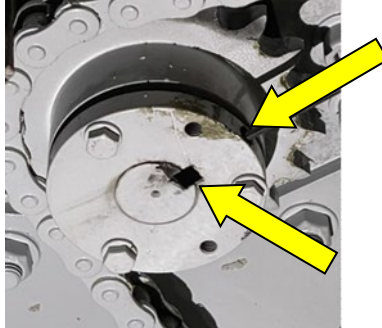
It has come to our attention that on some trucks, built between February 22, 2021 and May 5, 2021, the keyway, which prevents the swing drive gearbox output shaft from rotating within the drive sprocket, has become dislodged and fallen out of the assembly.

The photo above depicts a dislodged keyway

- The keyway is .375 x .375 x 2.25 carbon steel keyway.
- The set screw is a 5/16 cup point set screw

1. Back the set screw out far enough until it becomes exposed at the surface of the sprocket collar
2. With the chutes in a position approximately aligned with the chute saddle, align the keyway slots on the gearbox shaft and the drive sprocket.
3. Using a brass hammer or other form of shielding, drive the replacement keyway into the slot. The replacement keyway may need a slight bevel ground on all corners of the end being inserted to help facilitate the inset.

1. With the keyway in the proper position, carefully remove the set screw.
2. Apply 1-2 drops of thread locker such as Loctite 271 to the threads of the set screw
3. Thread the set screw into the assembly until it firmly seats against the keyway.
4. Using a 5/32 Allen Head socket apply 160 in-lbs of tightening torque.
