IMPORTANT SAFETY RECALL NOTICE – SMART-STEER 2.0 Self-Steer Axle

Re: Safety Recall - Smart-Steer 2.0 Self-Steer Axle

SERVICE BULLETIN #009R

Subject: SMART-STEER 2.0 Bolt-On Steer Arm Reinforcement Welds

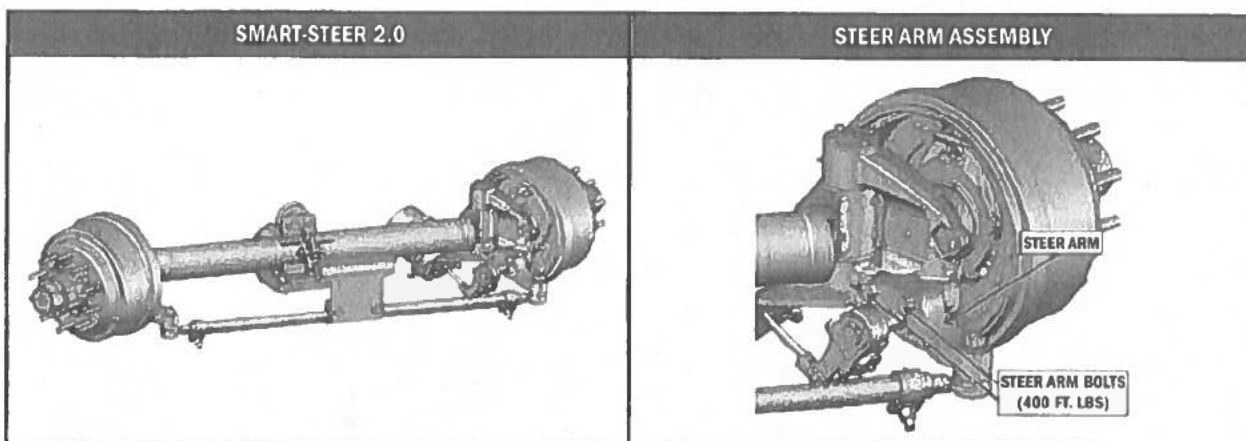
Based on feedback from our customers, Dexter Heavy Duty has become aware that under certain loading conditions, the 8-7/8" steer arm setup on the SMART-STEER 2.0 axle is prone to shearing the attaching steer arm bolts. This will lead to a failure in the steer arm assembly.

Dexter recommends that you perform a steer arm inspection of your axle(s) as soon as possible; but no later than four weeks after receiving this service bulletin. Please follow the steps listed below:

1. Visually inspect steer arm bolts and washers for mechanical tightness and replace if necessary.
2. Ensure the steer arm bolts are torqued to 400 Ft. Lbs.
3. Place welds as shown on page three of this bulletin. If you would like a copy of engineering drawing 750049, please contact one of the service technicians listed below.
