NHTSA Recall Number: 21V541

IMPORTANT SAFETY RECALL

Trail King Recall Number: TK202103

Subject: SMART-STEER 2.0 Bolt-On Steer Arm Reinforcement Welds

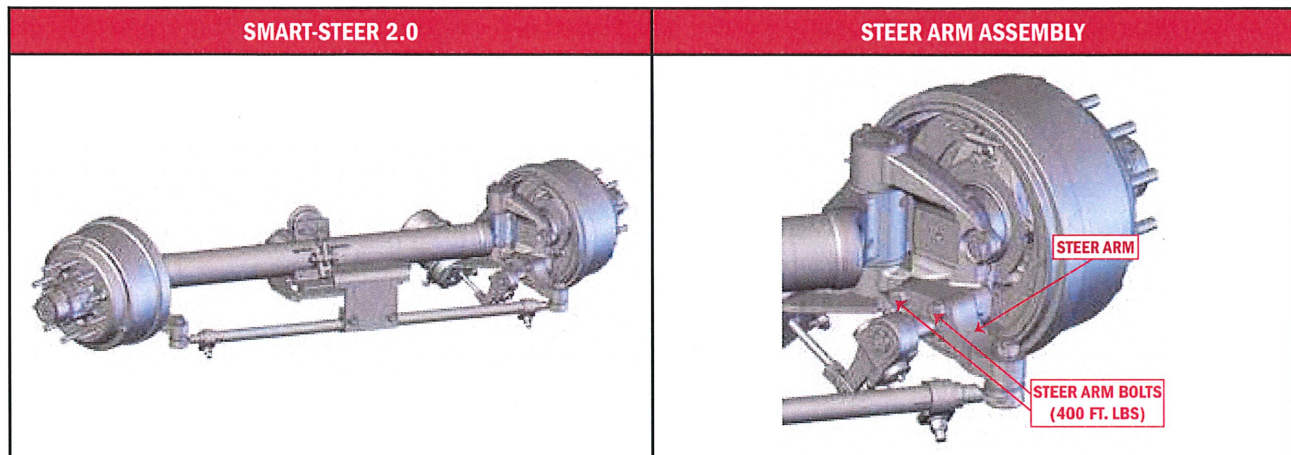
Based on feedback from our customers, Dexter Heavy Duty has become aware that under certain loading conditions, the 8-7/8" steer arm setup on the SMART-STEER 2.0 axle is prone to shearing the attaching steer arm bolts. This will lead to a failure in the steer arm assembly.

1. Visually inspect steer arm bolts and washers for mechanical tightness and replace if necessary.
2. Ensure the steer arm bolts are torqued to 400 Ft. Lbs.
3. Place welds as shown on page three of this bulletin. If you would like a copy of engineering drawing 750049, please contact one of the service technicians listed below.
