## IMPORTANT SAFETY RECALL

NHTSA Safety Recall  
No. 21V-722

CSN 833

## Rotation Bearing Washer Inspection

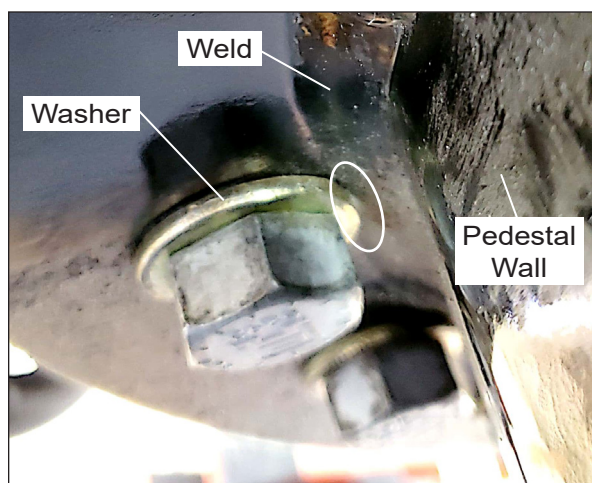
Altec has learned there can be the potential for washers on the outer race rotation bearing cap screws to overlap the adjacent weld on the affected units. Interference with weld under the washer can cause the cap screw to fail. The failure of rotation bearing cap screws can cause uncontrolled movement. **Death or serious injury can result from uncontrolled movement.**

**Figure 3 — Washer Overlapping Weld**

If no weld interference is found, no further action is required. If weld interference is found on only one washer, schedule Altec Service to repair the unit within 60 days, and put the unit back into service. If weld interference is found on more than one washer, take the unit out of service, and schedule Altec Service to repair the unit.

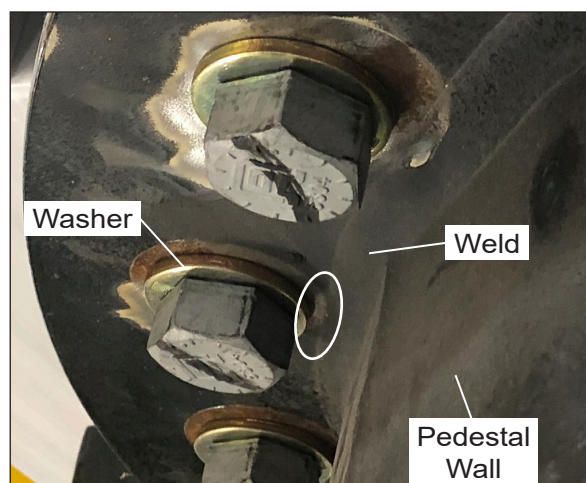
**Figure 4 — Washer Not Overlapping Weld**
