IMPORTANT SAFETY RECALL

NHTSA Recall Number: 21V736

Altec Identifier: CSN-3215

Mounting Frame Inspection

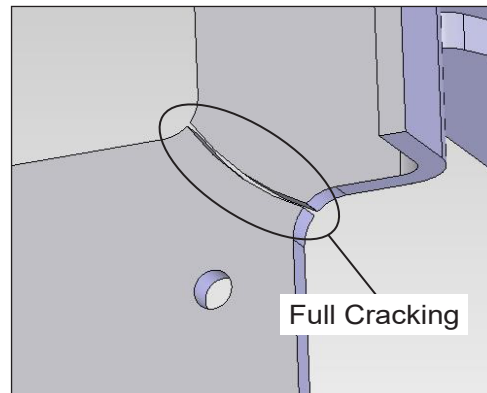
Figure 3 – Full Cracking Example

- Full cracking means a visible crack across the full width of the narrow section extending through the full thickness of the plate and causing the complete separation of the material (refer to Figure 3).

- If there is **full cracking**, take the unit out of service. The vehicle can still be driven, but the aerial device cannot be used until it is repaired. Proceed to Inspection Procedure B to determine the necessary repair procedure.

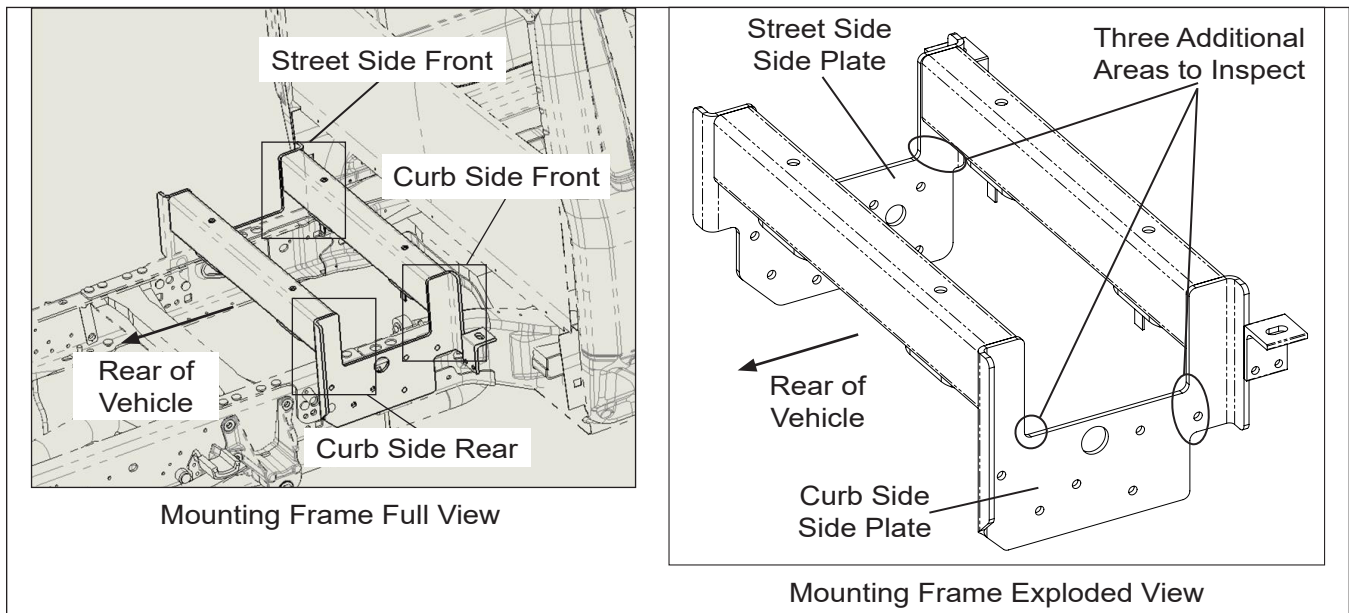
Figure 4 – Mounting Frame Additional Inspection B

7. Keep the unit set up as in Inspection Procedure A step 1.
8. Use a wire brush to remove any paint and rust from the other three corners of the mounting frame (refer to Figure 4).

9. Using a flashlight, inspect the outer surface and the rounded corners of the other three corners of the mounting frame as shown in Figure 4 for the extent of any cracking in the steel plate.
 - If there is no cracking in any of these three areas, order the Mounting Frame Reinforcement Kit, part number 991832504, and install it before putting the unit back into service.
 - If there is cracking in any of these three areas, call 1-270-505-1532 to speak to Telecom Product Support or email Telecom.Product.Support@altec.com to obtain further direction on repair.
