IMPORTANT SAFETY RECALL

Recall Remedy Service Bulletin

Safety Recall 21V-926

TSB 092921A LCT and TM Emergency Brakes
with John Deere Engines

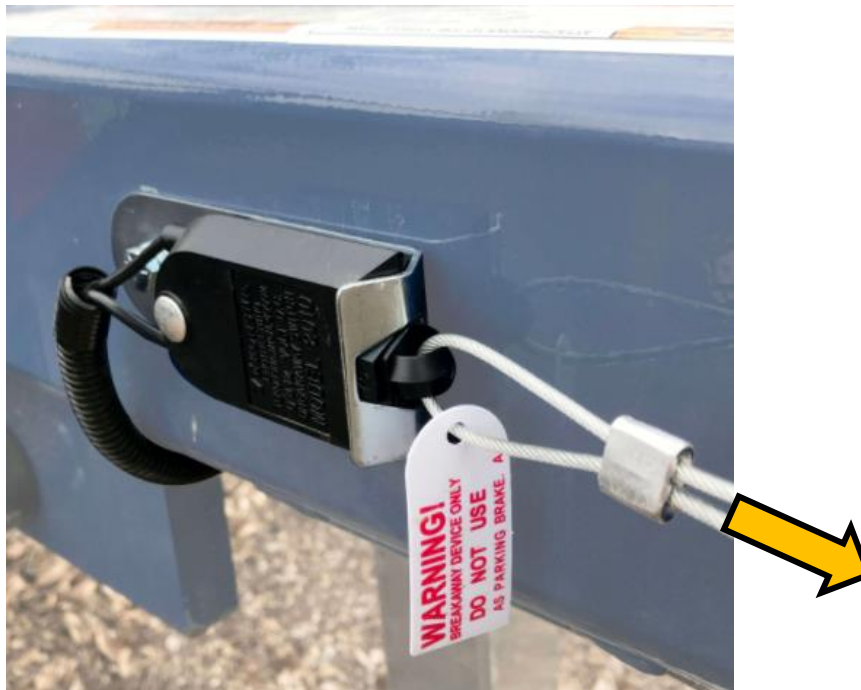
1. Connect the trailer to a towing vehicle. Ensure that the trailer engine is off, with the key in the off position.
2. Pull the breakaway cable until plastic plug disconnects from switch housing, this should apply the emergency brakes.

3. Attempt to drag the trailer 3 feet. Use a spotter to check that the brakes have been applied. Once the test is complete, reinstall the breakaway plug into the switch housing. **Failure to replace the plug into the breakaway switch housing will keep the emergency brakes applied and eventually drain the battery.**

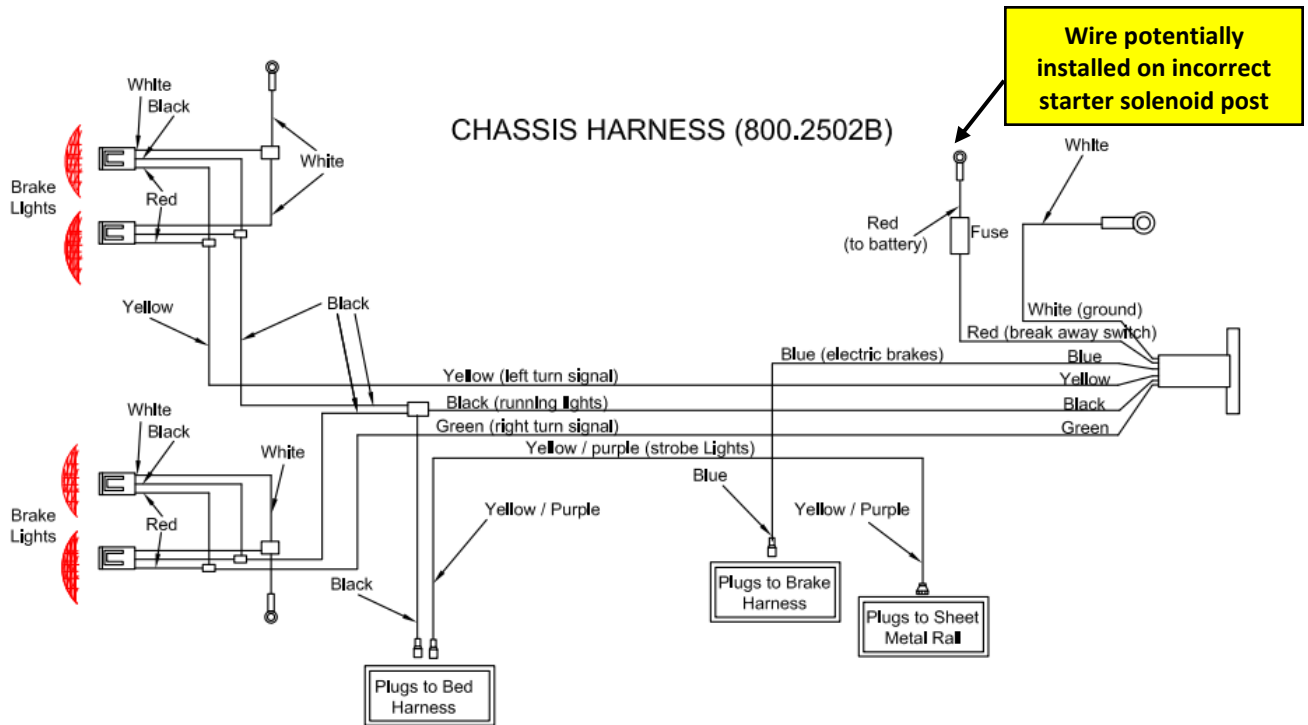
The chassis harness, (830XZ or 8002502B), provides power to the breakaway switch at the starter solenoid. If the chassis harness is connected to the wrong terminal, power cannot be applied to

provide emergency braking in the event of a breakaway between the trailer and towing vehicle. This hazardous condition would only occur if the debris collector's starter is off.

1. Open the engine panel facing the front of the machine. To the lower left, the starter solenoid is mounted to the engine bracket. Ensure that there are three ring terminals to the top post nearest the door opening. There should only be one ring terminal on the top post further from the engine panel.

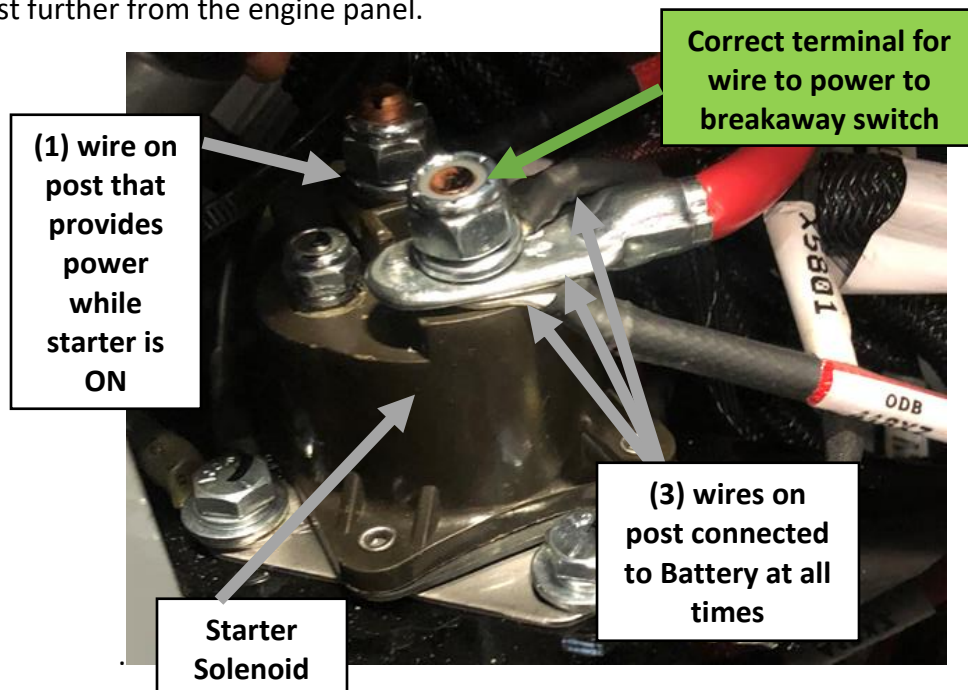
Issue Description: Power supply to the emergency breakaway switch may have been incorrectly installed on the wrong terminal of the starter solenoid. If incorrectly installed, the emergency braking would only be applied while the starter is running.

2. If the emergency braking power wire needs to be relocated, ensure that the correct wire is selected. This wire will have an in line 15 amp fuse and fuse holder approximately 6 inches away from the ring terminal.
3. Once the wire has been relocated, repeat the "Brake Check".
