Technical Service Bulletin

Technical Service Bulletin: TSB210113	Released Date: 28-Jun-2021
Fuel Rail Assembly Inspection and Repair Procedure: External Fuel Leaks

Fuel Rail Assembly Inspection and Repair Procedure: External Fuel Leaks

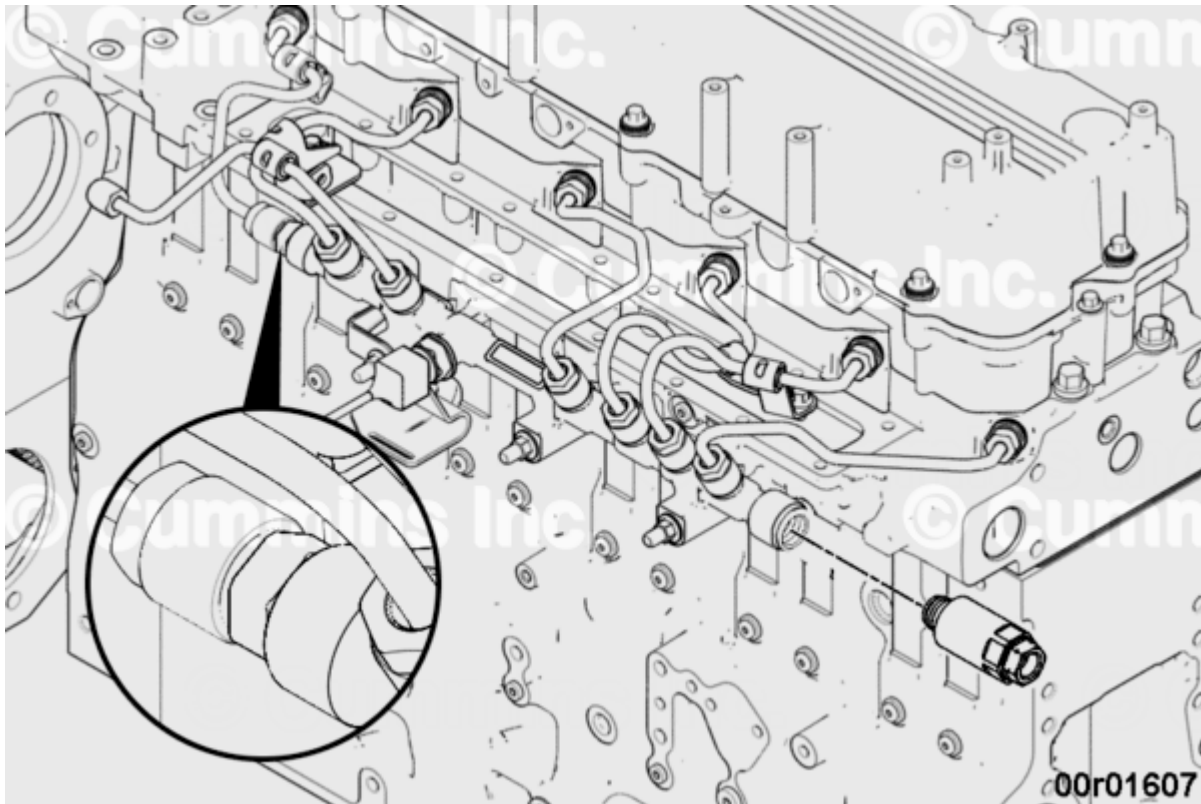
Figure 1, Removing the pressure relief valve and the high pressure fuel fitting.

- Remove the pressure relief valve and the high-pressure fuel fitting from the fuel rail.

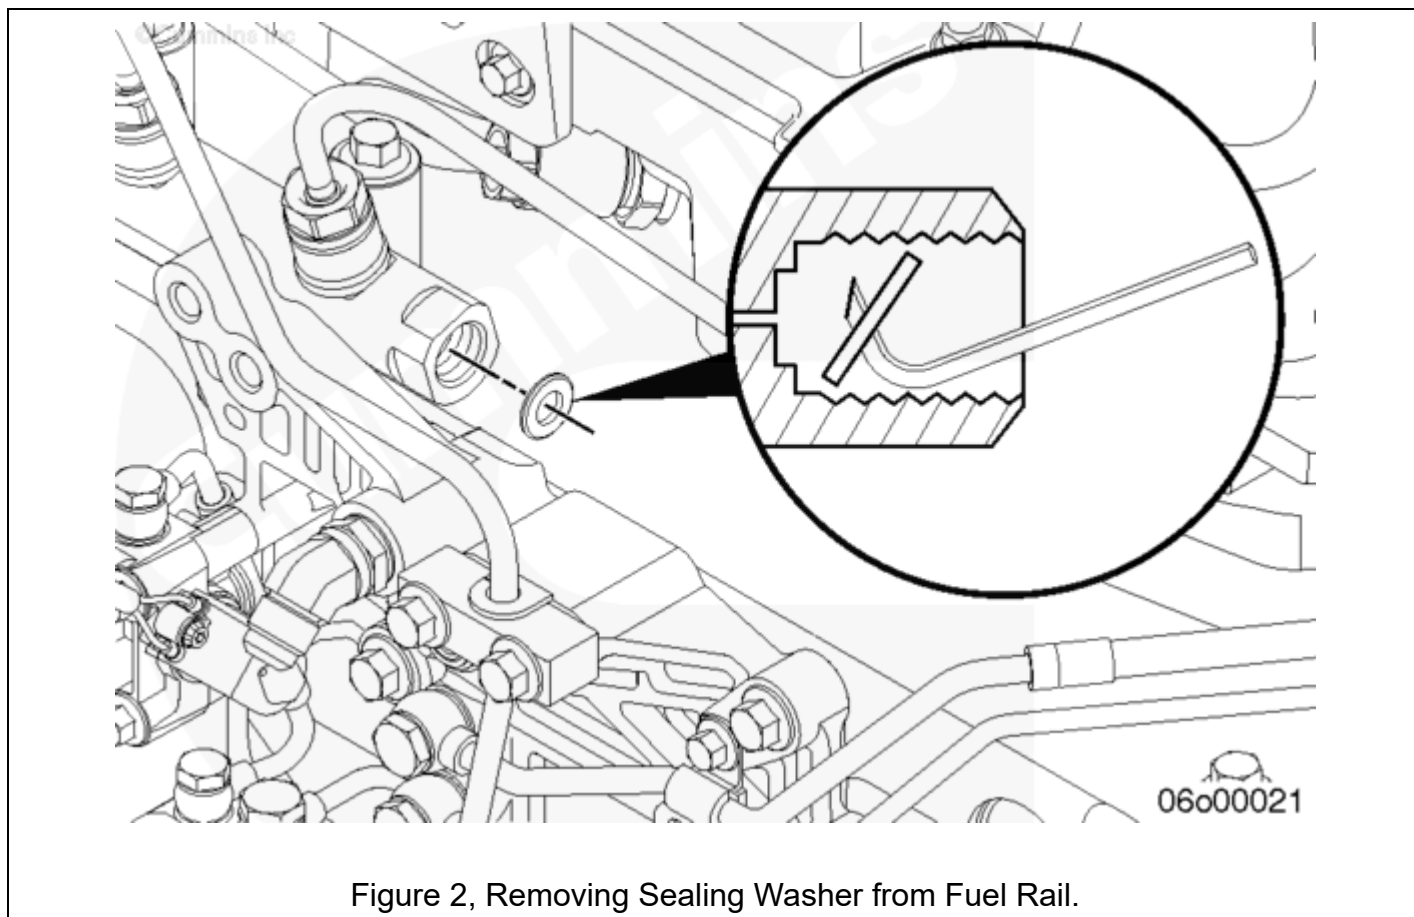
Figure 2, Removing Sealing Washer from Fuel Rail.

- Remove and discard the sealing washers. The procedure below outlines how to remove the sealing washers.

- A special tool **must** be created for the removal of the sealing washers by grinding a 45 degree angle on the short leg of a 1/8-inch or 3/16-inch Allen wrench, so that the wrench is no longer than 13 mm [½ in] long (measured from the outside of the long leg.)
- This tool acts as a mini heel bar to pry out the sealing washer without damaging the back of the hole.
- Use the modified Allen wrench to pry out the old sealing washer from the threaded hole in the fuel rail. Considerable force is required to remove the sealing washer.

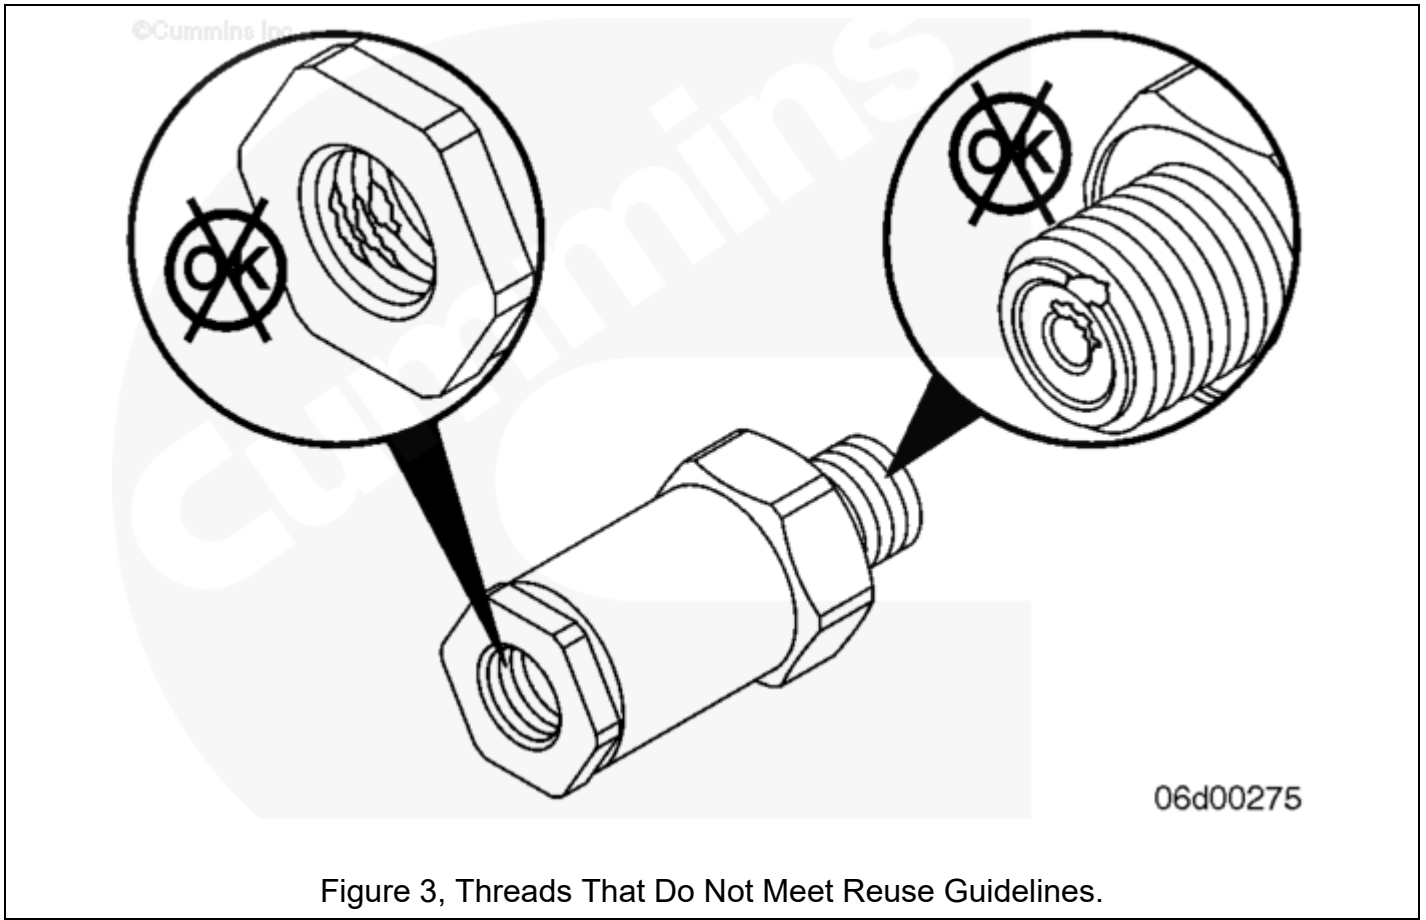
Figure 3, Threads That Do Not Meet Reuse Guidelines.

- Visually inspect the thread surfaces of the fuel rail, fuel pressure relief valve and the high-pressure fuel fitting for damage. Review Figures 3 and 4 below for guidance.
- Do **not** reuse components if the threads or sealing surfaces are damaged.

- If the threads or sealing surfaces are damaged, replace the fuel rail assembly. See corresponding Service Manual. Reference Procedure 006-060, 006-061 in Section 6 and Technical Service Bulletin, New Fuel Rail, High Pressure Injector Supply Lines, Fuel Supply Line, and Fuel Supply Line Braces, TSB210055 for directions.
- If the threads or sealing surfaces are **not** damaged, install the pressure relief valve and the end fitting with the following procedure:

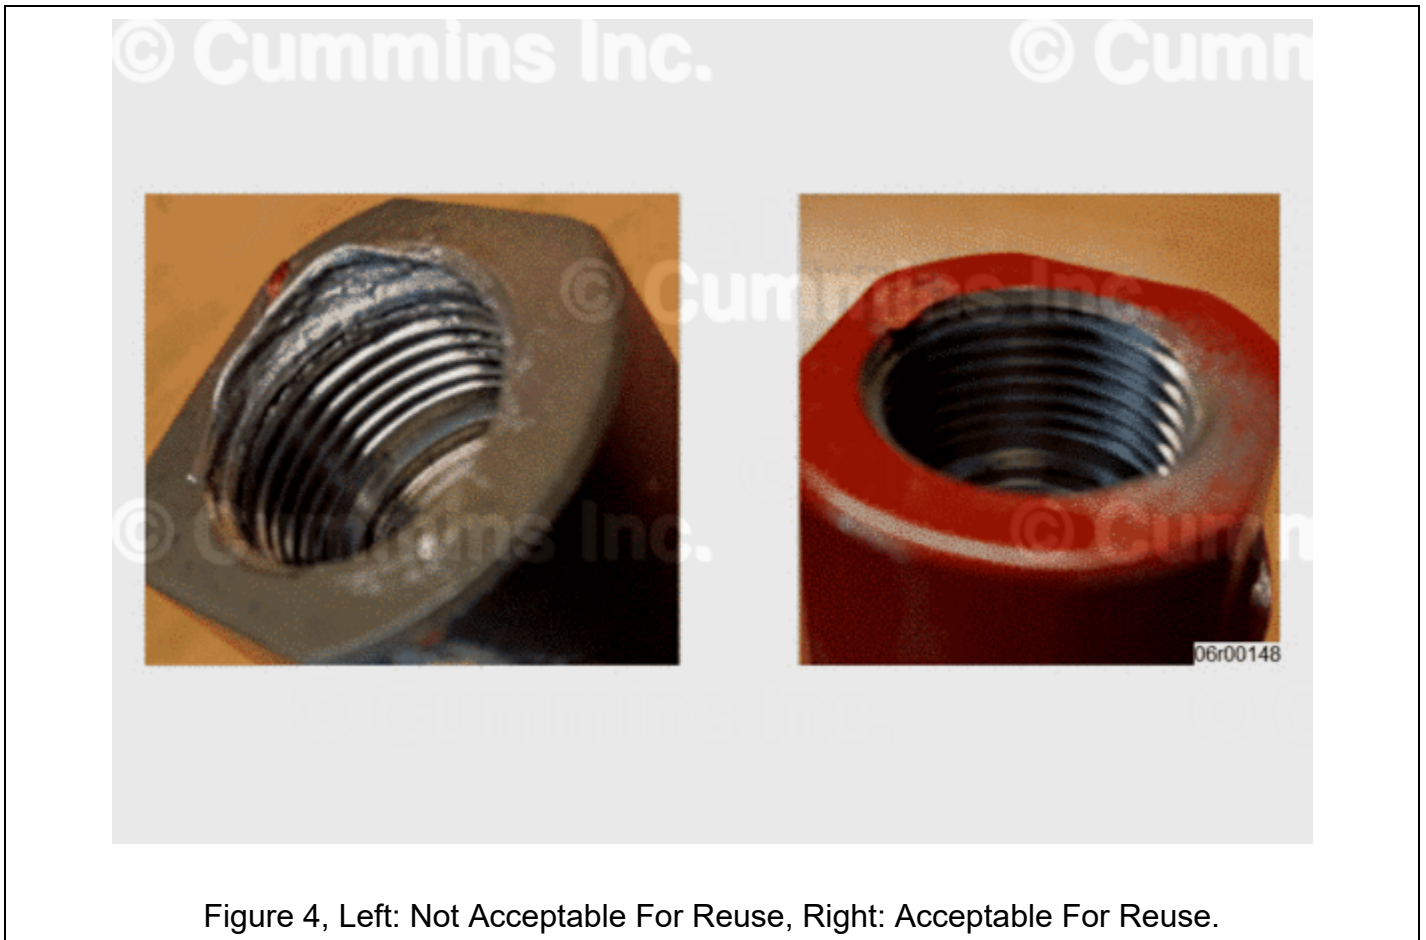
Figure 4, Left: Not Acceptable For Reuse, Right: Acceptable For Reuse.

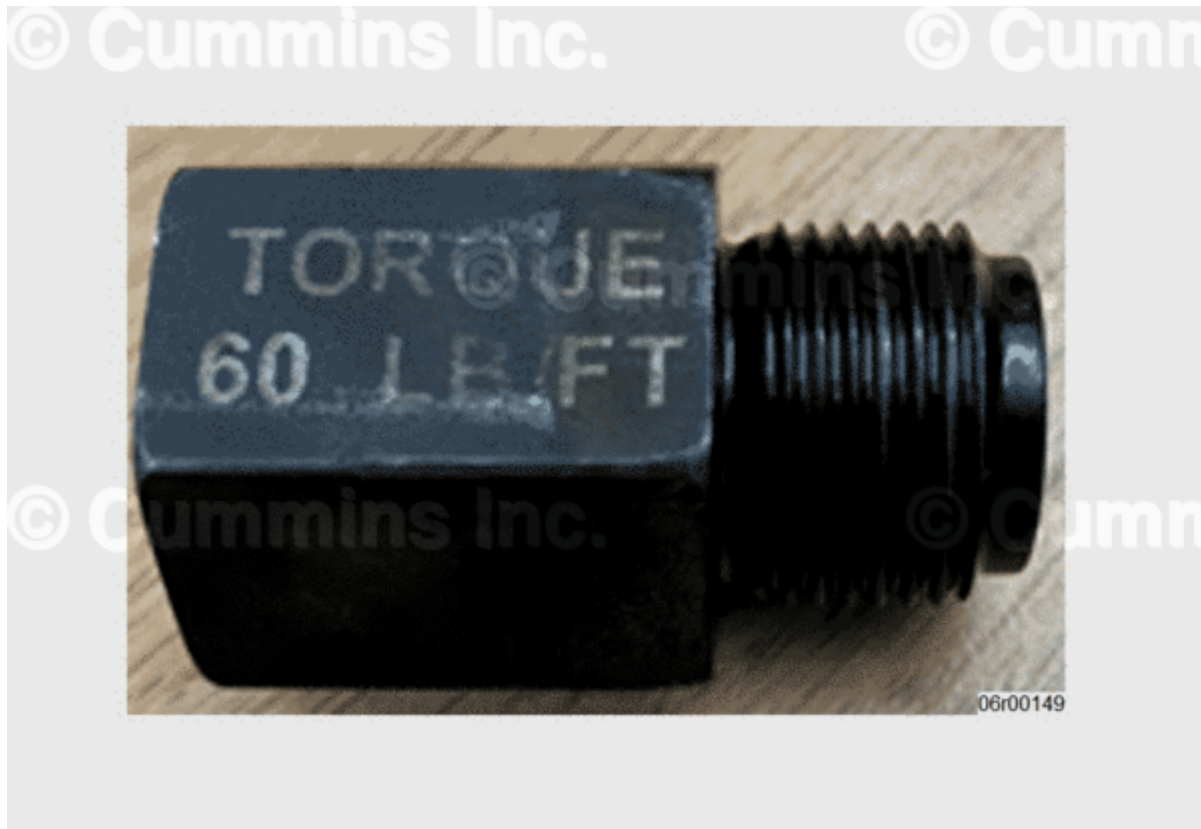
Figure 5, New Seal Installer Tool, Part Number 5573487.

- A new seal installer tool, Part Number 5573487, is now available for this repair.

- The new seal installer tool **must** be used for all repairs requiring the installation of pressure relief valve or the high pressure fuel fitting on the fuel rail. See Service Instructions section below.

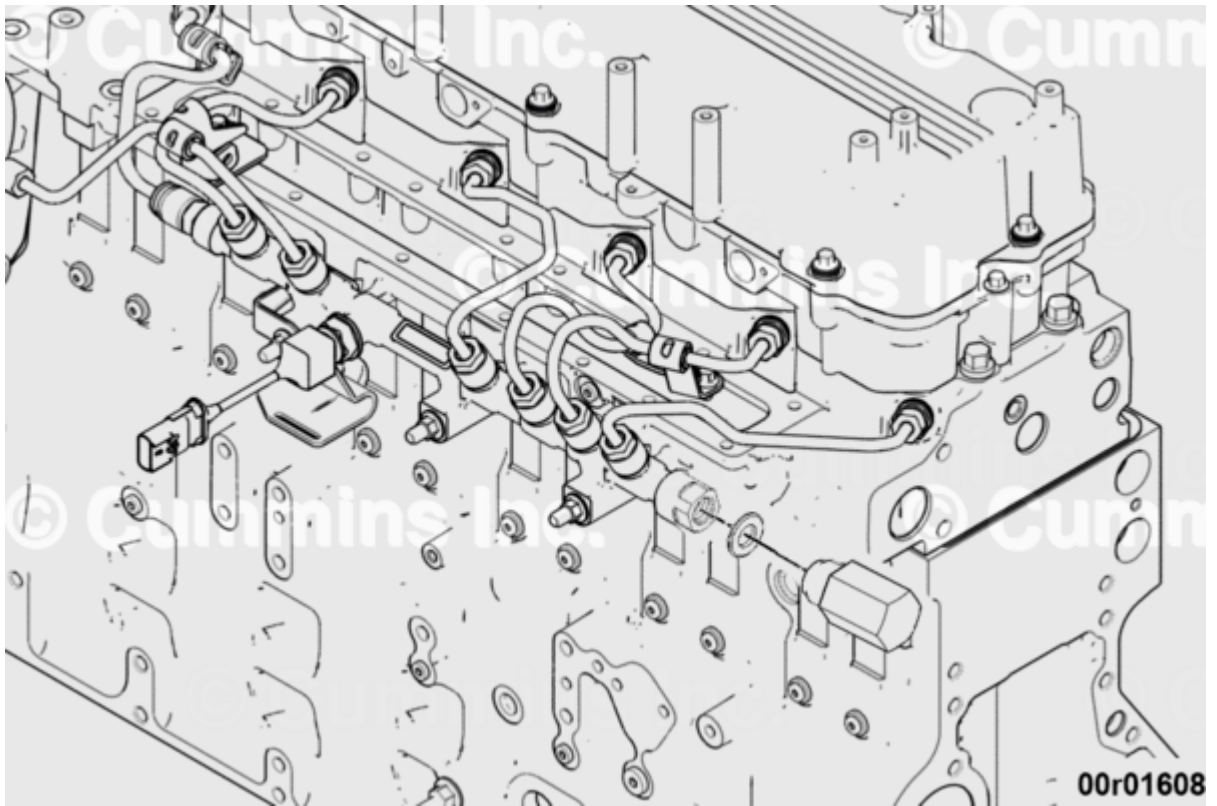
Figure 7, Installing Sealing Washer with The Seal Installer Tool.

2. Install a new sealing washer on the pressure relief valve bore in the fuel rail. Use assembly lubricant, Part Number 3163087, or equivalent, on the threads and the face of the seal installer tool. Use seal installer tool, Part Number 5573487, to seat the sealing washer fully in the fuel rail bore.

3. Torque the seal installer tool.

Torque Value: 81 n•m [60 ft-lb]

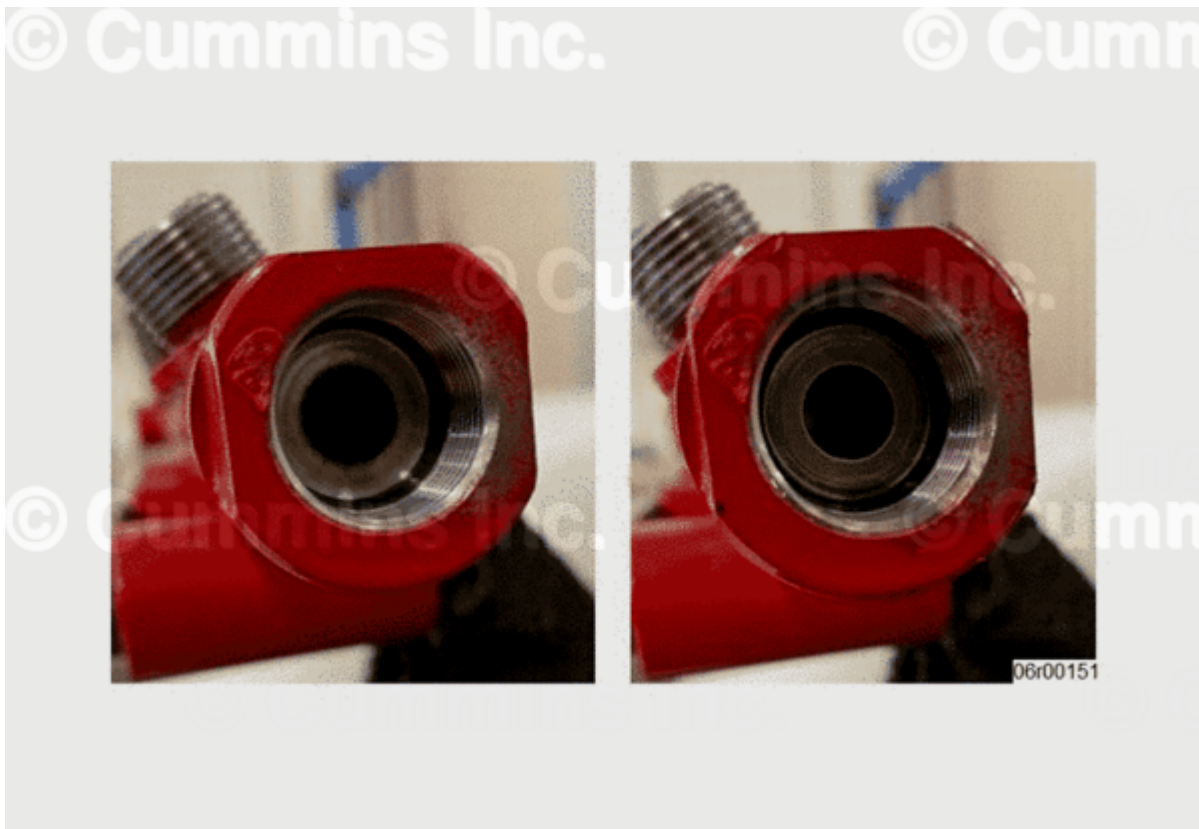
Figure 8, Left: Sealing Washer Not Installed, Right: Sealing Washer Installed Correctly.

4. Remove the seal installer tool after the sealing washer has been installed. Verify that the sealing washer remains seated inside the fuel rail after the seal installer tool is removed.

9. If either of the sealing washers do **not** remain seated inside the fuel rail after the seal installer tool has been removed, reinstall the sealing washer following the same procedure.
