Technical Service Bulletin: TSB210113 Released Date: 27-Jul-2021

Fuel Rail Assembly Inspection and Repair Procedure: External Fuel Leaks

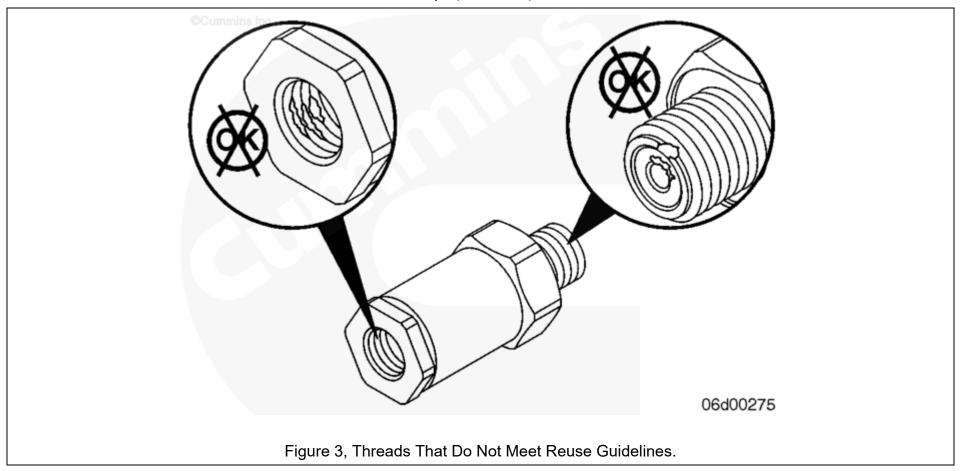
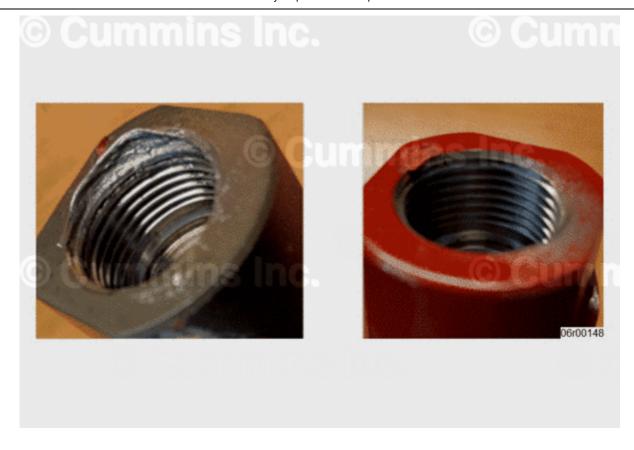
- Visually inspect the thread surfaces of the fuel rail, fuel pressure relief valve and the high-pressure fuel fitting for damage. Review Figures 3 and 4 below for guidance.
- Do **not** reuse components if the threads or sealing surfaces are damaged.

Figure 4, Left: Not Acceptable For Reuse, Right: Acceptable For Reuse.

• If the threads or sealing surfaces are damaged, replace the fuel rail assembly. See corresponding Service Manual. Reference Procedure 006-060, 006-061 in Section 6 and Technical Service Bulletin, New Fuel Rail, High Pressure Injector Supply Lines, Fuel Supply Line, and Fuel Supply Line Braces, TSB210055 for directions.

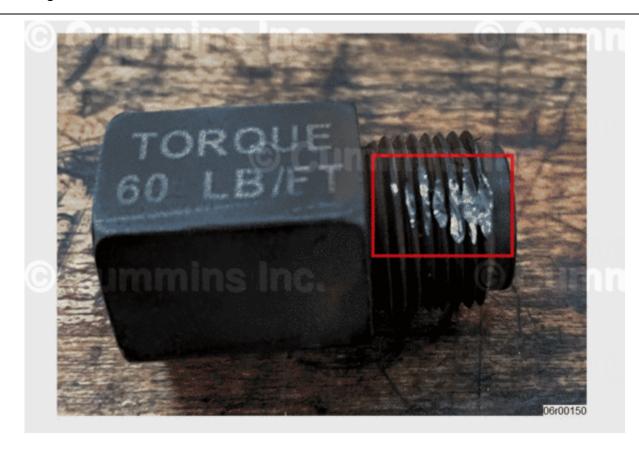
Figure 6, Seal Installer Tool Threads Not Acceptable for Use.

- If the threads or sealing surfaces are **not** damaged, install the pressure relief valve and the end fitting with the following procedure:
- 1. Inspect the seal installer tool for damage on the threads or sealing surfaces. Do **not** use the seal installer tool if the threads or sealing surfaces are damaged.

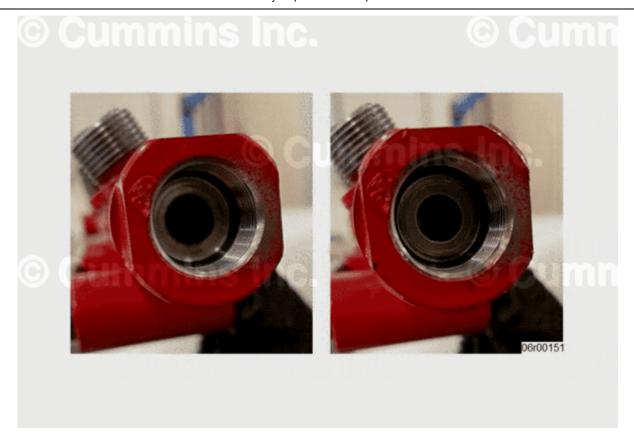
Figure 8, Left: Sealing Washer Not Installed, Right: Sealing Washer Installed Correctly.

- 9. If either of the sealing washers do **not** remain seated inside the fuel rail after the seal installer tool has been removed, reinstall the sealing washer following the same procedure.
- 10. Install the pressure relief valve and the high-pressure fuel fitting. Use assembly lubricant, Part Number 3163087, or equivalent, on the threads. Tighten the pressure relief valve and the high-pressure fuel fitting with the torque plus angle method.
