Watson & Chalin Pivot Bolt Replacement VHD

RECALL INFORMATION

(June, 2021)

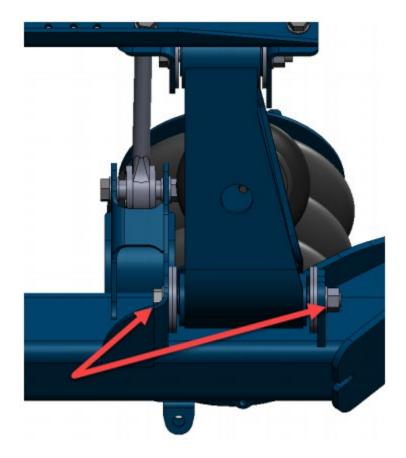
a. Make note of the lower control arm spacer washer locations. These are the large diameter washers

inside of the axle flanges. If required, mark the locations or take photographs to reference during re-installation. NOTE THAT WASHER LOCATIONS MAY DIFFER FROM THE ABOVE PICTURE. Spacer

washers may be left in and reused if they are free from damage.

b. Use 1-5/16-inch wrenches and/or sockets to remove the nuts.

c. If required, use a grinder and cutoff wheel to remove stuck fasteners. Take care not to damage the axle flange, axle tube, or any other vehicle components when using the grinder.

d. Secure the control arm with a jack stand, so it does not fall, and knock out the cap screw using punches and a hammer. USE CAUTION, AS CONTROL ARM MAY SHIFT WHEN THE FASTENER IS REMOVED.

b. Install the lower control arm spacer washers. An alignment or center punch inserted from the outboard side may be used to hold them in place until the cap screw is inserted. For correct washer locations, reference notes taken in Step 18a.

c. Install the lower control arm pivot cap screw, washers, and nut, but do not tighten.

d. Use 1-5/16-inch wrenches and / or sockets to snug the lower pivot fastener. Confirm fastener is fully engaged with the joint.

e. Secure the heads of the cap screws with a combination wrench and tighten the nuts to 400 lb-ft torque. DO NOT TORQUE FROM HEAD OF CAP SCREW.
