Technical Service Bulletin: TSB210146
 Released Date: 13-Sep-2021

Safety Campaign #4495 RBAB Lift Cable Crimp Issue

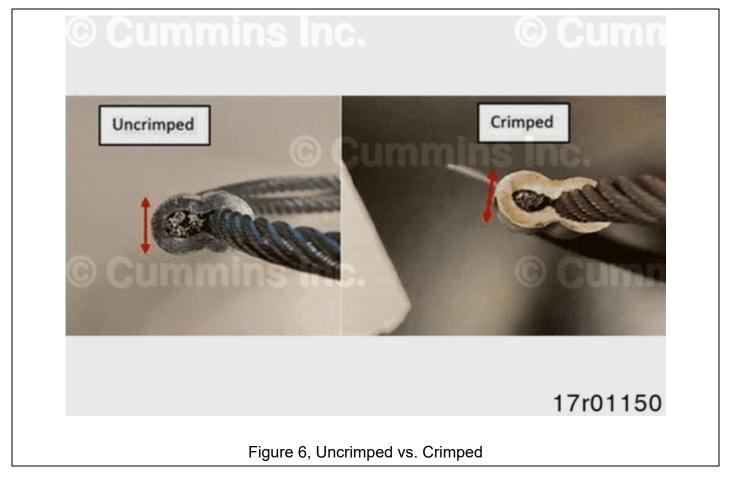
5. Inspect the cable ferrules for the marking to see if the unit's cable is properly crimped. The cable can also be visually inspected for a crimped cable.

Note: If cable has no crimp marking, continue to follow the steps below and replace the cable. If cable is marked (and properly crimped), no repair is required. Replace enclosure panel.
