HYUNDAI Technical Service Bulletin	GROUP RECALL	NUMBER 22-01-025H
	DATE FEBRUARY, 2022	MODEL(S) SANTA FE HYBRID (TM HEV) SANTA FE PLUG-IN HYBRID (TM PHEV)
SUBJECT: DIGITAL INSTRUMENT CLUSTER (SUPERVISION) REPLACEMENT (RECALL 217)

Description: Certain 2022 Santa Fe Hybrid (TM HEV) and Santa Fe Plug-In Hybrid (TM PHEV) instrument panel (“IP”) cluster liquid-crystal display (“LCD”) may have been produced with incorrect resistors resulting in the possibility of an inverted image of associated controls, gauges, and telltale indicators upon startup of the vehicle at extremely low temperatures.

Applicable Vehicles: Certain 2022 MY Santa Fe Hybrid (TM HEV) and Santa Fe Plug-In Hybrid (TM PHEV) produced from 10/25/2021 - 12/01/2021 equipped with all digital instrument cluster (Supervision) display.

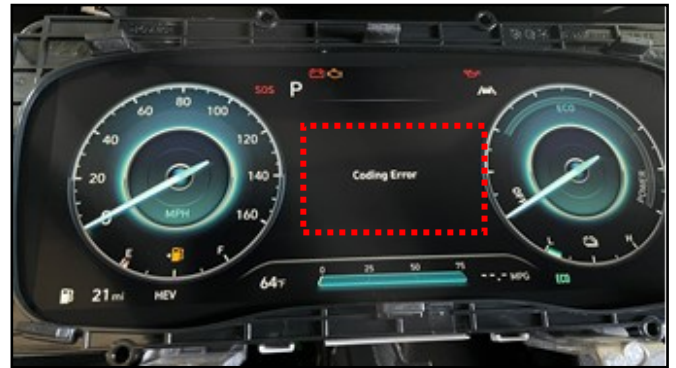
A “Coding Error” message will appear, which means the instrument cluster requires variant coding.

4. Install the new instrument cluster and turn the ignition to the ON position.
