HYUNDAI Technical Service Bulletin	GROUP RECALL	NUMBER 22-01-051H
	DATE MAY, 2022	MODEL(S) ELANTRA (CN7A) SANTA FE (TMA)
SUBJECT: WINDSHIELD GLASS REPAIR (RECALL 216)

Description: Certain 2021MY Elantra (CN7A) and 2020 – 2021MY Santa Fe (TMA) vehicles may have been built with nonconforming clear coat paint, which may lead to inadequate front windshield adhesion to the vehicle body. The windshield may not stay adequately retained in a crash, which may increase the risk of injury to an occupant. This bulletin describes the procedures to repair this condition.

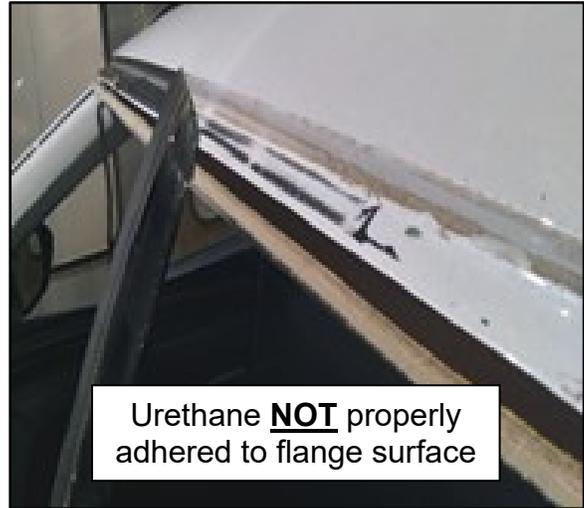
6. In the areas where the urethane did not adhere properly to the flange surface, the urethane will be easier to peel off as shown in the photo.

After removing any remaining urethane with a scraper, use 180 grit sandpaper to scuff these areas of the flange surface until it appears hazy.

Only scuff the areas where the urethane was previously or will be applied.

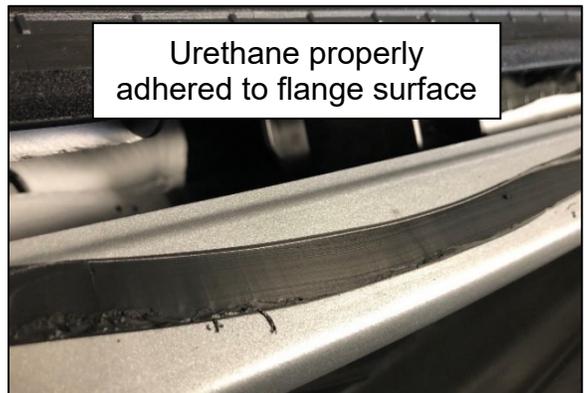
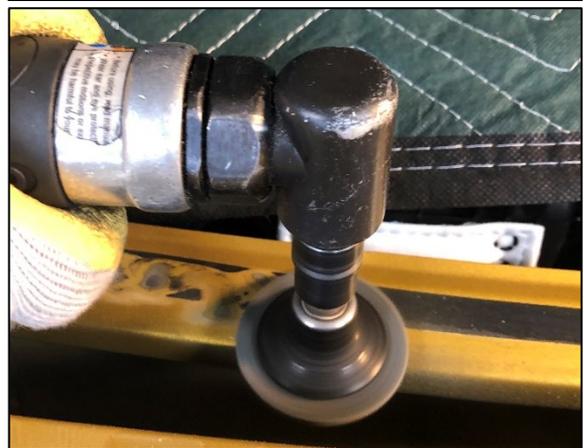
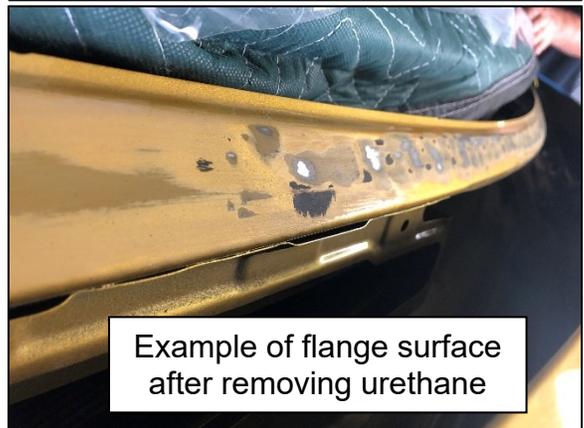
7. In the areas where the urethane is adhered properly to the flange surface, the urethane will be more difficult to remove by hand.

After trimming off as much urethane as possible, use a 180 – 240 grit (Super Fine or Very Fine) 3M Scotch-Brite Roloc disc to remove all remaining urethane in these areas.

Excessive abrasion will cause damage to the clear coat and base paint. Use light pressure to minimize damage to the flange surface.

Only scuff the areas where the urethane was previously or will be applied.
