RECALL CAMPAIGN BULLETIN

Classification: EL20-047a	Reference: NTB21-003a	Date: February 3, 2021
------------------------------	--------------------------	---------------------------

VOLUNTARY SAFETY RECALL CAMPAIGN 2013-2015 PATHFINDER; STOP LAMP SWITCH ADJUSTMENT

CAMPAIGN ID #: PC786
APPLIED VEHICLES: 2013-2015 Pathfinder (R52)

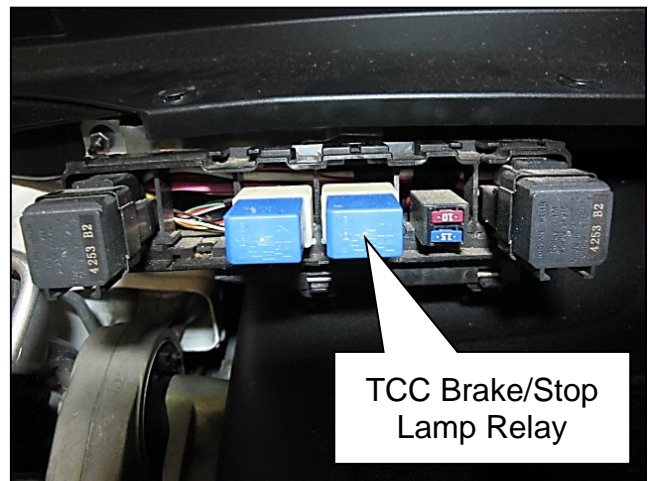
Figure 5

4. Locate the TCC brake/stop lamp relay.

- If the TCC brake/stop lamp relay is present, continue to step 5 on page 6.
- If the TCC brake/stop lamp relay is not present, no repair is required.
- Reassemble the vehicle in the reverse order of removal and review the **CLAIMS INFORMATION** on page 11.

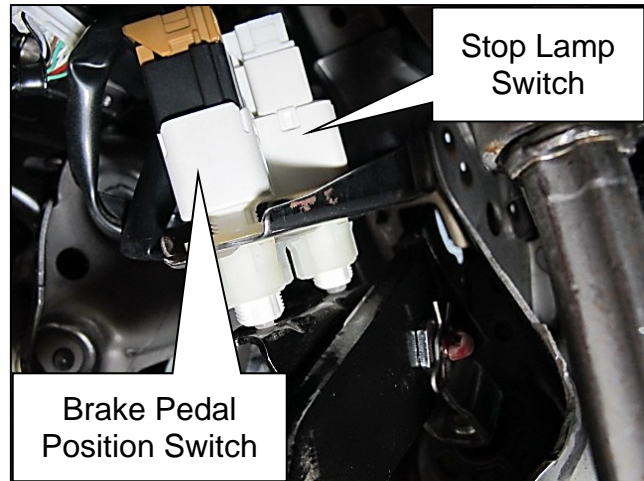
Figure 12

IMPORTANT: The stop lamp switch (white connector) must be in the upper position (Figure 12).

HINT: The stop lamp switch has a white connector with yellow and white wires. The brake pedal position switch has a tan connector with red and light green wires.

11. Swap the positions of the stop lamp switch and the brake pedal position switch.

- There is no need to remove the harness connector from either of the switches.
- Turn the switches 45° counterclockwise to remove.
- To reinstall, insert the threaded end of the switches into the brake pedal bracket, and then turn the switches 45° clockwise to lock in place.

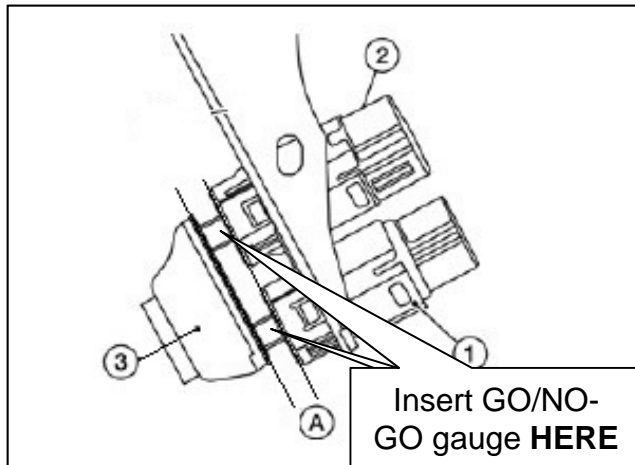
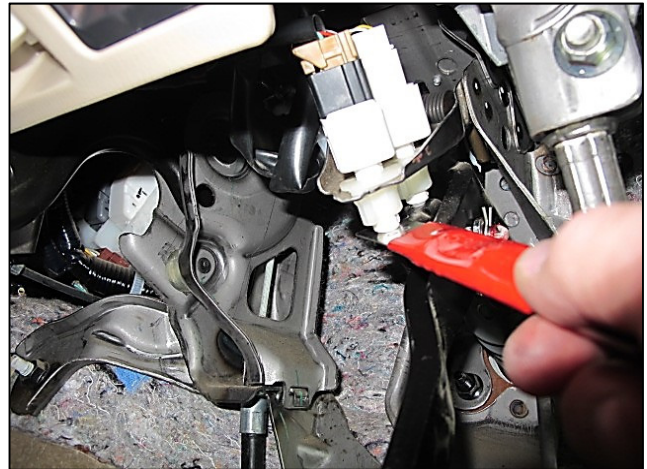
IMPORTANT: Make sure that the clearance (A) between the brake pedal (3) and the brake pedal position and stop lamp switch (1 & 2) are within specification using the GO/NO-GO gauge, special tool J-53099. The stop lamps must turn OFF when the brake pedal is released.

- Adjust both the stop lamp switch and the brake pedal position switch using the GO/NO-GO gauge, special tool J-53099 (Figure 13 and Figure 14).

- Be sure to adjust both the switches so that the gauge's GO side fits and the NO-GO side will not fit between the brake pedal and both of the switches.

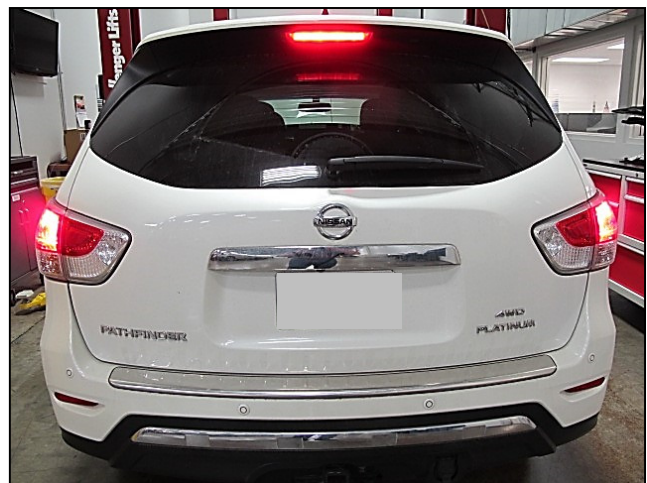
Figure 15

IMPORTANT: The stop lamps must turn OFF when the brake pedal is released.

- Verify the stop lamps operate properly.

NOTE: If the stop lamps do not operate properly, perform step 12 to readjust the switches.
