PRODUCT CAMPAIGN BULLETIN

APPLICABILITY: 2021MY Outback 2.5L
 2021MY Impreza
SUBJECT: CVT Select Lever Cable Nut- Low Torque

NUMBER: WRA-21
DATE: 01/21/21
NHTSA ID: TBD

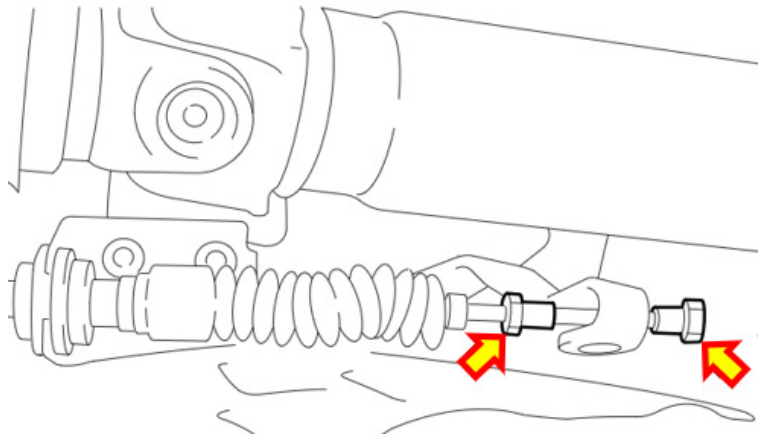
Step 4: With the center exhaust cover removed, locate the select cable adjusting nuts as shown below.

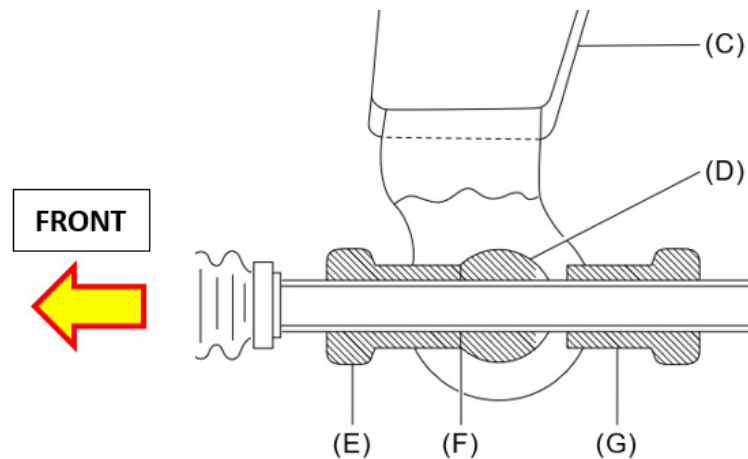
Step 5: Using the illustration below as a guide, confirm the select cable adjustment and proper torque of adjustment nut (G):

5a) Loosen the rear adjusting nut (G) while holding the front adjusting nut (E) with a wrench.

5b) With (G) loosened, turn the front adjusting nut (E) until it lightly touches the contact point (F) on the connector pin (D).

5c) Tighten the rear adjusting nut (G) against the connector pin (D).

5d) While holding the front adjusting nut (E) with a wrench, torque the rear adjusting nut to **7.5 Nm (5.5 ft. lbs. / 66 inch-lbs.)**.

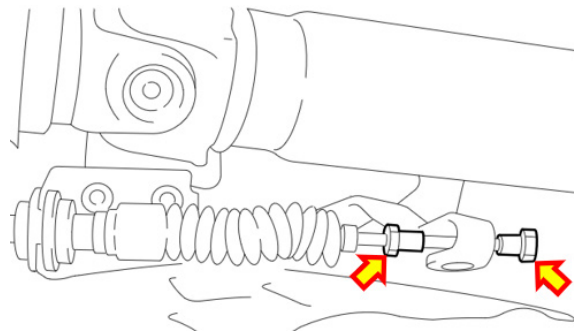
Step 4: With the center exhaust cover removed, locate the select cable adjusting nuts as shown below.

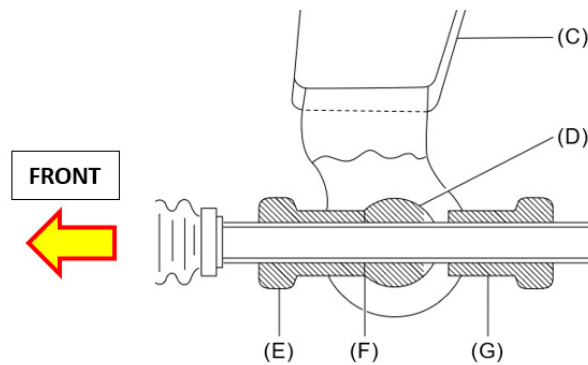
Step 5: Using the illustration below as a guide, confirm the select cable adjustment and proper torque of adjustment nut (G):

5a) Loosen the rear adjusting nut (G) while holding the front adjusting nut (E) with a wrench.

5b) With (G) loosened, turn the front adjusting nut (E) until it lightly touches the contact point (F) on the connector pin (D).

5c) Tighten the rear adjusting nut (G) against the connector pin (D).

5d) While holding the front adjusting nut (E) with a wrench, torque the rear adjusting nut to **7.5 Nm (5.5 ft. lbs. / 66 inch-lbs.)**.
