# Safety Recall

## Code: 40Q7

**Subject** Steering Knuckle(s)

**Release Date** February 05, 2021

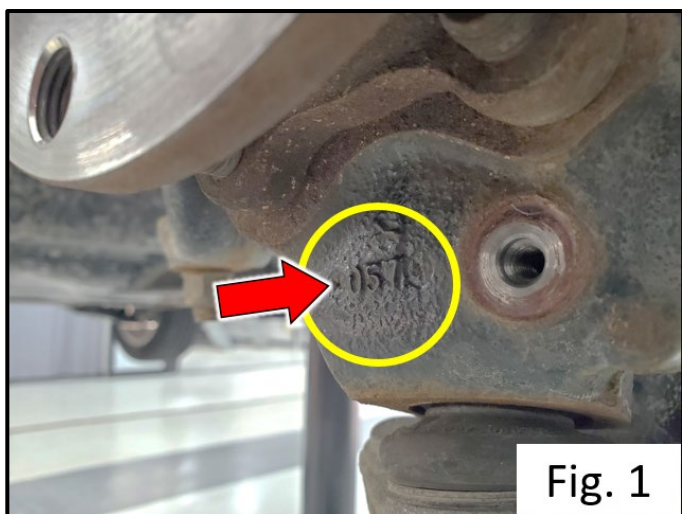
Fig. 1

- Inspect both front wheel bearing housings.
- Locate the wheel bearing housing casting date <arrow> (Fig. 1).
- If the casting date is **254**:

- **THE VEHICLE MUST NOT BE RETURNED TO THE CUSTOMER OR DRIVEN!!**

The casting date may be preceded by the letters "JD".

- The affected wheel bearing housing must be replaced.

**Take a clear photo of the casting date.**

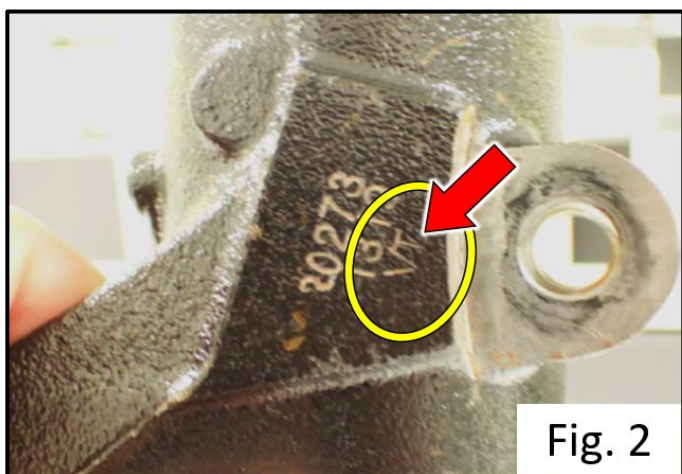
Fig. 2

- Inspect both front wheel bearing housings.
- Locate the production stamping on the wheel bearing housing <arrow> (Fig. 2).
- If the casting date is **253** (Fig. 1) AND the machining code **VT** is present (Fig. 2):

- **THE VEHICLE MUST NOT BE RETURNED TO THE CUSTOMER OR DRIVEN!!**

- The affected wheel bearing housing must be replaced.

**Take clear photos of the casting date and machining code.**
