SIB 32 01 21

RECALL 21V-031: STEERING SPINDLE

BMW AG is conducting a Voluntary Safety Recall (effective January 22, 2021) on a small number of Model Year 2021 BMW vehicles that were produced between September 8, 2020 and September 17, 2020.

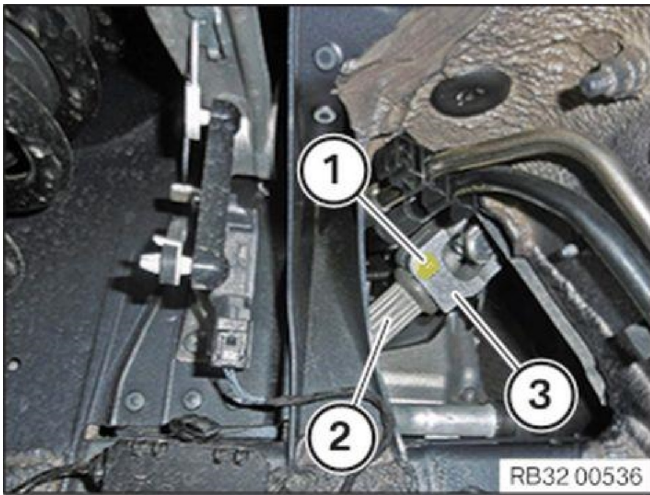
2. Remove the bolt (1) from the steering spindle universal joint connection (3).

3. Inspect universal joint for imprint from the bolt head.

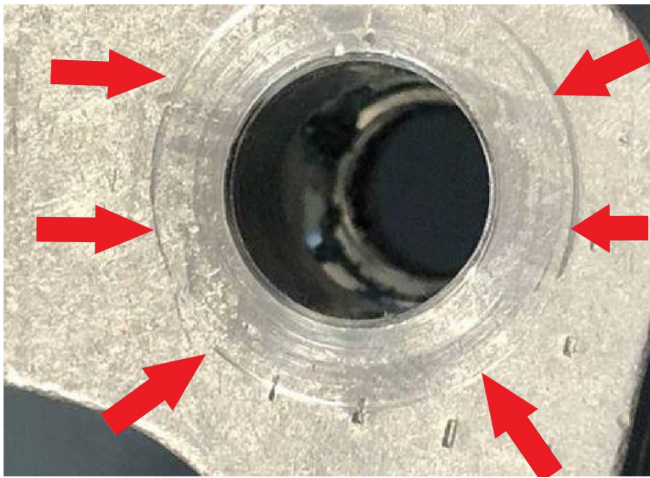
NOTE: A clear photo of the universal joint surface where the bolt head contacts it (see next photo), regardless of results, must be submitted immediately via a TSARA info case.

4. Can an imprint of the bolt head be seen on the universal joint surface as indicated in the area of the red arrows?

Yes, replace the bolt, and torque to specifications per REP 32 31 211

No, replace the steering spindle and universal joint as per REP 32 31 070 and 32 32 211
