# Recall Campaign Bulletin

Campaign No. 2021020010, February 2021  
Revision A 11/11/2022

SUBJECT: **Model C-Class Cabriolet vehicles (A205 platform)**  
**Model Year 2017-2021**  
**Check Front Seat Belts (Driver and Passenger)**

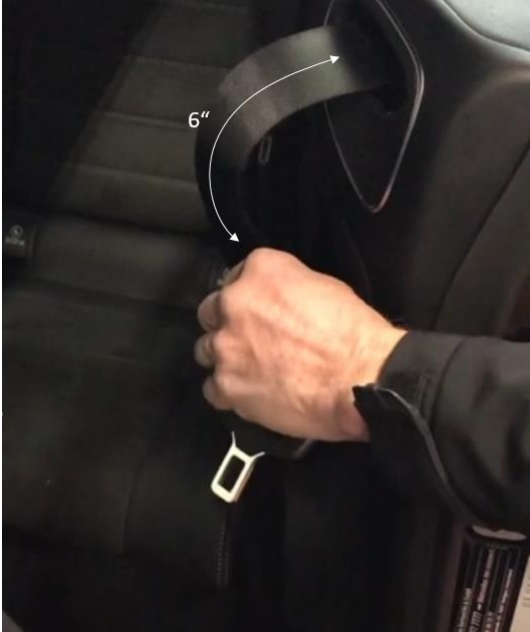
Figure 1

**i** For the last 6" manual assistance to rolling up the seat belt strap is allowable. The last 6" is defined as being measured from the buckle latch plate button (**Figure 1**).

- a. Seat belt strap does **not** roll up into its final position automatically even with manual assistance **for the last 6"**: Carry out **work procedure**.
- b. Seat belt strap rolls up into its final position automatically with or without manual assistance for the last 6": **End measure**.
