Recall Campaign Bulletin

Campaign No. 2022050004, June 2022

SUBJECT: **Model GLE-Class (167 platform)**
Model Year 2020

Check and Replace Lighting Control Unit

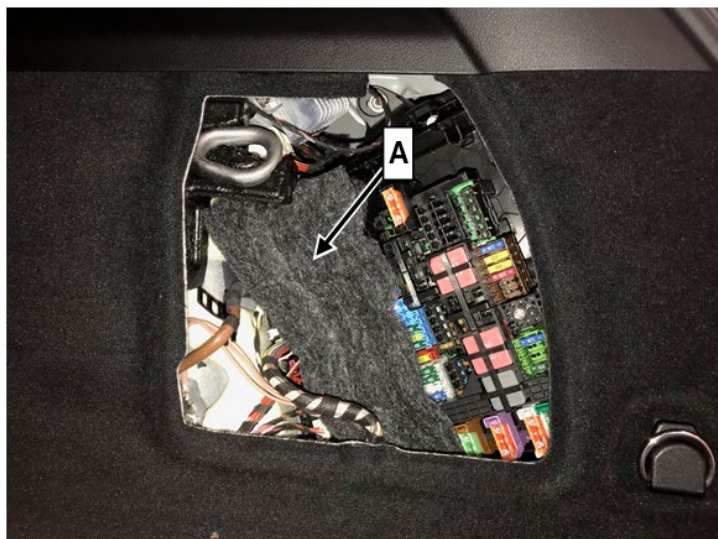
Figure 1

1. Connect XENTRY Diagnosis.
2. Update software of signal acquisition and actuation module.
 - i** The software with the part number **A1679027813** **must** be updated.
 - i** To do this, select menu item "Quick test view – N10/8 rear signal acquisition and actuation module (rear Sam) – Adaptations – Control unit update – Updating of control unit software".
 - i** Then follow the user guidance in XENTRY Diagnosis.
3. Disconnect ground line of battery (AR54.10-P-0003ME).
4. Remove service flap in right rear trunk.
5. Remove insulation (**A, figure 1**) and unscrew screw (**B, figure 2**).

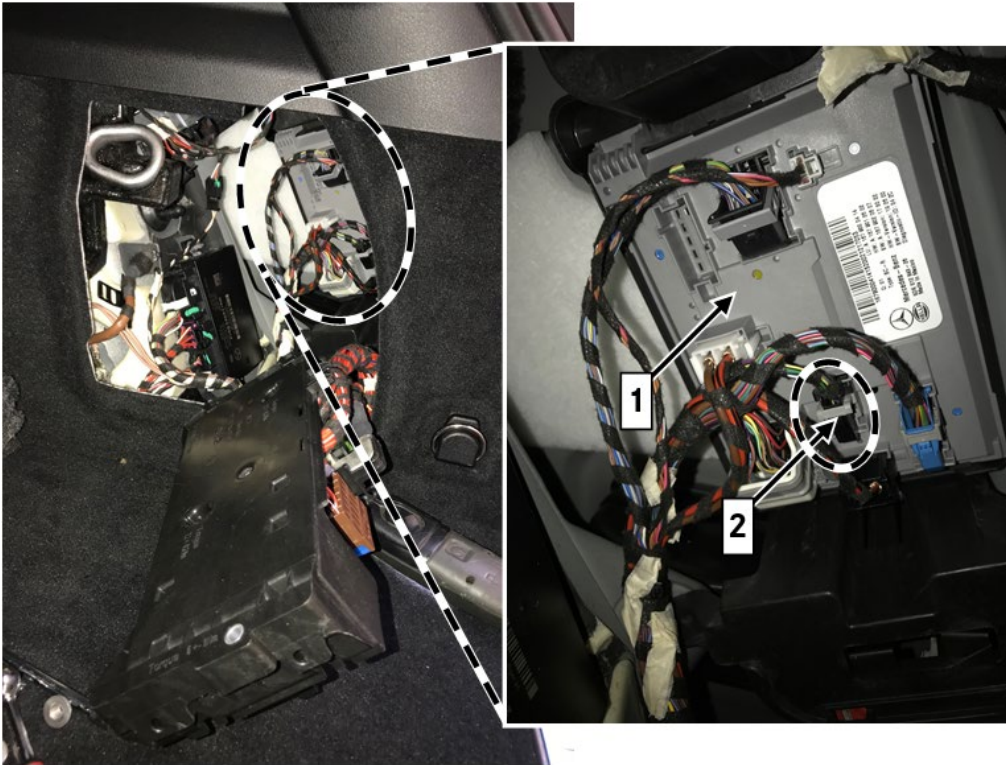
Figure 3

6. Release fuse and relay module and set down with connected lines through service flap in trunk (**figure 3**).

7. Move/wiggle Heck L plug (**2, figure 3 and figure 4**) as well as disconnect the contacts and connect the contacts again.
i Ground line of battery shall **not** be connected.
