**Safety Recall 4621B – 2020-2021 CX-30 Power Liftgate May Partially Lower Unexpectedly**

**REPAIR PROCEDURE**  
**Recall Campaign 4621B**

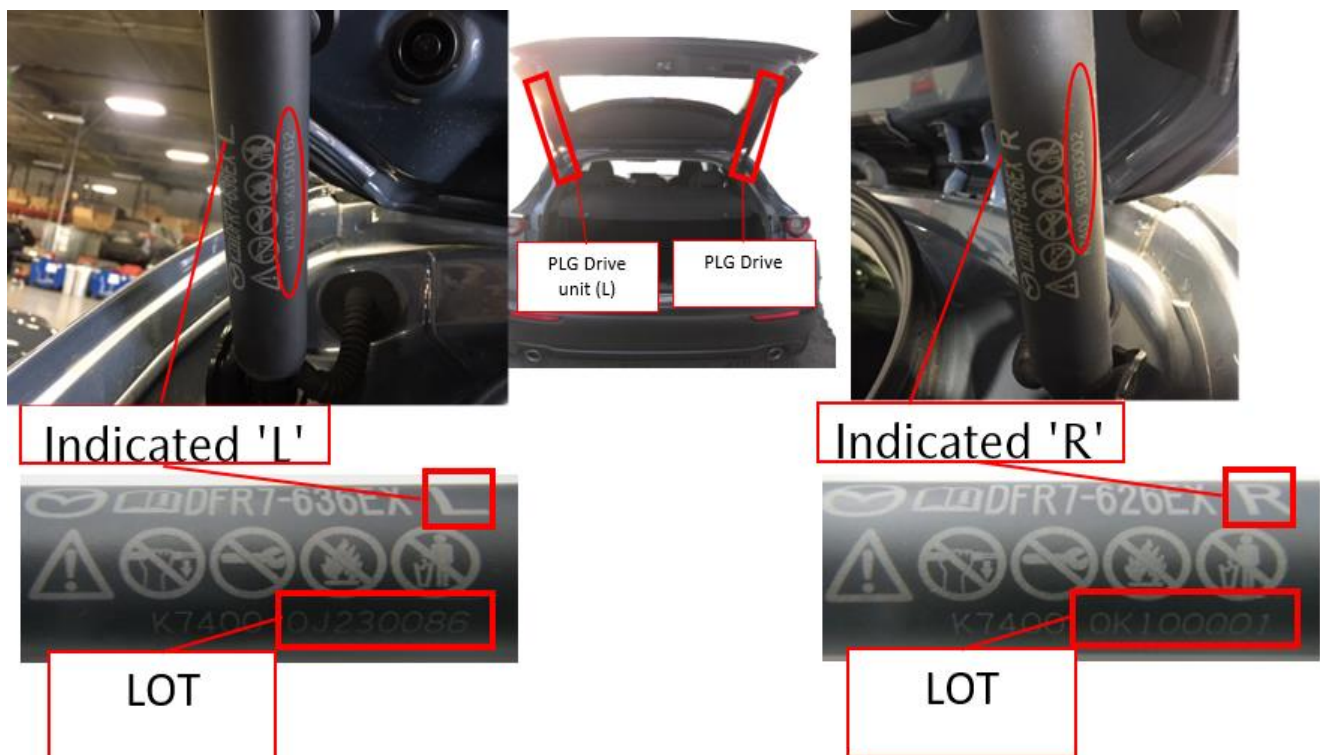
1. Open the Liftgate and write down the 8 Digit Lot Number
2. There is a number (9 or 0 indicates year) followed by a letter (Indicates month) and 6 numbers. Input all 8 digits into the Lot Number calculator or an error will occur. Note: If there is no number before the letter, input 9 (2019 production). Example : G050032 →9G050032
3. If the result is Not Affected replacement is not required. Reprogram power liftgate module with supplied SSPC5/4621B MDRT. This will be 96% of the vehicles.
4. If the result is Affected, write down the affected side Left, Right, or Both, Contact Dealer Recall Help with the Affected Lot number. They will verify and order the part. Proceed to MDRT reprogramming and then to Replacement of the PLG Drive Unit "C".
