**UPDATED June 7, 2024 – Using M-MDS to reprogram vehicle and added labor ops**

## Safety Recall 4621B – PLG Reprogramming and replacement

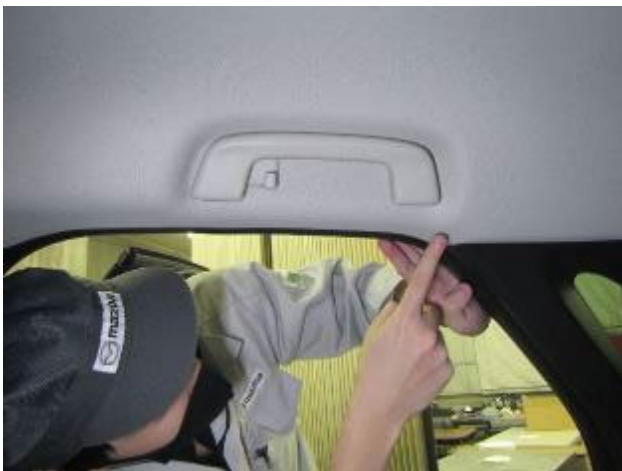
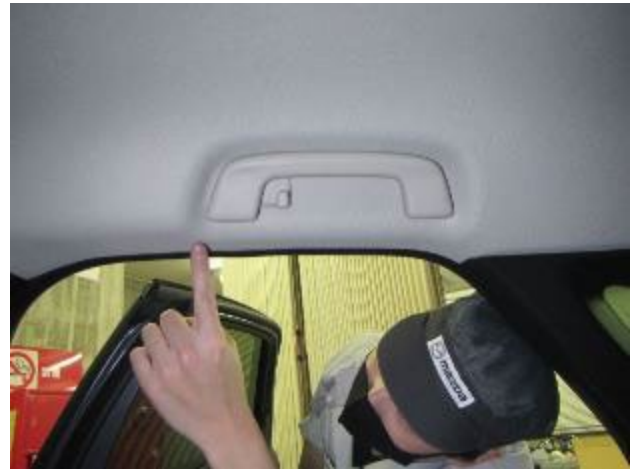
**AFTER-POST REPAIR CHECK - Make sure the headliner has no damage (or wrinkle) around assist handle, or interference with the trim after installation.**

REMOVE AND REPLACE WITH THE NEW PLG DRIVE UNIT (ONE SIDE OR BOTH SIDES) Following the MGSS Procedure: [POWER LIFTGATE \(PLG\) CONTROL MODULE REMOVAL/INSTALLATION](#)
