SIB 66 02 21

RECALL 21V-096: REARVIEW CAMERA

This Service Information bulletin (Revision 2) replaces SI B66 02 21 **dated February 2021**

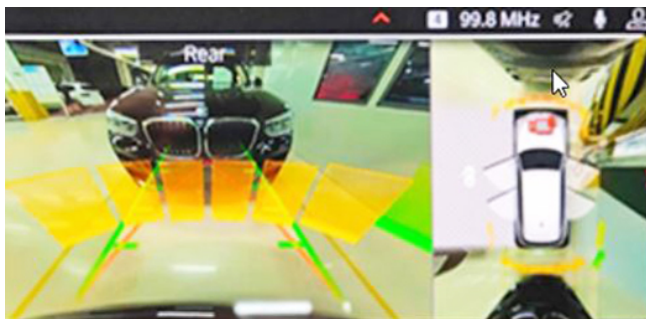
Picture 1.

The images are displayed in the **correct image position** on the CID for vehicles equipped with option code 6U3.

10. Allow the vehicle to sleep for 5 minutes.
11. Reassess the vehicle.
Note: Camera image in the CID must match the picture 1 seen in the situation above.

12. If the image does not match picture 1, then recode the ICAM by repeating steps 5 – 9 above.

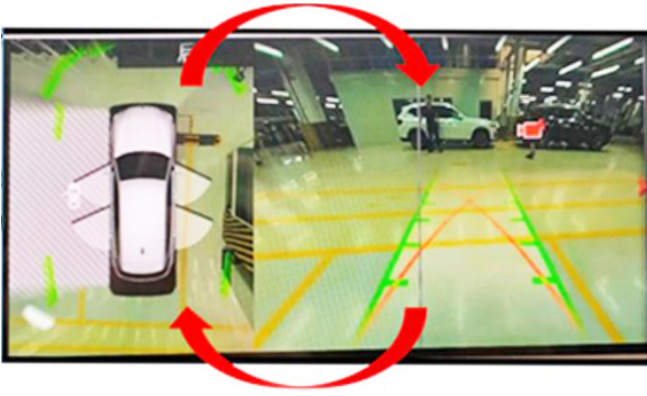
Picture 2.

Shows a possible failure in vehicles equipped with option 6U3.

The top view and rearview images are **incorrectly displayed** in the wrong position (swapped) on the CID.

Note: The camera icon is in the correct location, however it seems out of place due to wrong image location.

Software coding error in the ICAM control unit with Integration Level-

Encode the ICAM using ISTA 4.27.1x or higher (released December 2020).

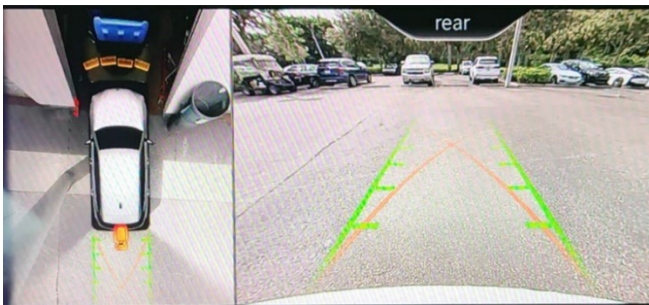
Picture 3.

Shows the **correct image display** for vehicles without option code 6U3.

Note: The correct image layout for vehicles without option code 6U3 is opposite to the layout for vehicles with option code 6U3 (seen in Picture 1 above).

1. Visually check and compare the camera image in the display to picture 3 above in the situation.
2. If the camera image is displayed in the CID match picture 3, then no further repairs are required.

9. Depending on the rework list, if necessary, perform vehicle test and delete the error memory (faults).
10. Allow the vehicle to sleep for 5 minutes.
11. Reassess the vehicle.
Note: Camera image must be displayed in the CID as shown in picture 3 seen in the situation above.
