SIB 66 02 21

RECALL 21V-096: REARVIEW CAMERA

This Service Information bulletin (Revision 1) replaces SI B66 02 21 **dated February 2021**

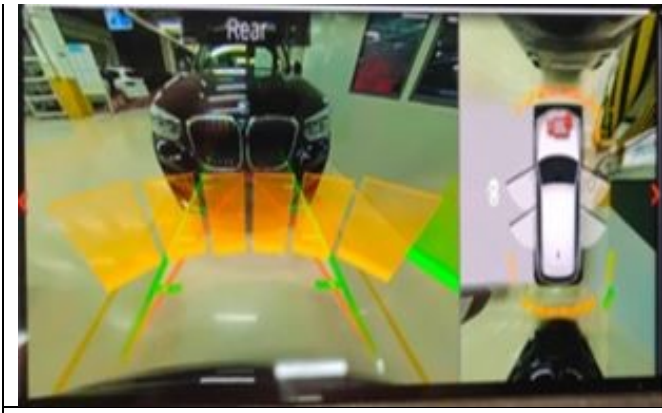
<p>Picture 1. The images are displayed in the correct image position on the CID for vehicles equipped with option code 6U3.</p>
--	---

1. Visually check and compare the camera image in the display to pictures 1 and 2 above in the situation.
2. If the camera image displayed in the CID match picture 1, then no further repairs are required.

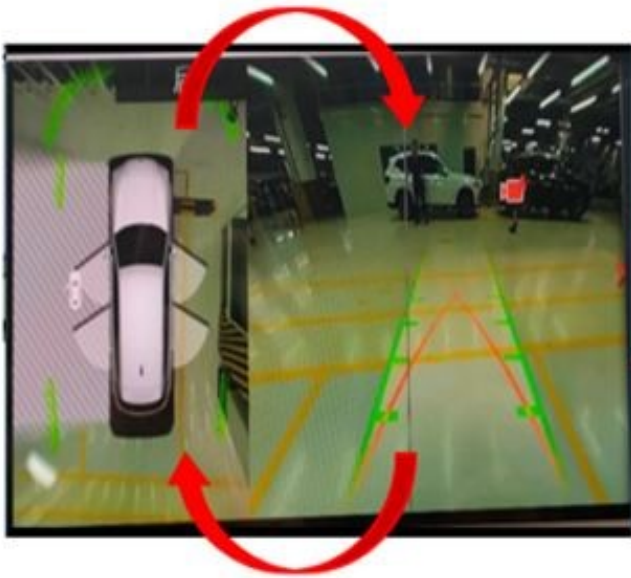
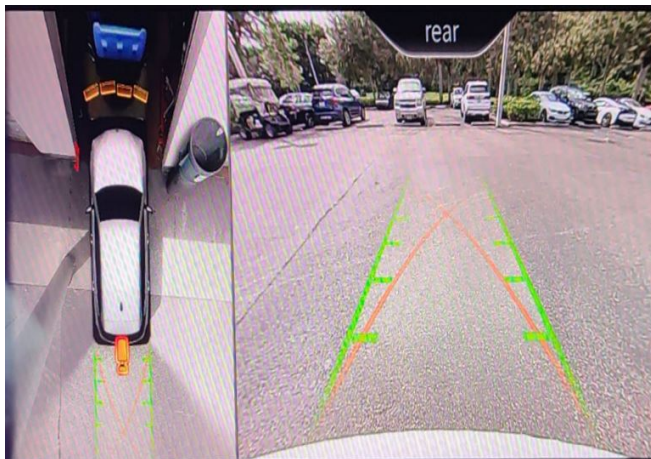
Picture 3.

Shows the **correct image position** for vehicles without option code 6U3.

1. Visually check and compare the camera image in the display to picture 3 above in the situation.
2. If the camera image is displayed in the CID match picture 3, then no further repairs are required.
