Campaign code:
L734-R.01.21

Campaign Name:
Replacement of engine hood hinge screws

Model:
Aventador SVJ Coupé

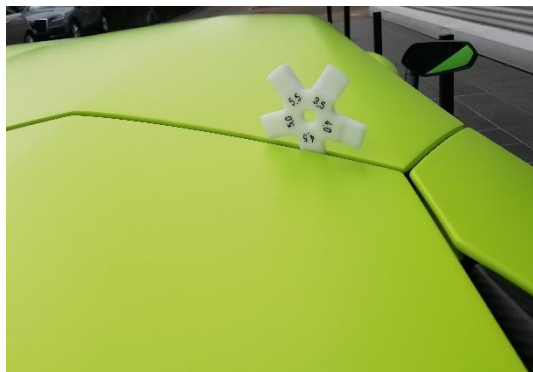
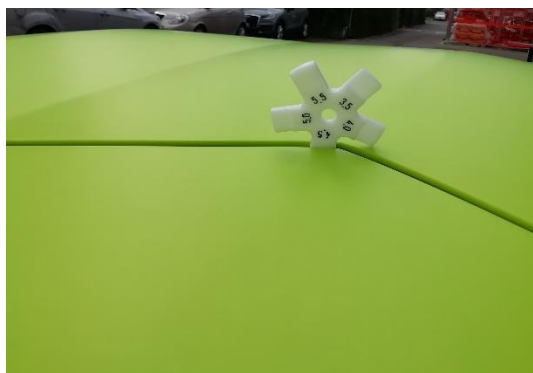
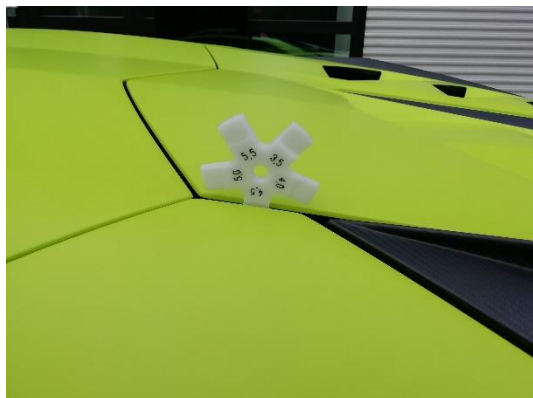
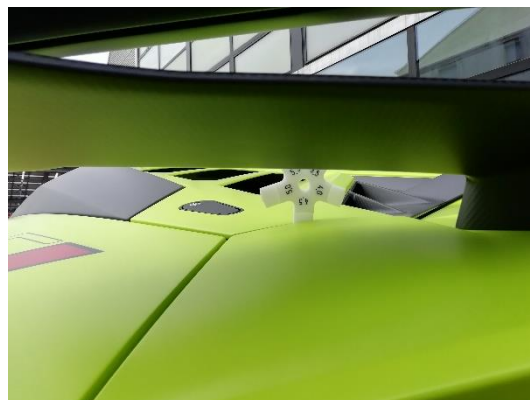
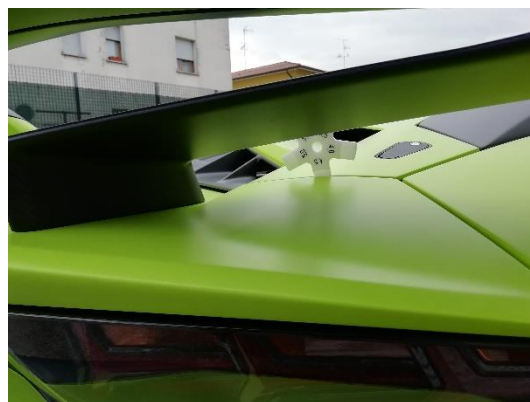
1. Using a appropriate feeler gage, check the alignment measurements of the engine hood along the entire perimeter before removal.

Take note of the measurements taken to perform a check when the job is completed.
